Seminar 3: Structures to withstand natural disasters: experiences and applications

Zeitschrift: **IABSE congress report = Rapport du congrès AIPC = IVBH
Kongressbericht**

Seismic Damage and Retrofit to California's Urban Concrete Bridge Structures

Frieder SEIBLE

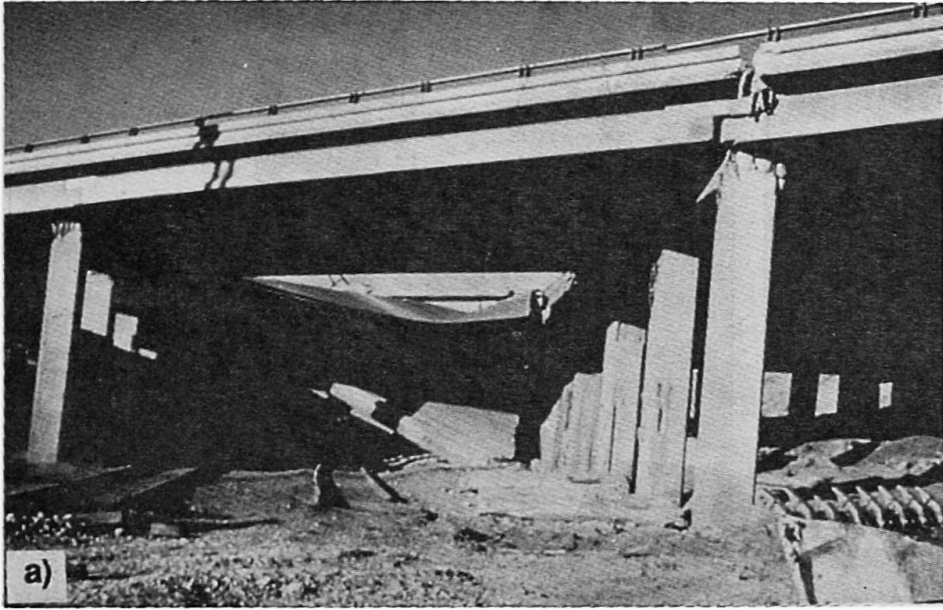
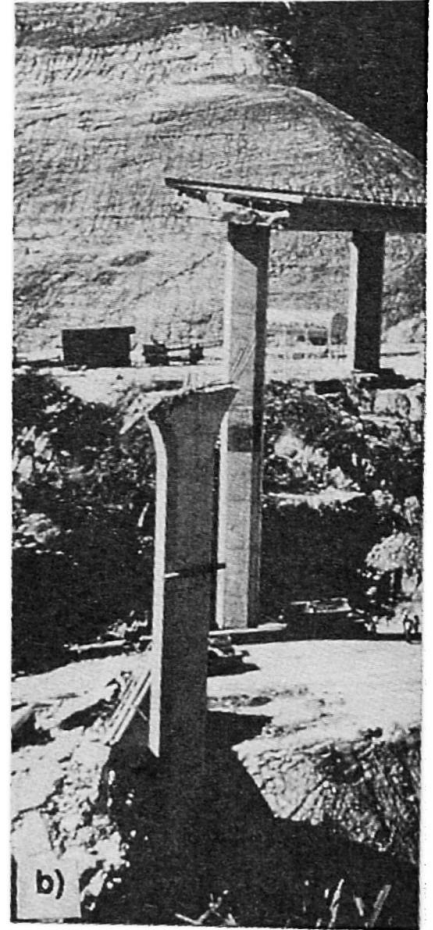
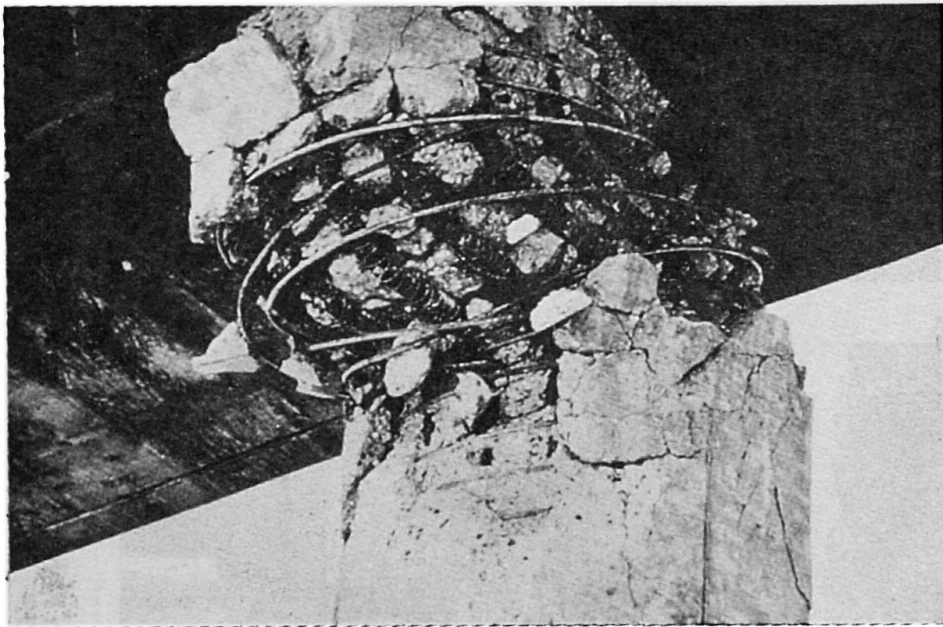
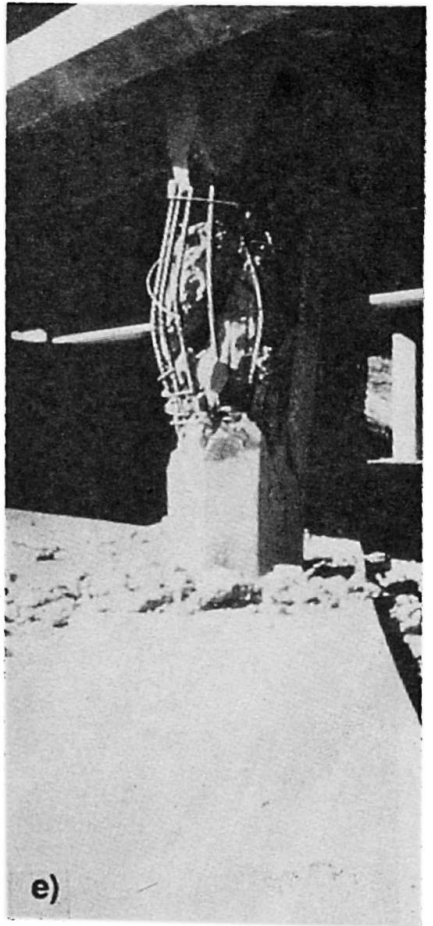
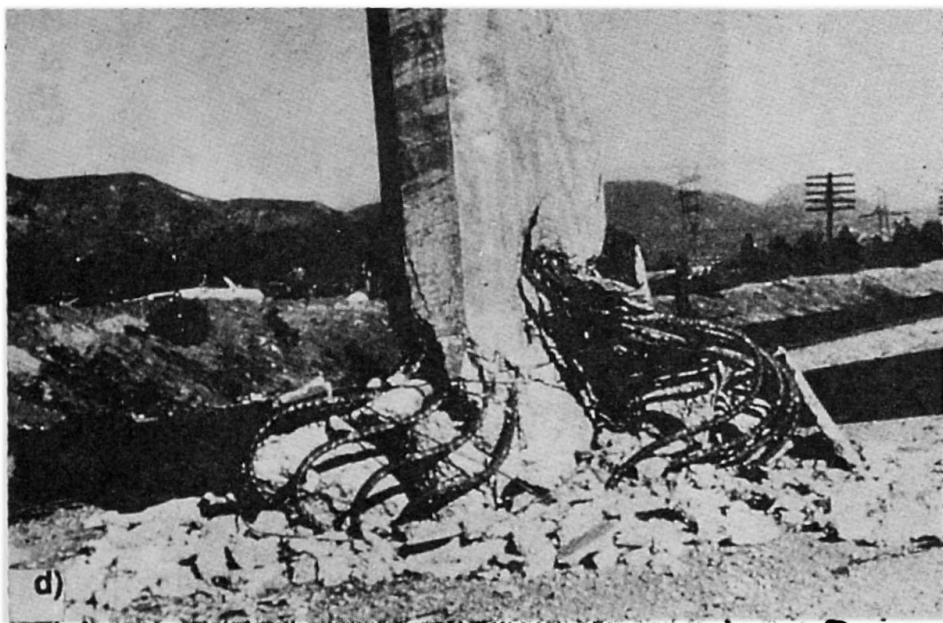
Fig 1. Bridge Damage During the 1971 San Fernando Earthquake

The 1971 San Fernando earthquake caused significant bridge damage, particularly to newly constructed interstate bridges. Key problems identified ranged from excessive seismic displacements and subsequent unseating of complete bridge spans at movement joints, see Figs. 1a and b, inadequate confinement of flexural plastic hinge regions in columns, see Figs. 1c and d, and Figs. 2a and b, anchorage problems with large diameter \varnothing 57 mm (#18) column reinforcement into the footing, see Fig. 2d, brittle shear failure of short columns with insufficient shear reinforcement, see Fig. 1e, and joint failures of knee joints due to the lack of joint shear reinforcement, see Fig. 2c. It is of interest to note that subsequent earthquakes such as Whittier (1987) and Loma Prieta (1989) did not uncover completely new problem areas which were not already identified in San Fernando (1971) but rather reemphasized some of the above mentioned problems.

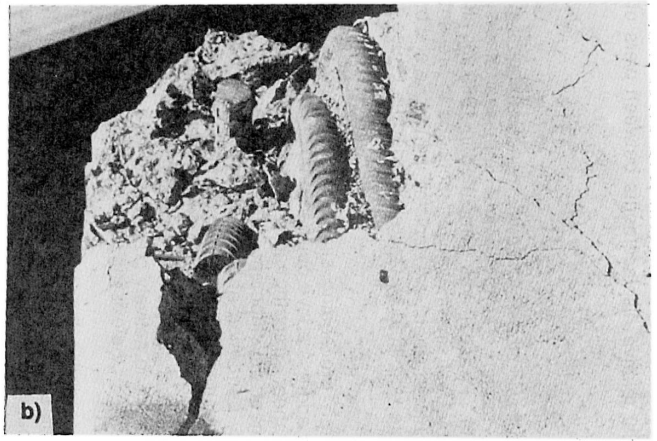
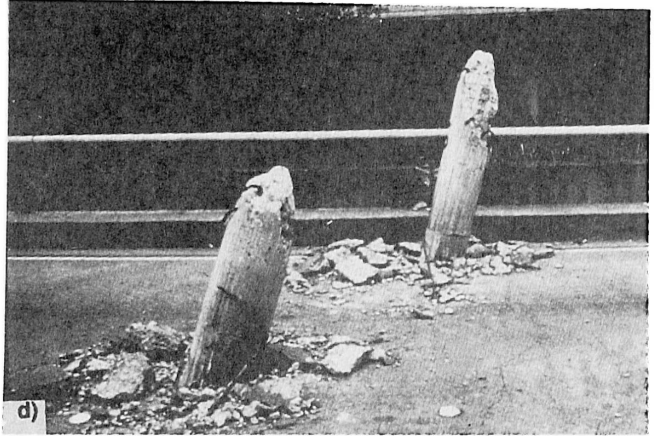
Fig 4. Knee Joint and Plastic Hinge Failure, Loma Prieta 1989

Outrigger bents showed problems in flexure and shear in the cap and shear failure of knee joints, see Fig. 4a, due to lack of shear reinforcement, and a fractured 57 mm \varnothing (#18) bar was encountered in a damaged knee joint on I-980, see Fig. 4b, which can be attributed to large strains introduced during bar bending (6.25%) and possible strain aging effects.

Finally, on struve slough, Figs. 4c and d, the plastic hinge at the column top sheared off and the column offset in the longitudinal bridge direction and punched through the reinforced concrete deck slab.

A flared pier wall which experienced shear distress during the Loma Prieta earthquake was repaired and retrofitted with a full height steel jacket, see Fig. 5c, for increased shear capacity. The previously discussed joint shear failure in an outrigger knee joint of I-980, see Fig. 4b was repaired by full replacement of the joint concrete, see Fig. 6d, and added joint shear reinforcement, while the outrigger bent shown in Fig. 4a was completely replaced, see Fig. 5e.

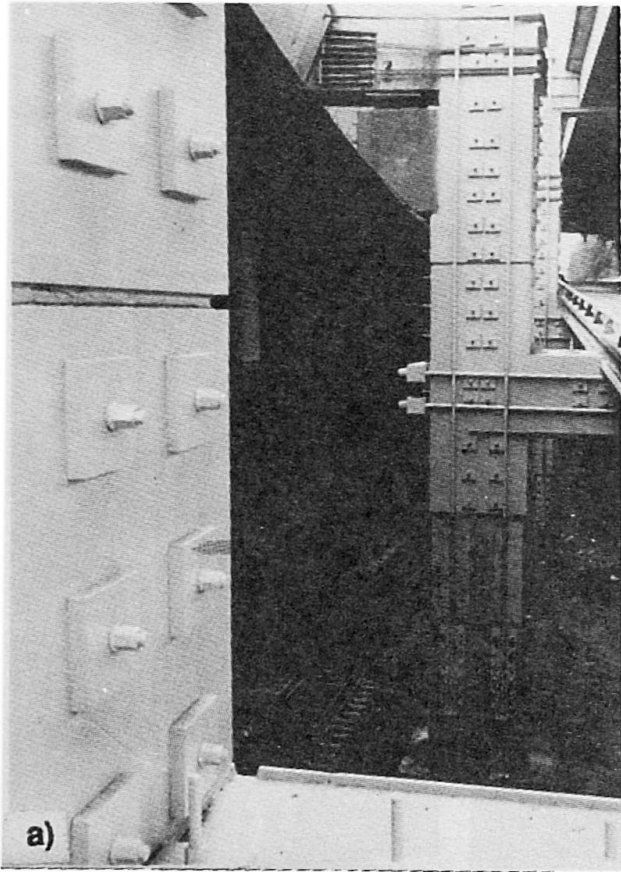
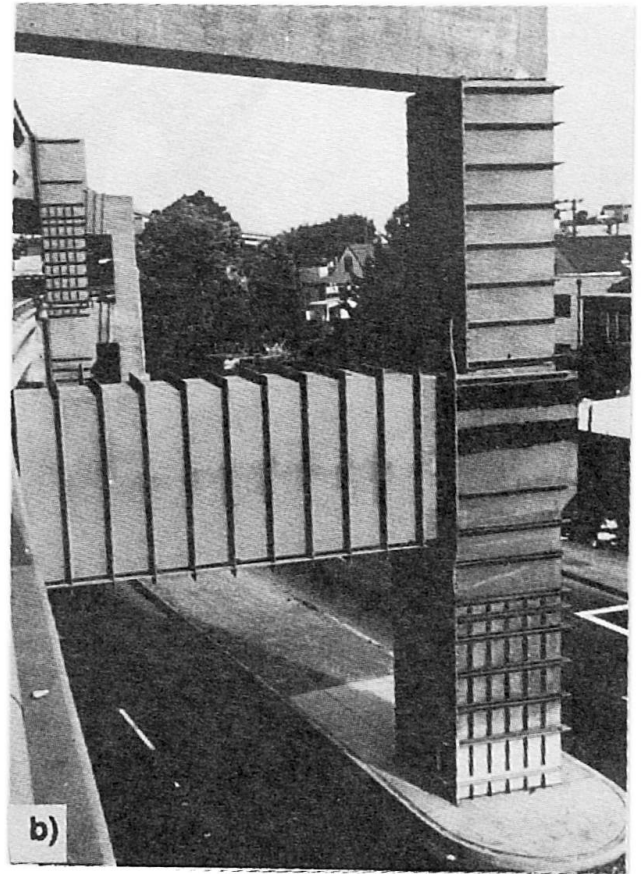
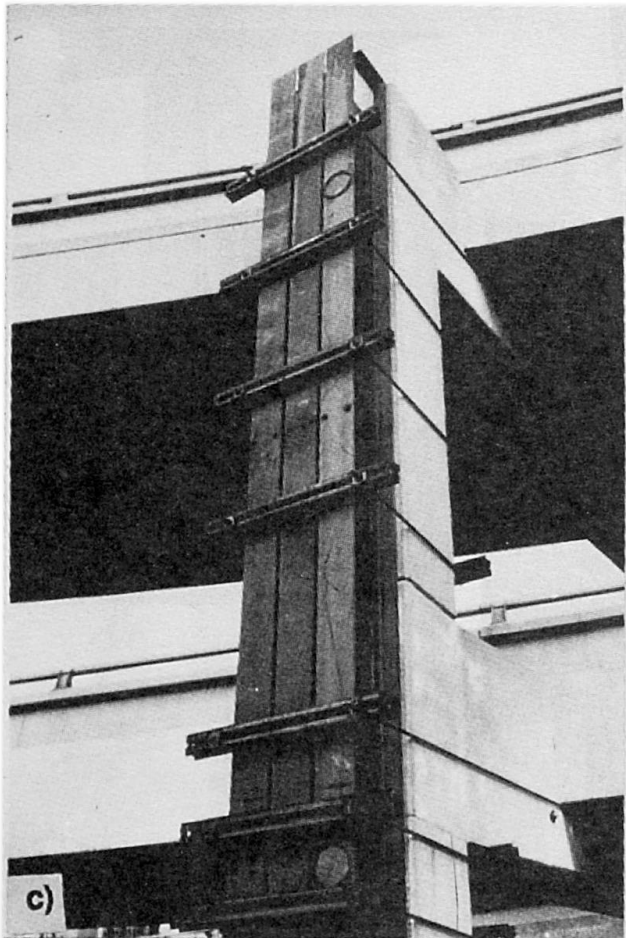
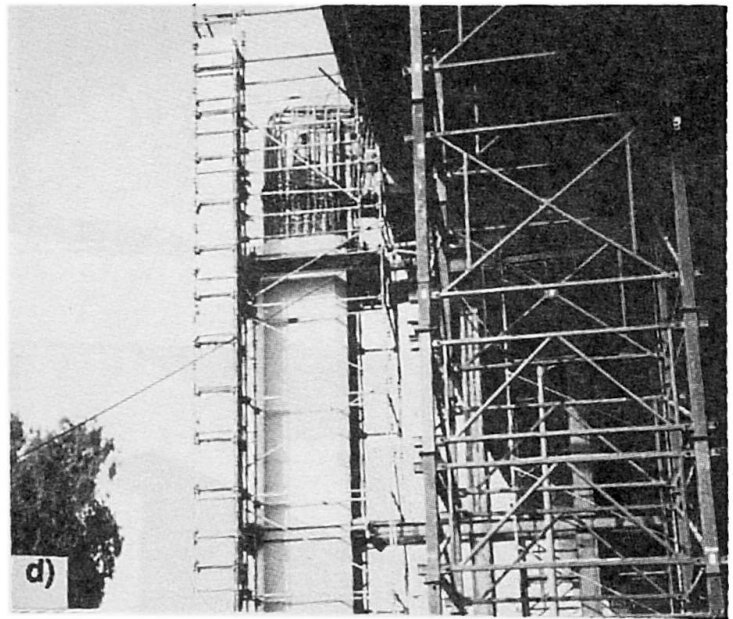
Fig 6. Temporary and Permanent Retrofit Measures

**Full joint replacement
I-980, Oakland, CA**

Following the Loma Prieta earthquake, several double-deck viaducts in San Francisco were closed to traffic and temporary retrofit strategies were designed to prevent collapse in the case of additional seismic activity in the near future. Some of the temporary retrofits were fully or partially implemented, see Figs. 6a, b and c. However, their ineffectiveness in providing required lateral confinement levels and their lack of global structural seismic retrofit strategy, see [3], prompted a reevaluation of these temporary retrofit schemes and resulted in the immediate design of permanent and final retrofit measures, which are currently being scrutinized, proof tested and implemented [3]. The difficulties encountered during the design process of the San Francisco double-deck viaduct retrofits and other ongoing retrofit projects showed the need for the development of consistent seismic assessment and retrofit strategies for bridge structures.
