**Structures to Withstand Natural Disasters:  
Experiences and Applications**

## Seismic Damage and Retrofit to California's Urban Concrete Bridge Structures

### **Frieder SEIBLE**

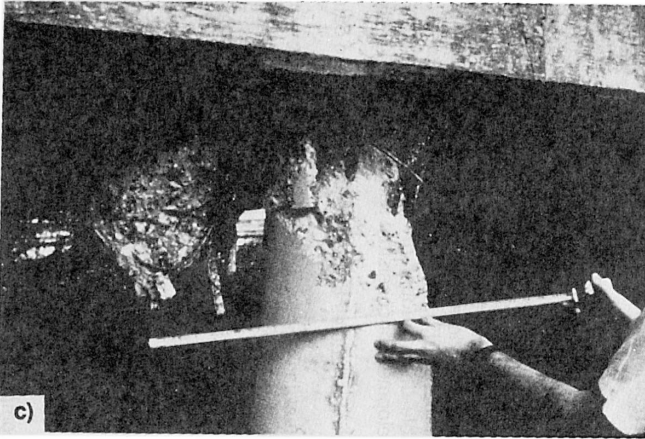
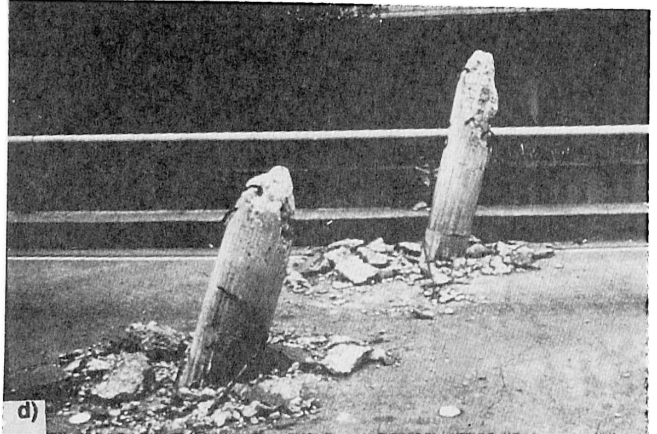
**Fig 4. Knee Joint and Plastic Hinge Failure, Loma Prieta 1989**

Outrigger bents showed problems in flexure and shear in the cap and shear failure of knee joints, see Fig. 4a, due to lack of shear reinforcement, and a fractured 57 mm  $\varnothing$  (#18) bar was encountered in a damaged knee joint on I-980, see Fig. 4b, which can be attributed to large strains introduced during bar bending (6.25%) and possible strain aging effects.

Finally, on struve slough, Figs. 4c and d, the plastic hinge at the column top sheared off and the column offset in the longitudinal bridge direction and punched through the reinforced concrete deck slab.

A flared pier wall which experienced shear distress during the Loma Prieta earthquake was repaired and retrofitted with a full height steel jacket, see Fig. 5c, for increased shear capacity. The previously discussed joint shear failure in an outrigger knee joint of I-980, see Fig. 4b was repaired by full replacement of the joint concrete, see Fig. 6d, and added joint shear reinforcement, while the outrigger bent shown in Fig. 4a was completely replaced, see Fig. 5e.
