Artikel: Seismic damage and retrofit to California's urban concrete bridge
structures

Autor: Seible, Frieder

Seismic Damage and Retrofit to California's Urban Concrete Bridge Structures

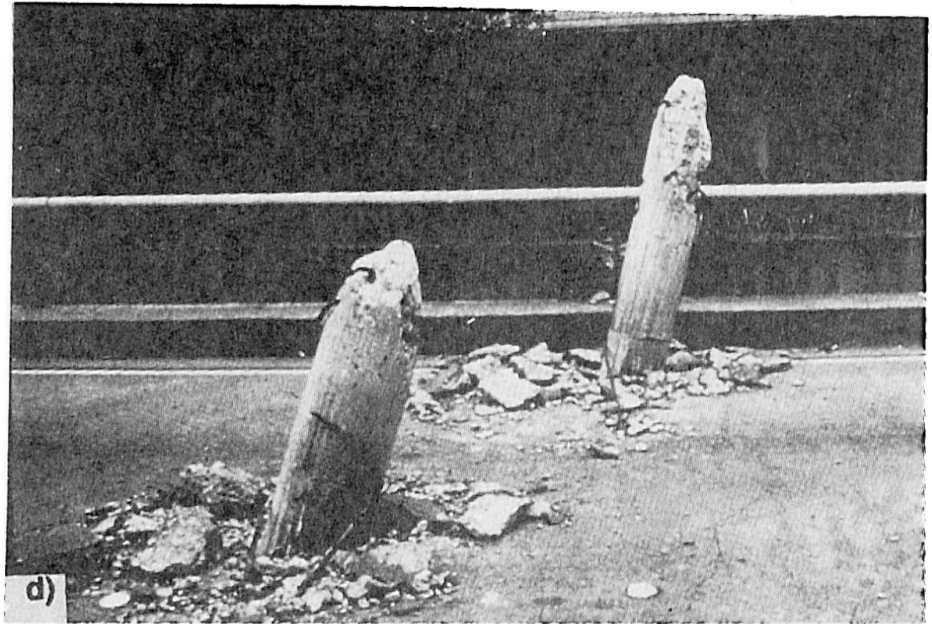
Finally, on struve slough, Figs. 4c and d, the plastic hinge at the column top sheared off and the column offset in the longitudinal bridge direction and punched through the reinforced concrete deck slab.
