# Recorded Failures of Electrically Welded Wrought Iron and Mild Steel Bridges.

H. J. L. Bruff,

Bridge Engineer, North Eastern Area, London & North Eastern Railway. York.

The failures occurred in the course of carrying out the repairs to an old Wrought Iron plate girder bridge in the City of Leeds, which, apart from having suffered very badly from corrosion needed to be strengthened, as it was considered of inadequate strength to carry modern traffic.

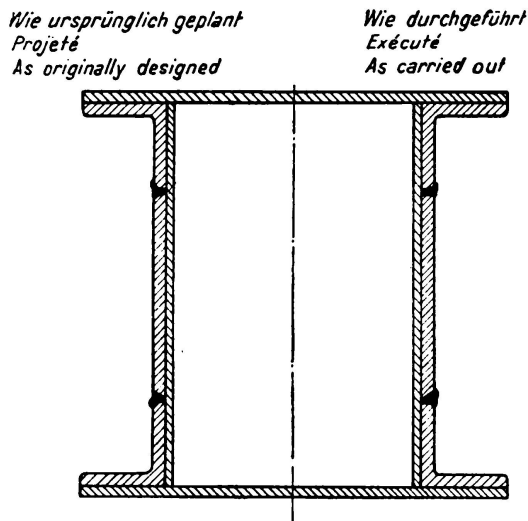
Fig. 1.

The observed failures of the welding occurred in the cross girders, which were of box type construction. They were badly corroded and had also suffered distortion of the webs due to overloading. This was caused by the removal, at some time, of certain rivets and their substitution with bolts which had rusted

Section of Cross Girder.

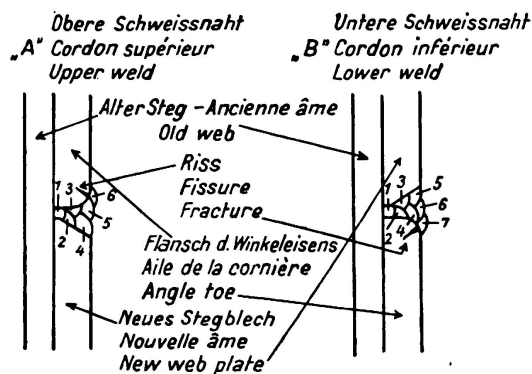
Fig. 2.

Details of Web Butt Welds as designed.

The most difficult portion of the work was the welding in of new web plates, as these had to be fitted in between the vertical flanges of the cross girder angles, which necessitated using fairly large butt welds. The procedure of carrying out this work was to tack weld the new web plates to the angle toes and then to weld alternately the top and bottom butts in runs of six inches, the number of runs being in some cases as many as seven. The butts when prepared were of the usual form adopted by my Chief for welds of this kind and the welding was as indicated in Fig. 2, A and B.
