# Maintenance of steel structures: discussion

Autor(en): **Berridge, P.S.A.**

Zeitschrift: **IABSE congress report = Rapport du congrès AIPC = IVBH  
Kongressbericht**

Band (Jahr): **5 (1956)**

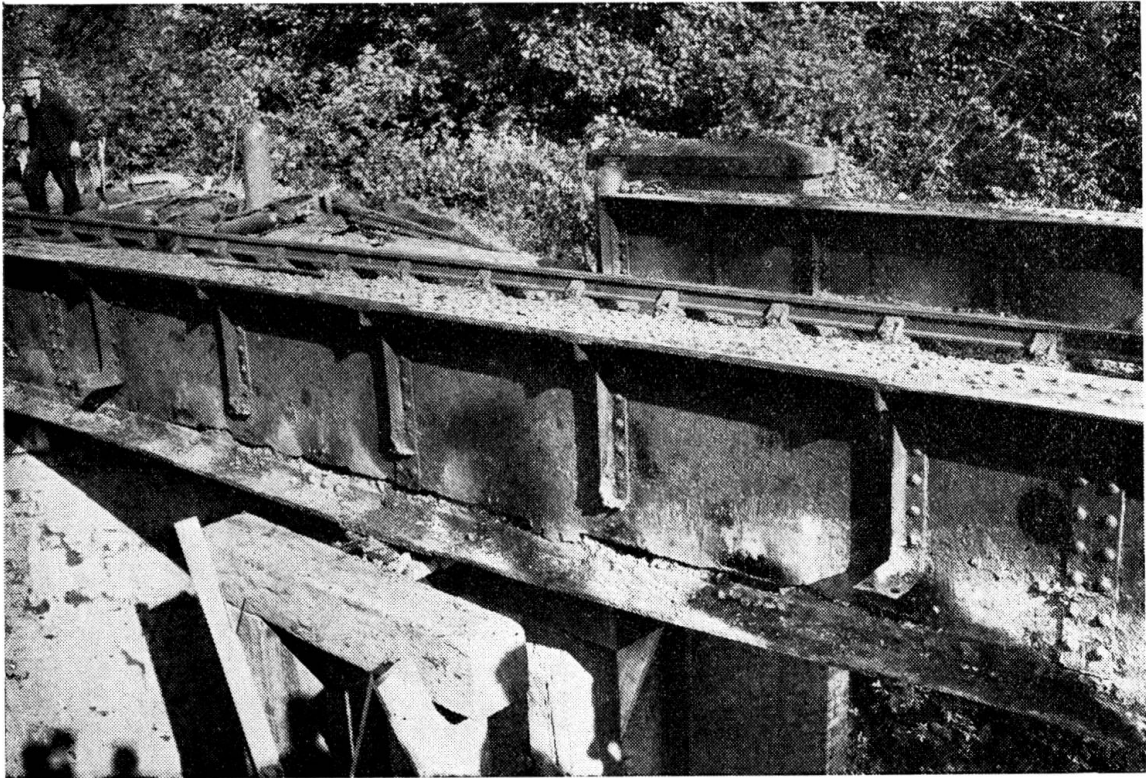
FIG. 1. The failure of a plate girder caused by corrosion fatigue of the mild steel web which had been obscured by concrete haunching. The decking on the nearside of the girder had been removed before this photograph was taken

Turning to the importance of accessibility for the proper maintenance of railway girder bridges, Mr BERRIDGE showed a picture (Fig. 1) of a centre girder of a double track half-through type plate girder span which through corrosion fatigue had developed a crack in the web plate

at a point just above the bottom flange angles. The crack had extended over a length of 19 feet in a 30-foot span. The primary cause had been the masking of the girder by concrete haunching placed against the web with the object of reducing maintenance work. Damp had got down between the concrete and the steel web plate with the result that corrosion had set in where it was wholly obscured from view. The decking was of transverse steel troughing resting on the bottom flanges of the girders

and the web stiffeners stopped on the top of the troughing so that there was in fact no connection between these stiffeners and the bottom flange of the girder. Alternations of loading by the passage of trains, first on one track, and then on the other, had led to high concentrations of stress on the web plate at a point immediately above the flange where moisture was trapped behind the concrete. To guard against such a failure it was imperative that the all-important connections between decking and main girders should be wholly accessible for inspection and painting; no concrete should be placed against steelwork unless it was absolutely certain that no moisture could get down between the concrete and the steel. Showing a slide (Fig. 2) he indicated how bolted joints between deck units and the main girders of a bridge carrying a ballasted sleeper track could be made fully accessible for maintenance. On the subject of the connections between cross girders, deck units, etc. and main girders in half-through type spans, Mr BERRIDGE showed a diagram (Fig. 3) indicating the bending moments caused by the end fixity of the deck members. In the past so many bridges had been built on the assumption that cross girders were simple beams unrestrained at the ends. Such an assumption was quite wrong when, as generally happened, some degree of fixity became inevitable in designing the connection between a cross girder and the side of a plate girder. In the joint just visible below the weather plates (Fig. 2) the moment stresses due to end fixity were taken by high strength bolts connecting the deck units to the sloping flanges of web stiffeners on the main girders.

Stressing the importance of accessibility, the author instanced (Fig. 1) a double track half-through type plate girder bridge where concrete haunching against the web of the middle girder had prevented the detection of a serious corrosion fatigue fracture of the web plate.

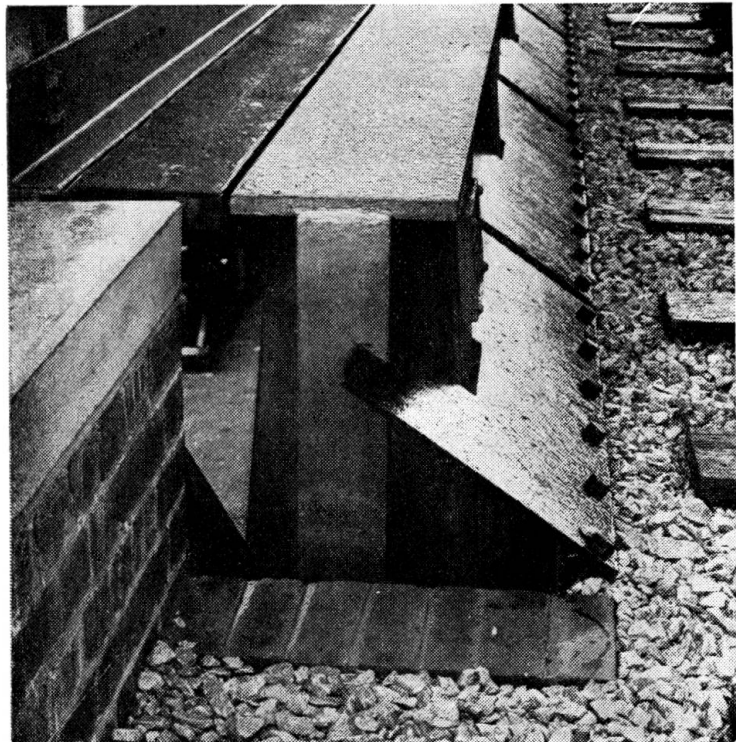
FIG. 2. The end of a welded plate girder showing how, by the removal of the bolted weather plates, full access is given to the joints between the deck units and the main girders

Improvements in the connections of deck units to main girders were shown (Fig. 2); attention was focused on the importance of designing such joints to carry the stresses induced by the end fixing moments inevitable wherever there is end restraint (Fig. 3).

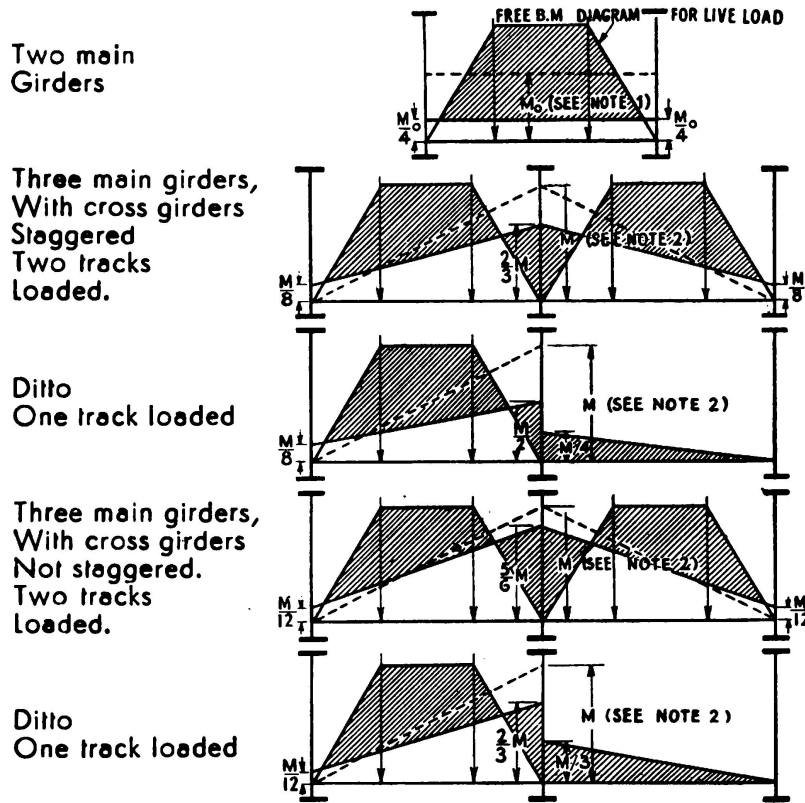
FIG. 3. Diagram indicating the end fixing moments on cross girders in half-through type spans
