The condition of partially prestressed concrete structures after 3 to 7 years' use

Zeitschrift: **IABSE congress report = Rapport du congrès AIPC = IVBH
Kongressbericht**

**The condition of partially prestressed concrete structures
after 3 to 7 years' use**

P. W. ABELES

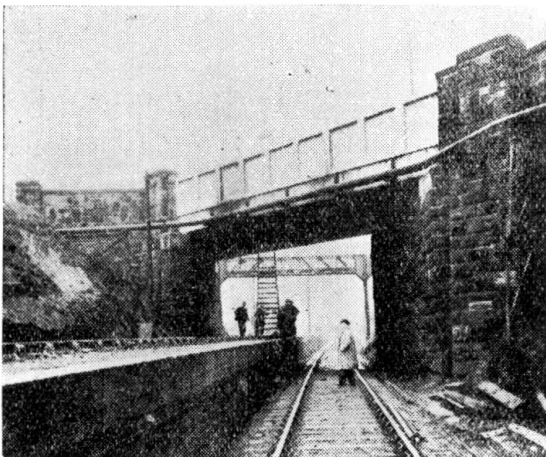
FIG. 1

deflection measurements [2]. A further inspection in May 1956 related to a skewed bridge of 50 ft. span which is particularly affected by smoke owing to the continual passing and repassing underneath of a colliery steam shunting locomotive at a pit near Rotherham (Fig. 1). Also this examination was very satisfactory (1).

(1) All these bridges, except that at Rotherham, were built to obtain greater head room for the overhead wire required for electrification of the railways. However, much steam traffic still occurs and instead of smoke plates metallurgical supersulphated cement has been successfully used. No sign of any damage due to smoke has been noticed.

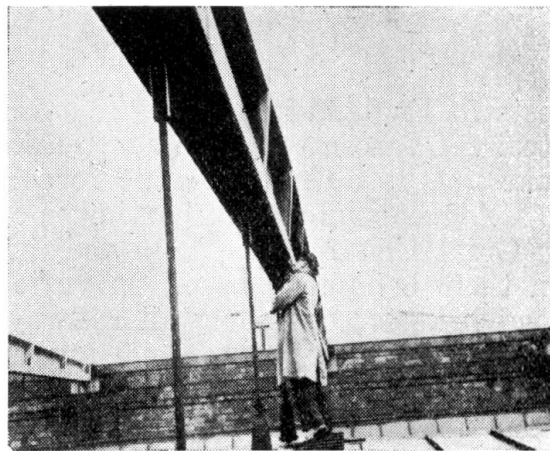
FIG. 2

of 1955/56, snow remained one to two months on most of the roofs discussed in the following. An inspection took place in April 1956 of the several roof constructions, e. g. of the Depot at Bury St. Edmunds built in 1952, described in [3]. Particulars of the examination in May 1956 of the main beams of 85 ft. span on the Victoria Station Roof Sheffield, built in 1953, are seen in Fig. 2.

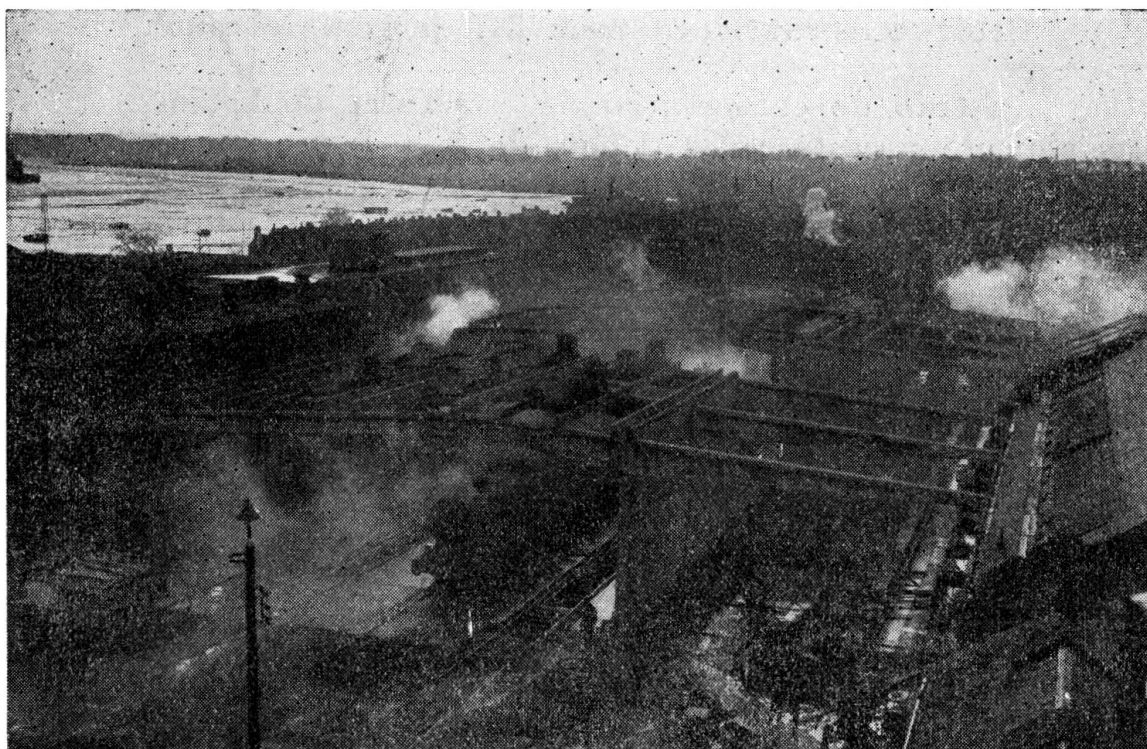
FIG. 3. Smoke development in Engine Shed, Ipswich

Figs. 3 and 4 are views of the Engine Shed, Ipswich, built in 1953, which was examined this year and proved fully satisfactory (2). This

(2) In some quarters it is thought that a particularly high factor of safety against cracking would be necessary where heavy smoke occurs, such as in an Engine Shed. However, any snow will immediately melt as long as the engine shed is in use and thus little such live load will occur. On the other hand, snow may remain on the roof when the engine shed is temporarily out of use.

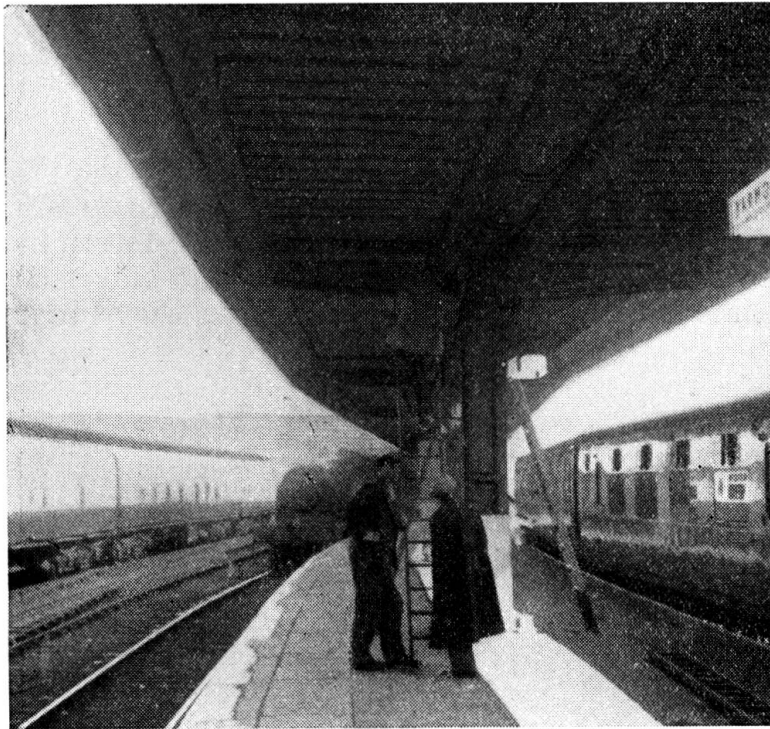
FIG. 5

roof contains 102 ft. long precast roof beams with post-tensioned cables and precast purlins with pre-tensioned wires. Fig. 5 shows the inspection of the platform roof at Yarmouth, built in 1953, containing 40 ft. long purlins 14 in. deep with pre-tensioned wires. In this case, both smoke and sulphate in sea air has not noticeably affected the construction. In Fig. 6 the platform roof at Grays built in-situ in 1953/54 is seen, which was inspected in 1955 with satisfactory results. The construction

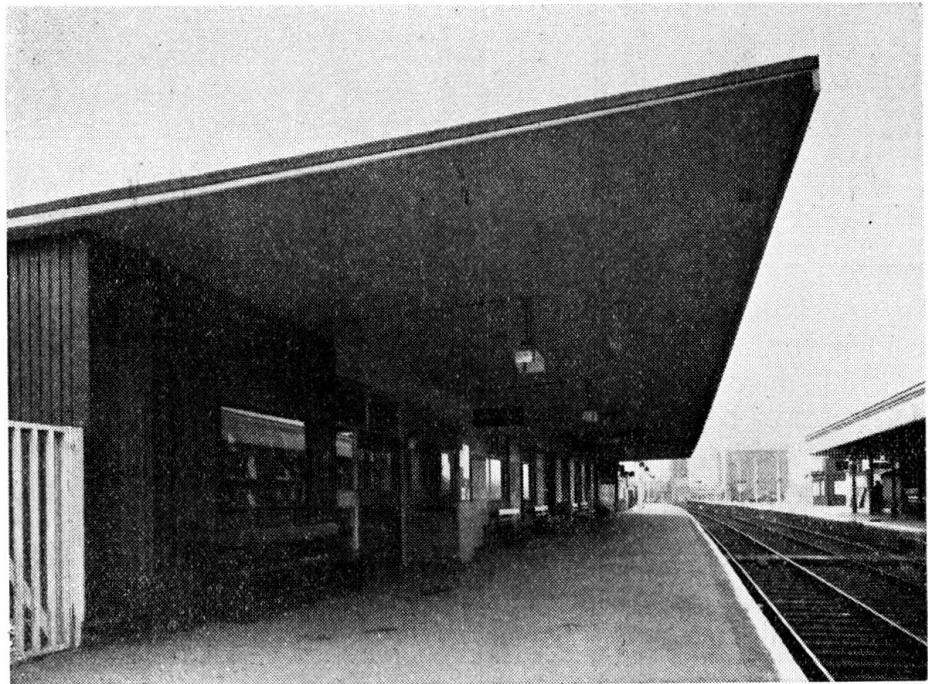
FIG. 6

is a cantilever slab with a maximum free cantilever of 18 ft. 6 in. length and a depth of 4 to 5 in.
