# Fracture and retrofit of Dan Ryan Rapid Transit Structure

**Fracture and Retrofit of Dan Ryan Rapid Transit Structure**

**J.W. FISHER**

**J.M. HANSON**

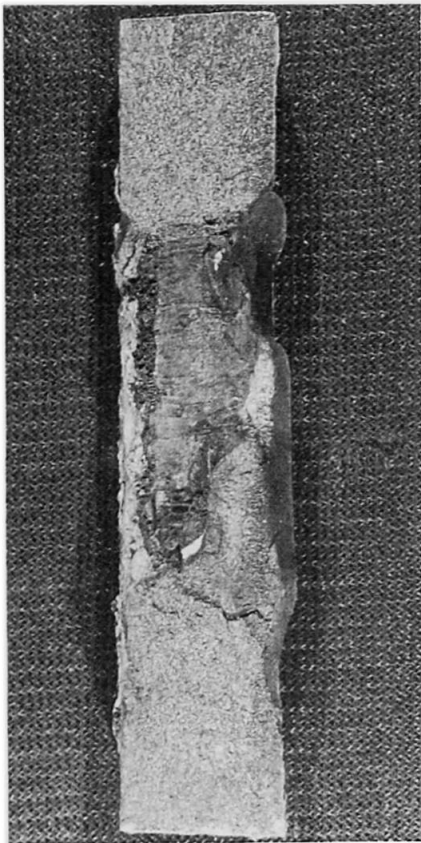
The crack surfaces of the side plates of the box girders adjacent to the flange tip were examined. Chevron markings found on the fracture surface indicated that the crack originated near the tip of the girder flange. A photograph and schematic of one fracture surface are shown in Figs. 3a and 3b. The overall fracture surface shows that the weldment connecting the flange tip to the box had a large lack of fusion area. Paint was found in some of these areas, which had penetrated from the inside of the box. The largest lack of fusion area was approximately 18 mm by 83 mm and was approximately elliptical shaped.

Fig. 3a Fracture Surface of Box Girder Web Plate

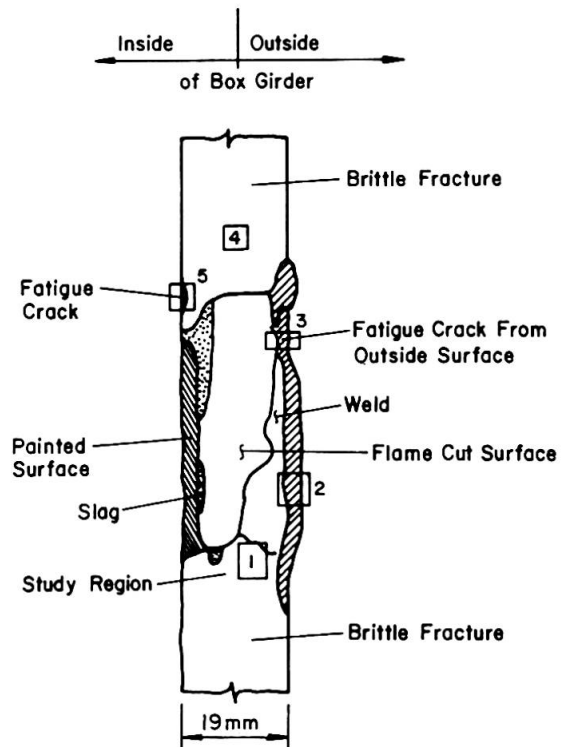
Fig. 3b Schematic of Fracture Surface

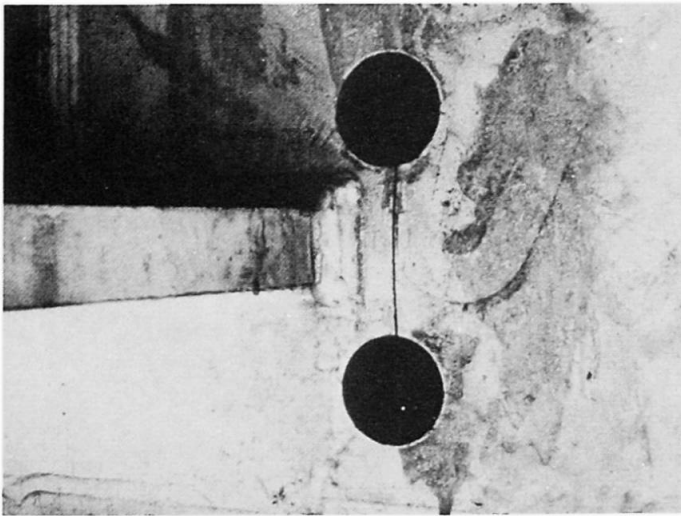
Fig. 6a Retrofitted Box Side Plate

Any retrofit must minimize the severe stress concentration at the intersection of the girder flange and the box girder webs and reduce the high residual stresses from the weld shrinkage. To accomplish this aim, those locations with small or negligible cracks at the flange tips were retrofitted by cutting holes and sawing between them to create a "dumbbell" configuration in the box side plates near the edges of the girder flanges, as shown in Fig. 6. This method of retrofitting was considered to release the residual stress field at the flange tip and to shield the critical location from the bending stresses.

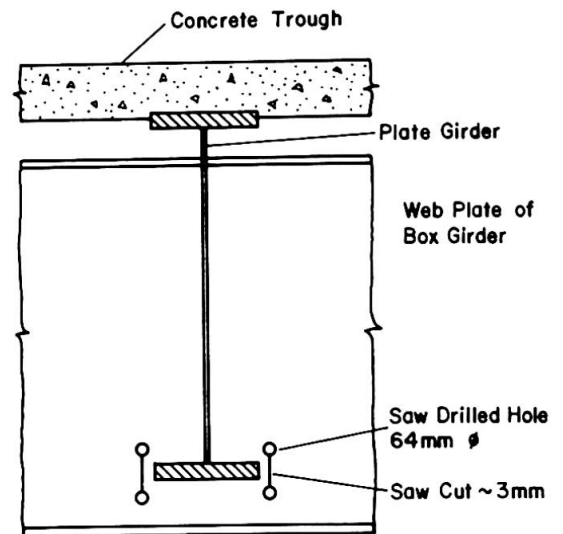
Fig. 6b Schematic of Retrofitted Detail
