IX**Reconstruction of a Railway Station in Budapest**

TIBOR SIGRAI

UVATERV

The track-hall of the Nyugati Western Railway Station of Budapest, built 1875–1877, is a steel structure with a span of 42 m, and a length of 153 m consisting of Polonceau trussing. The hall was to be reconstructed because of the damages caused by corrosion. The reconstruction was carried out during 1978–79, by taking into consideration the aspects of the protection of historical buildings. The less damaged but valuable structural parts were preserved and the newly manufactured parts were fitted to them.

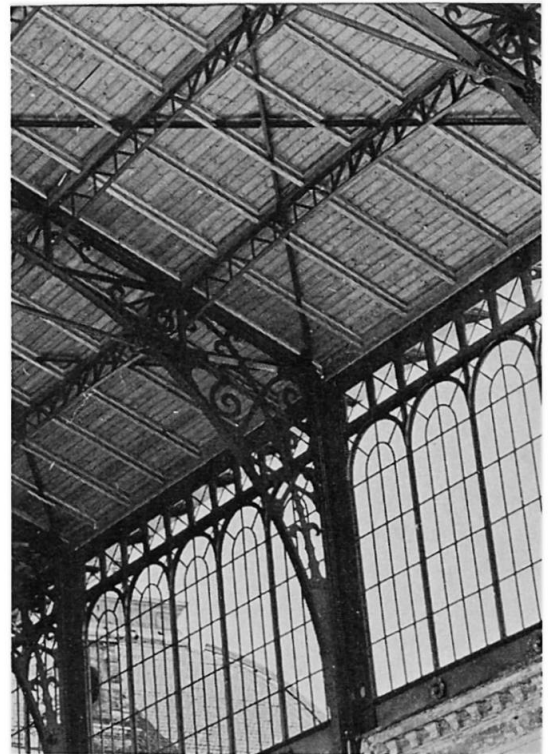
6. A renewed frame corner

The reconstruction took into consideration the point of view of the historical interest. It was based on saving of the less corroded structural parts, on the construction of a horizontal support system, on the load relief of the frame corners, and finally –taking into account that the problem was the mixed construction of the remaining and new parts– based on a conception that needs a very thorough manufacturing and assembly technology. The new track-hall, regarding its appearance, is almost the same as the old one, apart from minor details. The curtain wall, facing the Great Boulevard of Budapest, remained as it was and also remained the first two frames attached to it. These were cleaned by metal-spraying and were stiffened at the necessary places. The same principle applies to the decorative corners of the other frame structures. The latticed frame trusses between the frame corners are made anew by welding. The shape, the dimension and arrangement of the sections follows the original very closely.

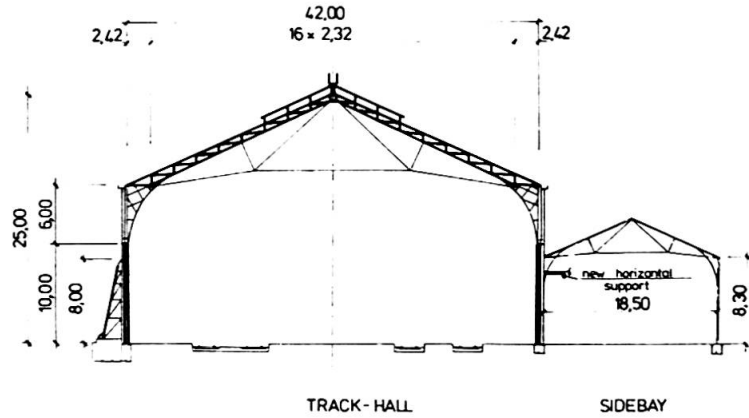
7. The remaining and the new parts of the frame structure

During the strengthening of the columns only those parts of the original columns were demolished which reached into the track-hall. The new and partly double-walled column section encases the remaining part of the original column, securing this way the composite action. Thus the remaining frame corners are located between new frame-beams and new columns. The full set of the tension bars of the trussings remained in the original state. But all of the latticed purlins had to be replaced. Also completely new are the construction of the roof glazing, the side glass-screens and the wind-braces, where the longitudinal wind-brace appears as a new structural element. The curtain wall on the exit side was totally destroyed and had to be completely rebuilt.

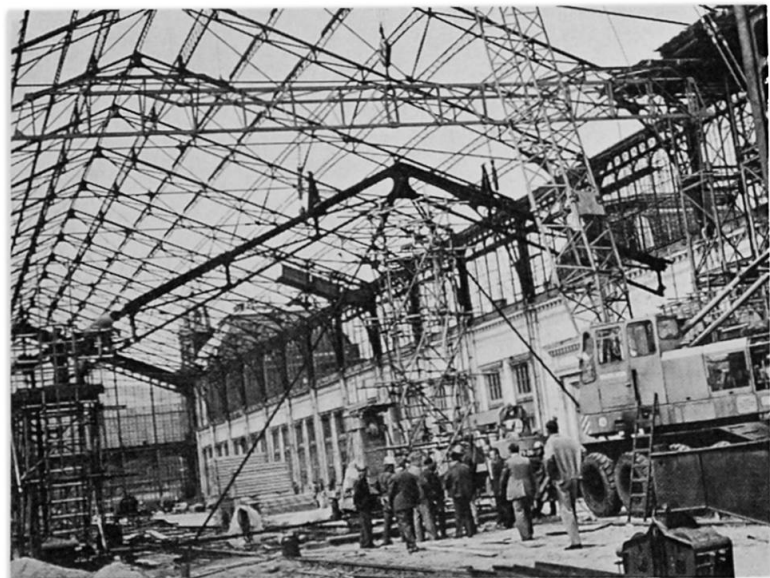
8. The demolition of a trussing

The demolition started at the exit side with the curtain wall, for this scaffolding was built on which the demolished structure was cut into transportable pieces. The demolition of the trussing was carried-out with the help of a rocker device that was fixed to the structure, and after the trusses were cut at the boundary line of the remaining frame corners they were lowered by an autocrane to the floor. The construction was started by strengthening of the remaining two trussings and this was done with a full scaffolding. The repaired corner elements were replaced on the reinforced columns, then the connecting longitudinal walls were lifted-in and the junctions were made.

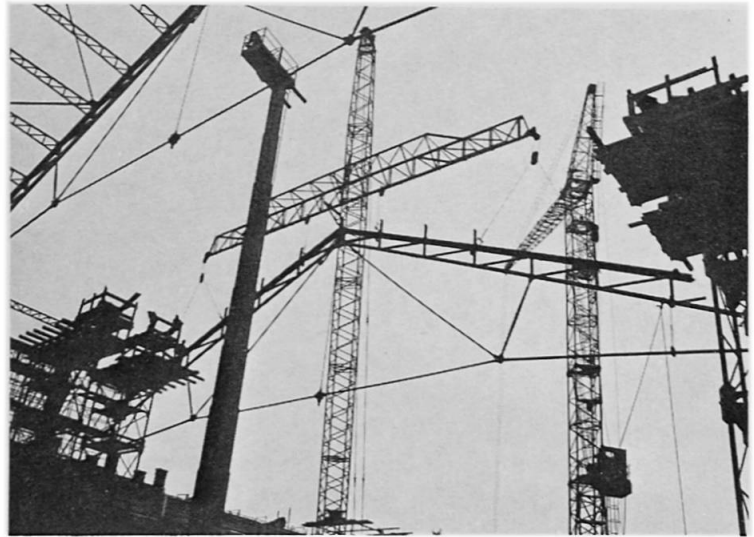
9. The lifting in of a new trussing

The new trussing part was assembled on the ground in the vertical position and the tension bars were adjusted in this position. With the help of the rocker device, the trussing

was lifted-in between the two corners. The tension bar was connected and the trussing was placed into its final position by further lifting to allow the connection of the trussing onto the corner parts with the plates. Afterwards the purlins and the windbraces were lifted-in. During the erection of the steel structure of the end wall for the exit side the 42 m long bridge, manufactured in three pieces was lifted in by three cranes simultaneously. The connections were made in the air, then the bridge was lowered onto its supports. The reconstruction of the roof boarding was made according to its original shape and over the boarding one layer of roof-plate water-proofing was placed finally on its top a zinc sheet covering was laid.

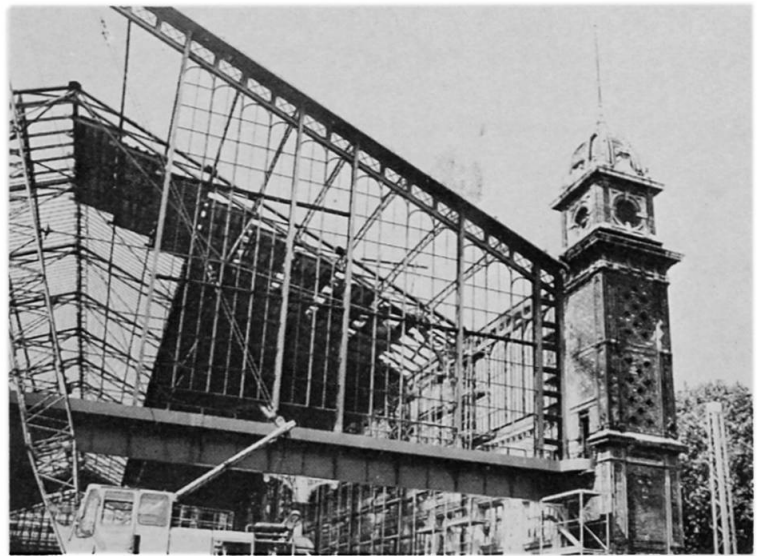
10. Erection of the new curtain wall

The new curtain wall was constructed as a closed frame-structure by building into a new vertical Vierendel-truss on each edge.

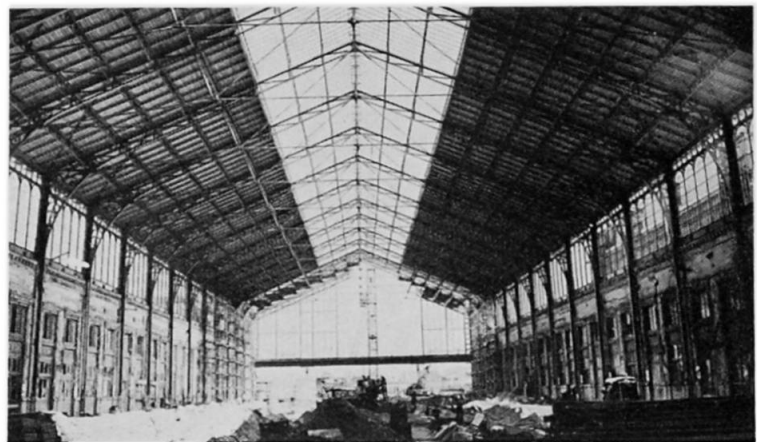
11. The track-hall before completion
