# Wood truss repair by epoxy injection

Autor(en): **Sanders, Paul H. / Avent, R. Richard**

Zeitschrift: **IABSE congress report = Rapport du congrès AIPC = IVBH  
Kongressbericht**

**IX****Wood Truss Repair by Epoxy Injection**

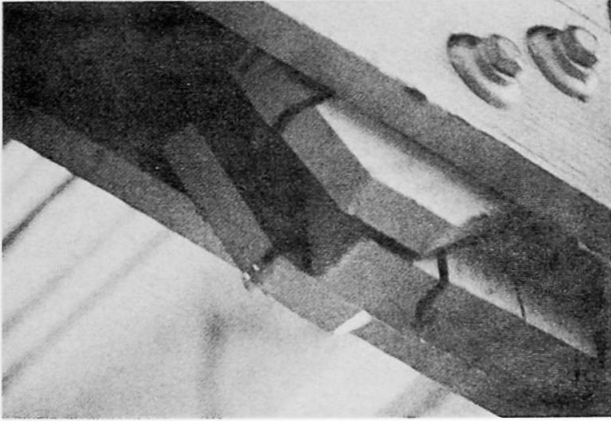
Fig. 1 - End Splits of Members

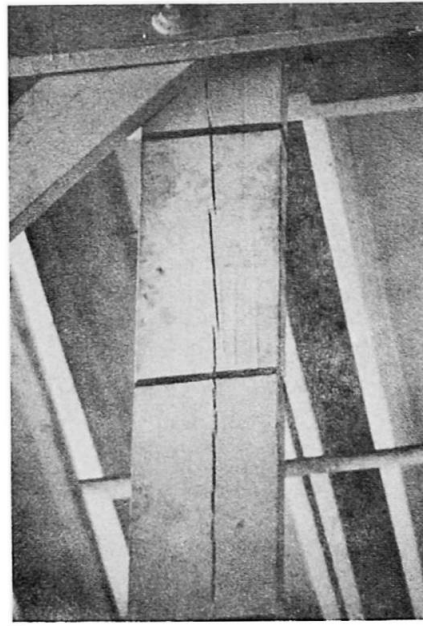
Fig. 3 - Longitudinal Split,  
Interior of Member

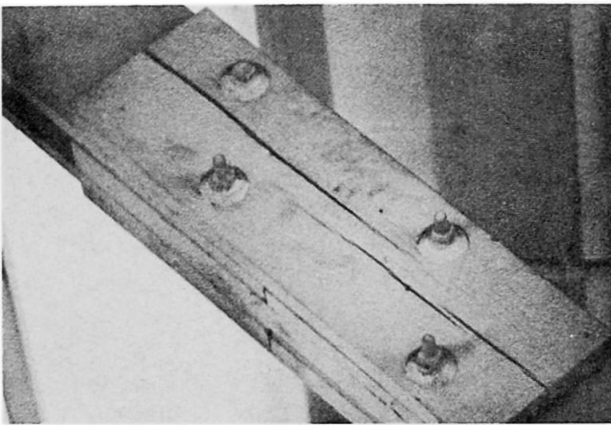
Fig. 2 - End Splits of Bolted Splice Plates
