RECORDED FAILURES OF ELECTRICALLY WELDED WROUGHT-IRON AND MILD STEEL BRIDGES.

H. J. L. BRUFF, Bridge Engineer, North Eastern Area, London and North Eastern Railway,
York.

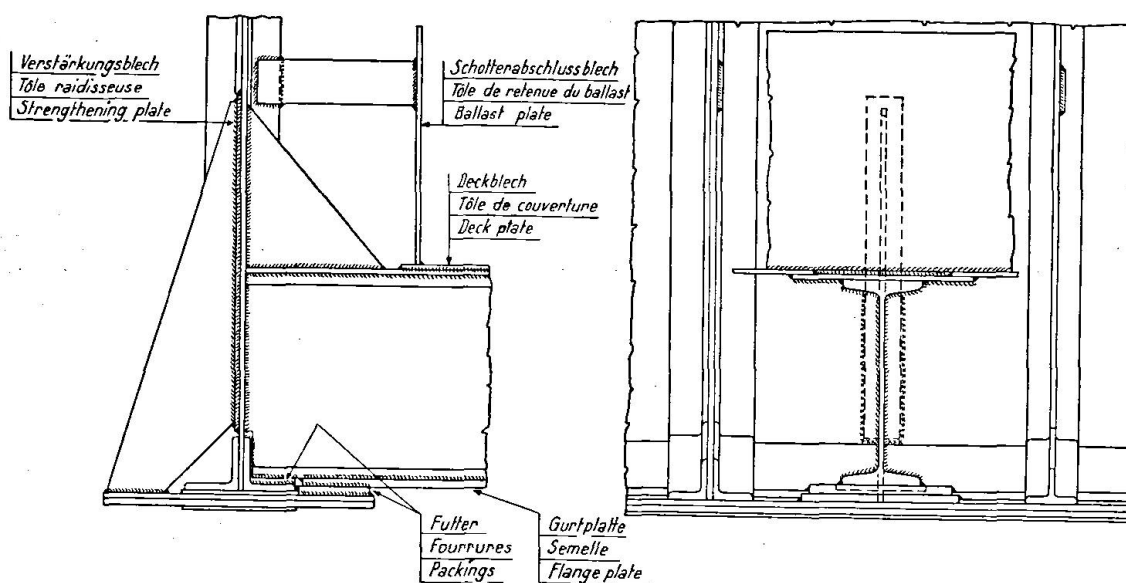
Einzelheiten von Knotenblech- und Stegblechsaufstärkungen (Brücke No. 32, South shields Linie).
 Détails des goussets et raidisseurs de l'âme. (Pont n° 32, ligne South shields).
 Details of gussets and web stiffeners. (Bridge N° 32, South shields branch).

The first experience of this type of failure occurred in the case of the reconditioning of a large plate main girder of a wrought iron bridge the floor of which was entirely renewed. As it was necessary to place the new cross girders between the old cross girders, where there were no web stiffeners, provision had to be made at these points for proper distribution of end fixing moments and shear from the cross girder ends. A strengthening plate was therefore welded to the outside of the web of the main girders and a triangular gusset plate welded on to it directly opposite the new cross girder end, as shown on Fig. 1.

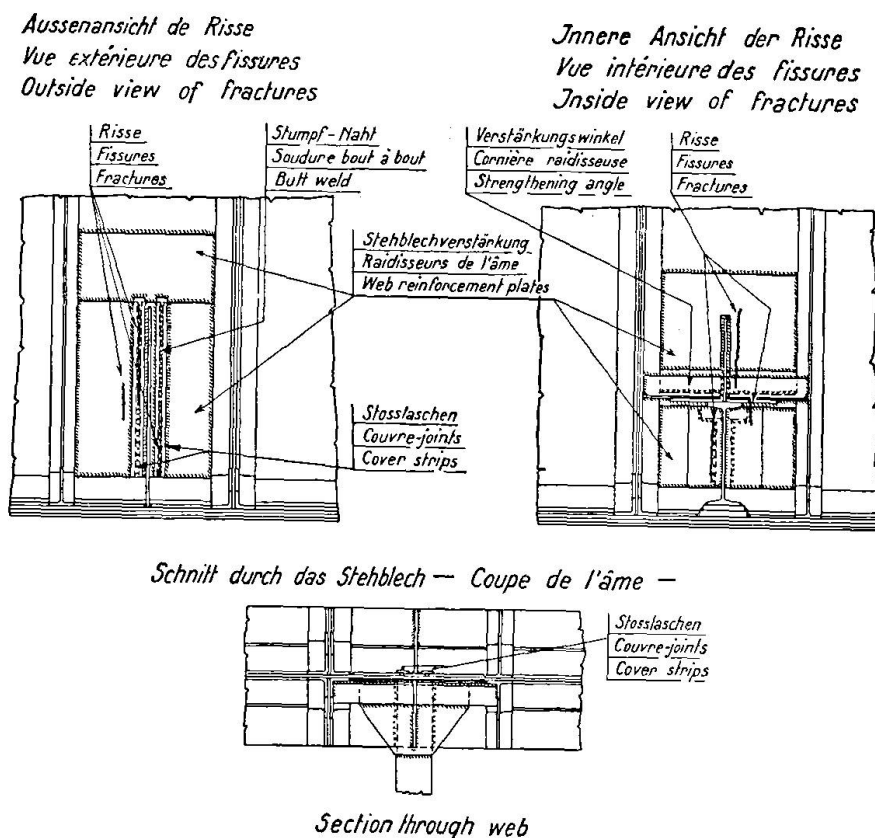
Fig. 2.

Einzelheiten eines reparierten gerissenen Stegblechfeldes.
 Détail d'un champ réparé de l'âme où celle-ci était fissurée.
 Details of repaired panel of fractured web.

The webs of the main girders were badly corroded and in places reduced down to 1/16" and less in thickness. On welding the flat strengthening plates to the main girder web plates, fractures developed in two instances, which travelled up the web plate at the same rate as the weld was run. As the crack formed while the weld metal was being deposited and not during the cooling down of the heated part of the girder, it is reasonable to assume that the stress set up by the contraction of the weld metal added to the existing shear stress brought the total stress up beyond the ultimate strength of the web plate. Fig. 2 shows the repairs.

Extra web cover plates were therefore tack welded to the "T", angle stiffener and strengthening plate, the fracture having been "V'd" out and butt welded previously. The new web reinforcement plates were then finally butt

welded to the strengthening plate and the toes of the "T" and angle stiffeners of the girder.

In the case of repair work like this, where the webs are thin, web strengthening plates are now always provided, which are welded to the adjoining main angles and stiffeners.

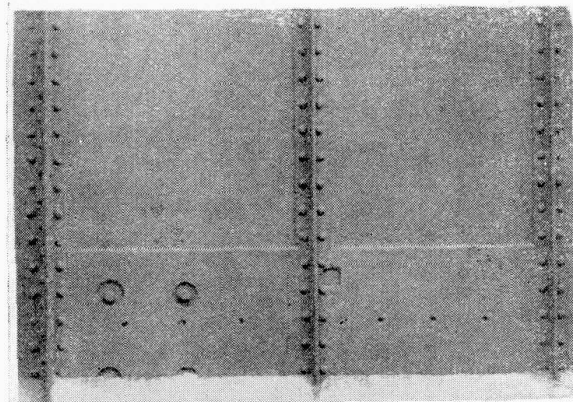
Fig. 5.

As will be seen from the section it was intended that the welds should not only unite the strengthening plates and the toes of the "T" or angle stiffeners, but also the old web itself. On cutting out the fractured welds, as shown in Fig. 5, it was found, that good penetration had been obtained between the strengthening plate and the "T" but that there was no penetration in the case of the web, as will be seen from the photograph of a part of the "T", strengthening plate and web which were cut out in order that the cause of the fracturing might be ascertained.

Schnitt durch die gerissene Schweißung.
Coupe à travers la soudure rompue.
Section of fractured weld.

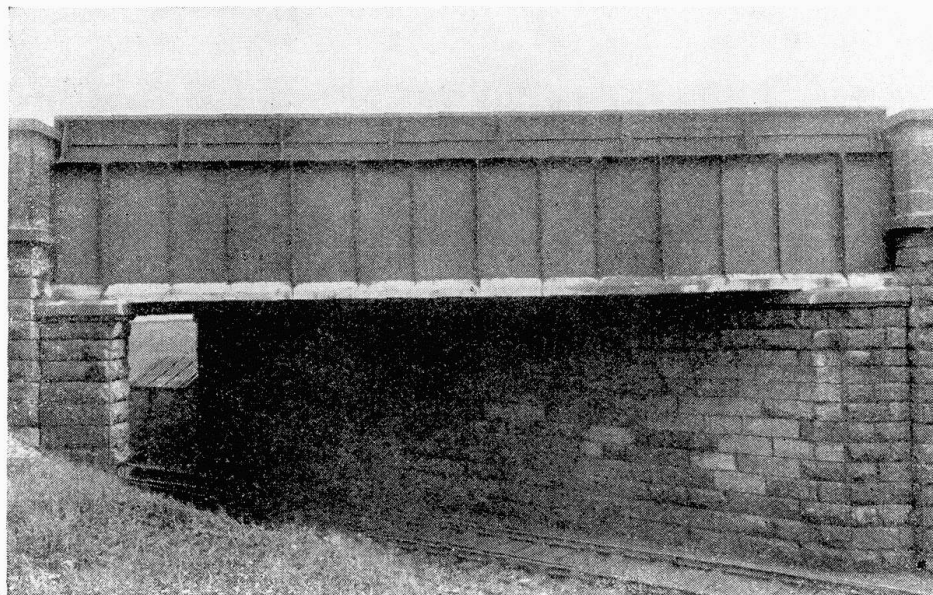
Fig. 6.

amperage than normal, which in the case of so light a run is not likely to over-heat the mild steel. Fig. 6 shows the repaired girder with removed section (Fig. 5) which was not replaced, the hole was merely fillet welded round the edges as there was ample section left for strength. The bottom flange, which the photo shows covered with gunite, was badly wasted by blast from engines,

Träger mit repariertem Stegblech. — Poutres dont l'âme est réparée.
Girder showing repaired web.

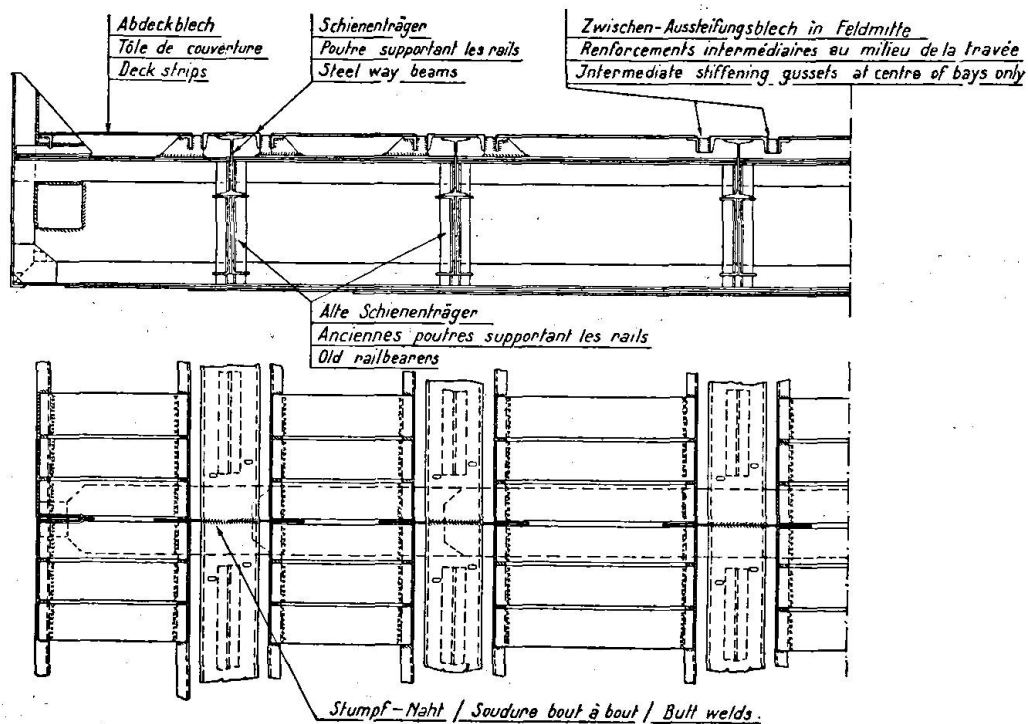
The welded work in question comprised the connections of a welded way beam, illustrated in Fig. 7, further details are shown in Fig. 8.

As will be seen the rails and chairs were bolted to the webs of the steel channels, which again were welded to rolled steel beams resting on the top flanges of the old rail bearers to which they in turn were welded. At each cross girder gusset plates were welded to the vertical channel flanges and to the top flange plates of the cross girders, for the purpose of taking up any side sway

of the steel way beams (consisting of the rolled steel beam and the channel). Two of these gussets at one end of the bridge, where there is a switch, have fractured. The position of the fractures are indicated on Fig. 7 and on the photograph of the bridge end, Fig. 9.

Grundriß und Einzelheiten der Brücke. — Plan et détails du pont.
Plan and details of bridge.

Similar fractures have also developed where some small tie plates have been welded on to the way beam channels, for the purpose of adding support to the angles carrying the deck strips, the ties being welded on between the deck angles and the channel flanges along four of the channels (see Fig. 8). These ties also take up some side sway of the way beams. Of 348 welds (two to each tie) 10 have fractured, probably due to shock, as they fractured shortly after the centre track, where they were located, was brought into use. On close examination of the fractures it has been found that the welds are all indifferently

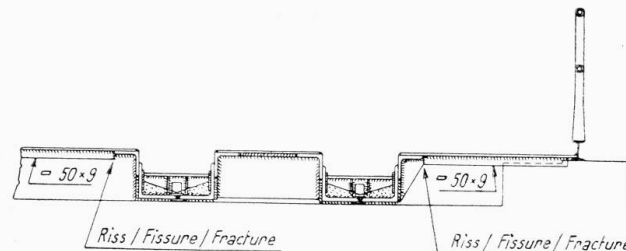
Fig. 11.

The bridge shown in Fig. 11 has a steel deck which is stiffened with $2" \times 3/8"$ flats on edge. Besides these there are transverse diaphragms between the two sets of troughs. When erected it was found that the brick abutments

when bared were not very good, showing fractures below the bedstones on which the troughs would be seated. The bedstones were carefully levelled before the girders were erected on them, but possibly owing to the more rigid construction and absence of cushioning due to steel bearers instead of timber way beams in the troughs, the fractures in the abutments increased and caused unequal depression of the girder ends which set up transverse bending moments

in the deck stiffeners, which were not anticipated. Such transverse bending moments would be additional to the bending moments caused by deflection of one set of troughs when one trough was loaded and the other was not simultaneously loaded by passing traffic.

Half section through bridge. (Bridge N° 25, York and Doncaster).

As mentioned above the bridge carries two separate main lines, and is therefore very busy, the average number of trains per 24 hours being 250 representing about $5\frac{1}{2}$ million stress variations annually, the traffic being about the same in both directions. Under these circumstances it will be realised that the enormous frequency of stress reversals which occur will tend to produce fatigue effects in parts unduly stressed. From the construction it will be appreciated that severe stresses must be set up in the transverse stiffeners of the deck plates due to such unequal deflections, which are enhanced by the settlement of the bedstones.

The welds connecting the deck plates and the $2" \times 3/8"$ stiffeners are not very large and even normally they are rather heavily stressed, with the consequence that 19 out of 20 have fractured.

heavy steel grillages embedded in concrete are now always provided. These grillages are most carefully and truly set, so as to reduce unequal settlement of adjoining troughs to a minimum. In addition to the grillages the stiffeners for the deck plates are not carried through and welded to the flanges, thereby permitting the deck plates to flexure and so give a little play which absorbs unequal deflections.

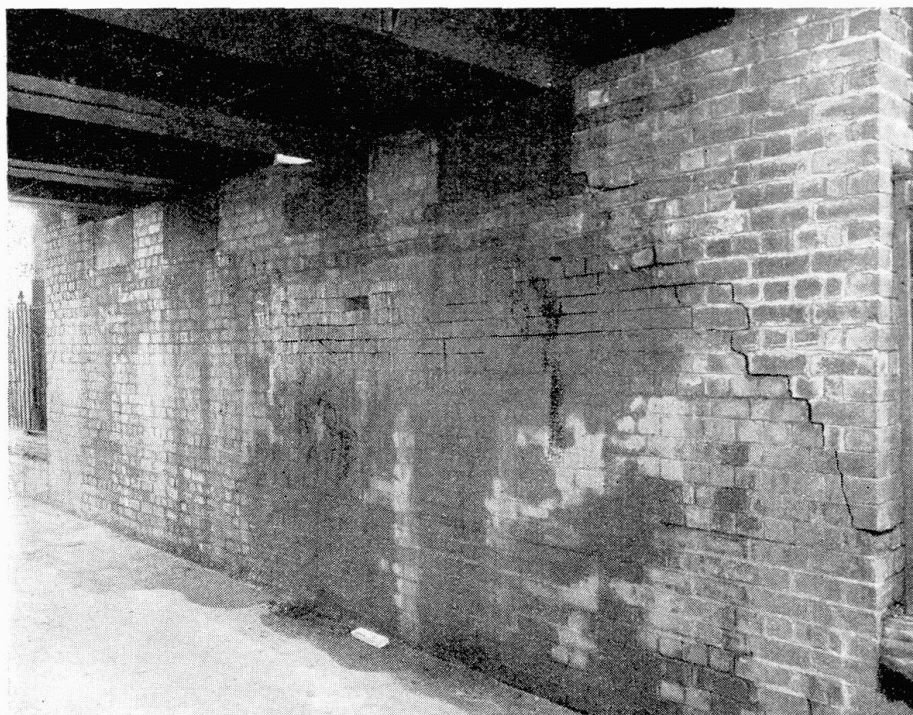
Fig. 12.

Gerissenes Widerlager. — Culée fissurée. — Fractured abutment.
