Zeitschrift: IABSE structures = Constructions AIPC = IVBH Bauwerke
Band: 9 (1985)
Heft: C-34: Telecommunication towers

Artikel: Structural updating of steel television and radio broadcast towers in the USA
Autor: Ratay, Robert T.
DOI: <https://doi.org/10.5169/seals-19421>

1. Structural Updating of Steel Television and Radio Broadcast Towers in the USA

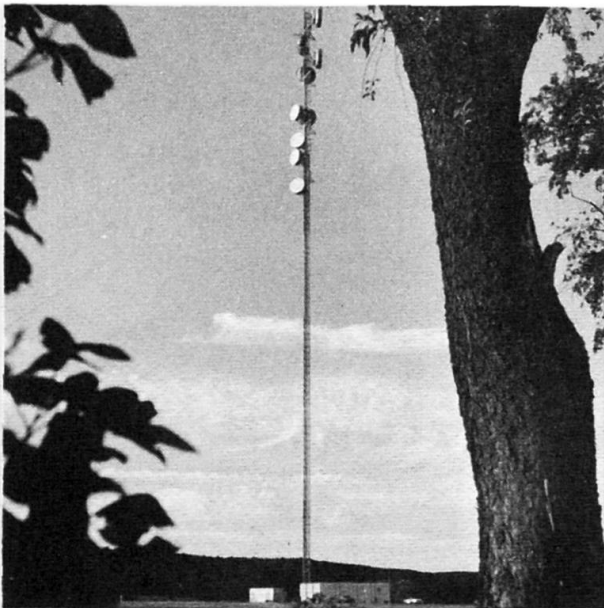
Fig. 1 147-meter guyed tower in West Chester, Pennsylvania. (Courtesy of ITT/United States Transmission Systems, Inc.)

A good example of a thorough investigation is the 147-meter guyed microwave tower in West Chester, Pennsylvania. As part of a program of structural review of their towers, ITT/United States Transmission Systems, Inc., commissioned a comprehensive structural analysis, supplemented by field inspection, of this tower. It is a slender triangular trusswork, has five levels of guy cables with torque stabilizers at the top three guy levels. It supports twelve large-diameter microwave dishes and several small antennae (Fig. 1). The work was performed under the author's direction. The calcula-

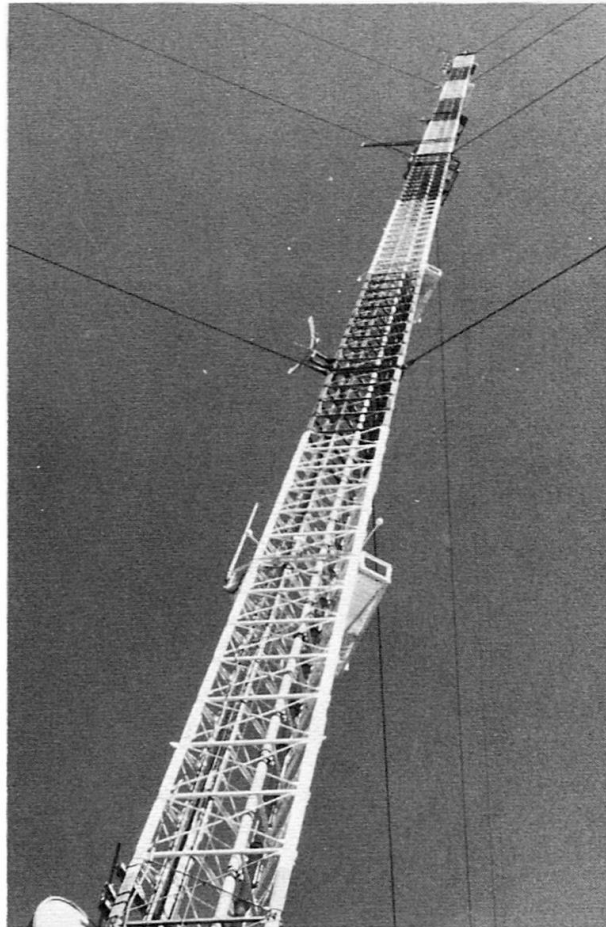
The changing requirements between 1953 and 1983 of the ANSI, UBC and EIA codes, as well as the local building code, were evaluated by the author for the 290-meter guyed tower of KMBC-TV in Kansas City owned by The Hearst Corporation, as part of an in-depth structural review (Fig. 2). The study traced the major events in the history of the tower: original construction, later changes of equipment, subsequent structural modifications and recent changes of ownership. It was found that at each event during those thirty years the codes required considerably different wind pressures: increasingly greater by the ANSI, EIA and local code and slightly decreasing by the UBC. This points up the situation that a tower standing for 30 or 40 years may become structurally inadequate and need to be reinforced because of changes in codes.

Fig. 2 290-meter guyed tower in Kansas City, Missouri. (Courtesy of The Hearst Corporation)
