Zeitschrift: IABSE structures = Constructions AIPC = IVBH Bauwerke
Band: 9 (1985)
Heft: C-34: Telecommunication towers

Artikel: Structural updating of steel television and radio broadcast towers in the USA
Autor: Ratay, Robert T.
DOI: <https://doi.org/10.5169/seals-19421>

1. Structural Updating of Steel Television and Radio Broadcast Towers in the USA

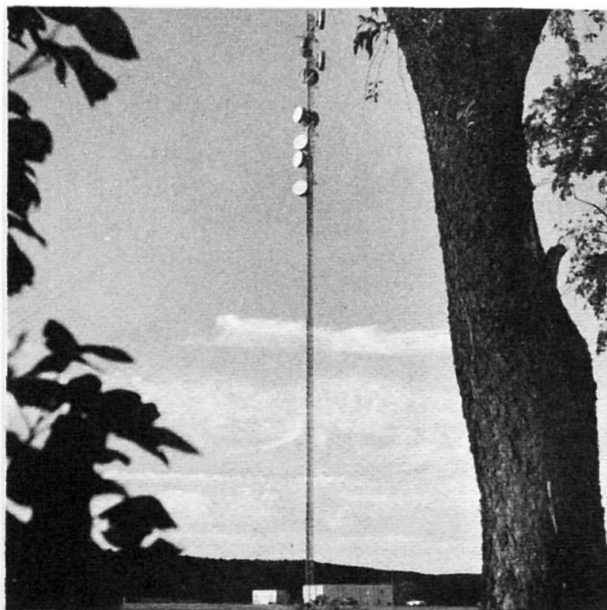
Fig. 1 147-meter guyed tower in West Chester, Pennsylvania. (Courtesy of ITT/United States Transmission Systems, Inc.)

A good example of a thorough investigation is the 147-meter guyed microwave tower in West Chester, Pennsylvania. As part of a program of structural review of their towers, ITT/United States Transmission Systems, Inc., commissioned a comprehensive structural analysis, supplemented by field inspection, of this tower. It is a slender triangular trusswork, has five levels of guy cables with torque stabilizers at the top three guy levels. It supports twelve large-diameter microwave dishes and several small antennae (Fig. 1). The work was performed under the author's direction. The calcula-
