Artikel: Protection against rock falls, Sterling Mountain Tunnel, NC (USA)
Autor: Munfakh, George A.
DOI: <https://doi.org/10.5169/seals-19877>

7. Protection against Rock Falls, Sterling Mountain Tunnel, NC (USA)

Owner: North Carolina Department of Transportation
Engineer: Parsons Brinckerhoff Quade & Douglas, Inc.
Contractor: Oman Construction Co., Inc./ Jensen Drilling, Inc.
Works' Duration: 9 months for design and construction
Service Date: November, 1985

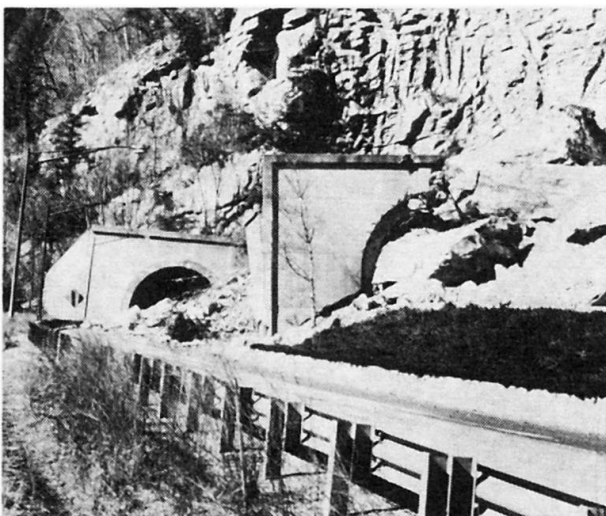
The 350 m long Sterling Mountain Tunnel in North Carolina, U.S.A. carries the Interstate 40 highway through the Blue Ridge Mountains about four miles from the Tennessee state line. The tunnel is composed of two rock bores lined with reinforced concrete. In March 1985, a 150 m by 100 m area of the mountain at the west portal failed cascading large rocks that completely destroyed the tunnel portal (Figure 1). No cars were passing at the time and no casualties were reported.

Fig. 1 Tunnel portal destroyed by rock slide

After removal of the debris, an emergency action was implemented to stabilize the side of the mountain and to reopen the tunnel to traffic. The construction also included protection against future large and small rock falls. This article describes the protection measures constructed in conjunction with the reopening of the tunnel.

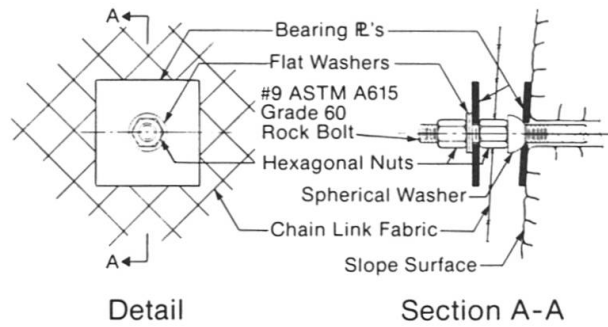
Fig. 2 Detail of chain link fabric/rock bolt assembly

Six major areas were stabilized by in-situ rock reinforcement. Loose small rock blocks were removed by scaling prior to reinforcement. Some large rock overhangs were removed by careful drilling and blasting. Reinforcement was provided by rock bolts 6 m in length, installed mainly on a 1.5 m by 1.5 m pattern. No. 9 (28 mm) ASTM A615 Grade 60 rock bolts were used. Galvanized chain link fabric was anchored to the rock bolts in one area to hold back small rock pieces that may break as a result of the blocky nature of the rock at that area. (Fig. 2)

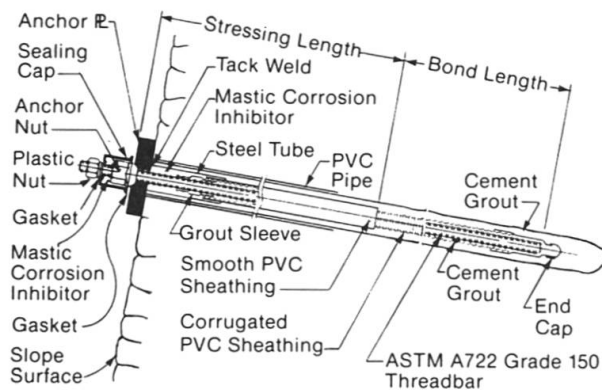
Fig. 3 Detail of high-strength rock anchor with double corrosion protection

Two potential large block failures were identified in an area of the slope parallel to the roadway. A large crack, 45 cm wide at the top, was measured behind two rock blocks 3 to 5 m thick. Because the loosened blocks were too large to be removed safely by blasting, they were stabilized by the installation of 12 m long high-strength bolts on a 3 m by 4.5 m pattern. Between these bolts, 6 m long rock bolts were installed at 1.5 m intervals vertically and horizontally to tie back smaller blocks and produce a final 1.5 m by 1.5 m pattern. Fig. 3 illustrates details of the high-strength rock anchors used on the project.

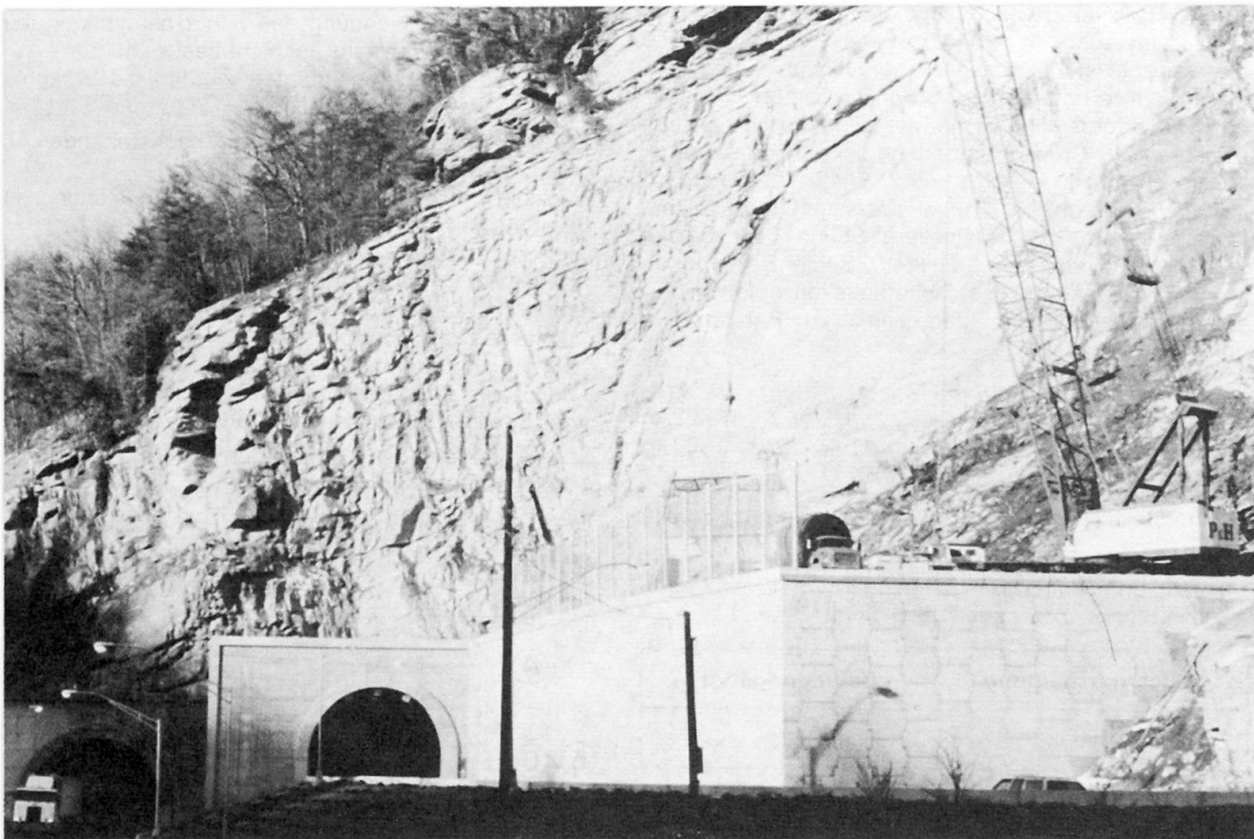
Fig. 4 Reinforced Earth wall with rock fence

A reinforced earth wall was constructed parallel to the roadway to protect the vehicular traffic from small rock pieces that may move down the rock slope in the future. The wall and its reinforced embankment will serve as a buffer zone between the roadway and the rock slope absorbing the kinetic energy of the falling rocks, and accumulating loose rock behind a rock fence erected above the retaining wall. Aesthetic benefits were also derived from the reinforced earth wall configuration.

Three types of retaining walls were considered for the project: a reinforced earth wall, a gravity-type interlocking concrete modules wall (Doublewal) and a concrete-faced tie back wall. The reinforced earth wall was the most suitable considering schedule, cost, aesthetics and construction requirements. The constructed wall had a constant height of 10.6 m above the roadway and a 90 degree end wall abutting the rock face (Fig. 4). Partial excavation of the rock was required near the portal to accommodate construction of the reinforced earth embankment. The rock fence consisted of 4.5 m high mesh chainlink fabric tied to standard pipe rail and extra strong pipe posts anchored 2.5 m in the compacted reinforced earth embankment. The construction time including materials procurement was about two months for the 63 m long wall.
