**Zeitschrift:** IABSE structures = Constructions AIPC = IVBH Bauwerke  
**Band:** 12 (1988)  
**Heft:** C-46: Repair and rehabilitation of bridges: case studies I

**Artikel:** Repairing work of the Käyräjoki Bridge (Finland)  
**Autor:** Huura, Jorma / Falck, Kalevi  
**DOI:** <https://doi.org/10.5169/seals-20923>

#### 4. Repairing Work of the Käyräjoki Bridge (Finland)

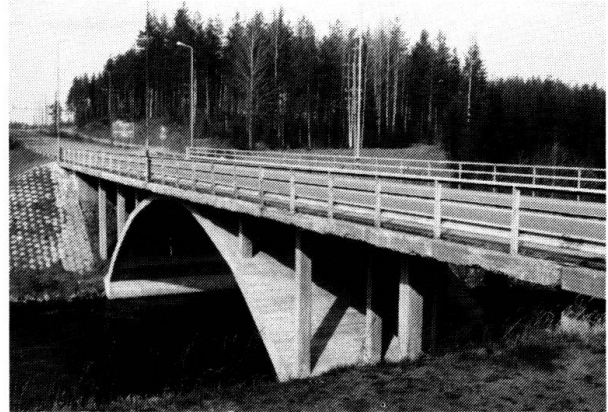
Fig. 1 The Käyräjoki bridge before repairing

The Käyräjoki bridge (Fig. 1) is located in a dell which causes that water is flowing on to the bridge more than otherwise. During wintertime the bridge is exposed to the salt-frost action. The bridge was built in 1963 when concrete was not air entrained. Consequently the concrete in the edge beams was scaling very badly twenty years after construction of the bridge.
