7. Off Ramp of Hanshin Expressway in Osaka (Japan)

Owner: Hanshin Expressway Public Corporation
Consultant: Prof. Dr. K. Horikawa
Contractor: Takara Giken Co. Ltd.
Work's duration (Field work): 4 months (2 weeks)
Repair date: 1985

Reshape of End Part of Plate Girder Bridge

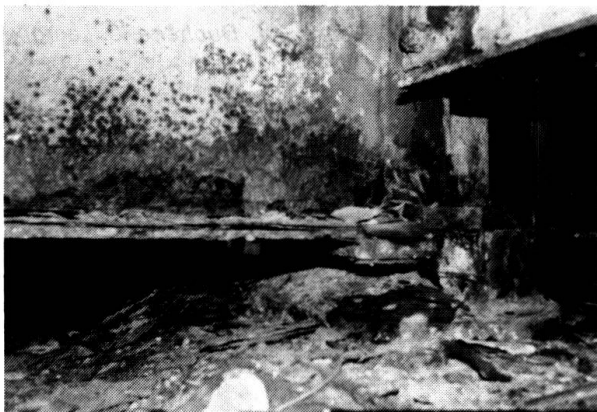
Corrosion is one type of damages in steel bridges in service and is apt to occur near expansion joints, bearing shoes and so on. In these parts, the thickness of members decreases by corrosion. In an extreme case, the fillet welds between web and lower flange are lost, as shown in Fig. 1. The cause of this example was considered to be the leakage of water with free lime because stalagmite was found on the lower surface of slab and water dropped even on a fine day.

Fig. 1 An example of corrosion

- 1) Cutting off the corroded part, then a new member with T section is connected using H. T. bolts.
- 2) Cutting off the corroded part, then a new member with T section is connected using welding at site.
- 3) Cutting off the corroded part, then only a new lower flange is connected using welding at site. As a result, the plate girder is reshaped from uniform section to non-uniform section.

These procedures have both merits and demerits. However, procedure 3) has merit for repair of bearing shoes, because the working space is secured after the reshape work, and the safety of structure is maintained during the repair.

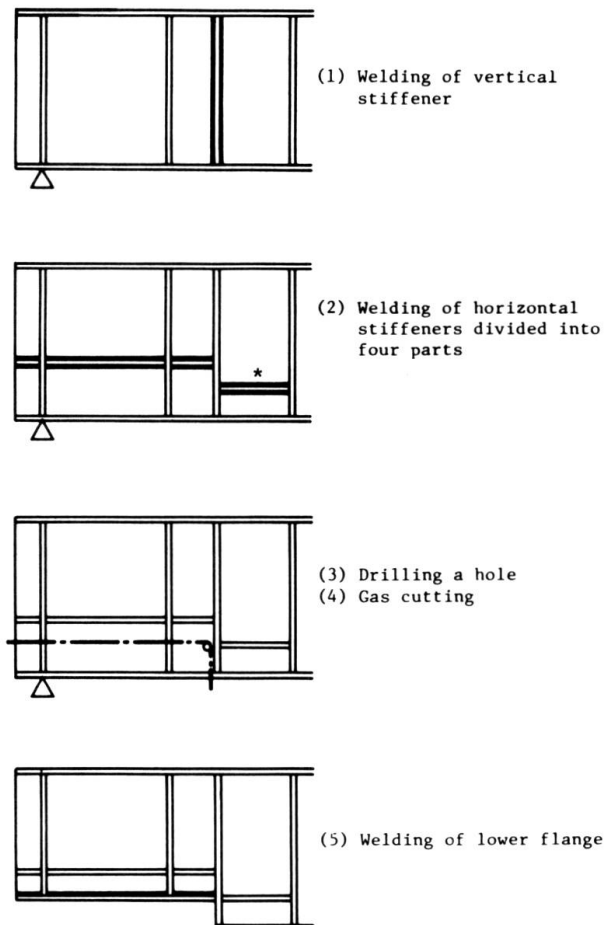
Fig. 2 Recommended procedures

From the above results, the procedures for the repair to be recommended are as shown in Fig. 2.

- 1) Firstly, welding of vertical stiffener
- 2) Secondly, welding of horizontal stiffeners
It is desirable that the stiffeners marked by * in Fig. 2 is welded on the same level as the lower flange fixed in stage 5) and welded to the next vertical stiffener.
- 3) Then drilling of a hole
- 4) And gas cutting
- 5) Finally, welding of lower flange

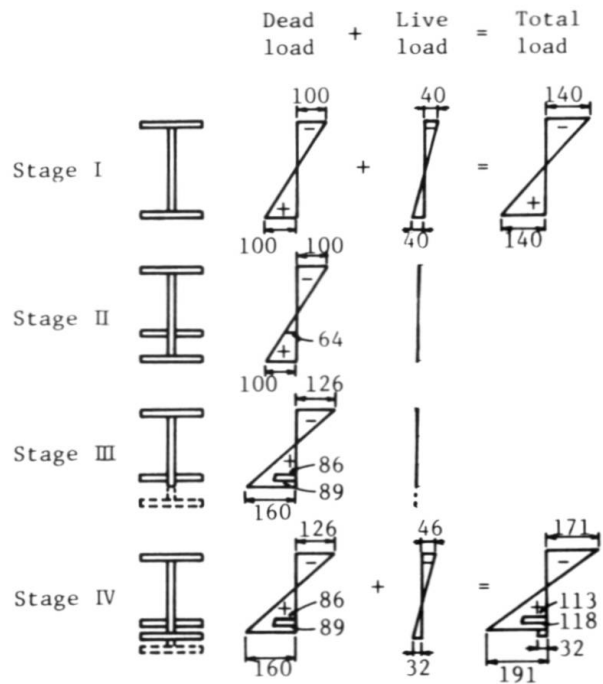
Assuming an existing girder with the same proportion as the model, the stresses on each stage are considered to be as shown in Fig. 3.

Stage I: Original section.
Assume the stresses due to the dead load and the live load as shown in the figure.

Stage II: Welding of stiffeners.
The live load is not considered, because there is no traffic. The stress due to the dead load does not change.

Stage III: Gas cutting.
The stress, that exists in the section to be cut off, is redistributed. Also, the force is shared by horizontal stiffeners. The stress after redistribution can be calculated from the following three conditions.
1) Difference of strains exists between stiffeners and web.
2) The integral of moment by the stresses equilibrates with the external moment.
3) The integral of the stresses is equal to zero.

Stage IV: Welding of lower flange.
The stress due to the dead load does not change. The entire section is effective to resist the live load.

(K. Horikawa, H. Suzuki) Fig. 3 Schematic example of stress (MPa)

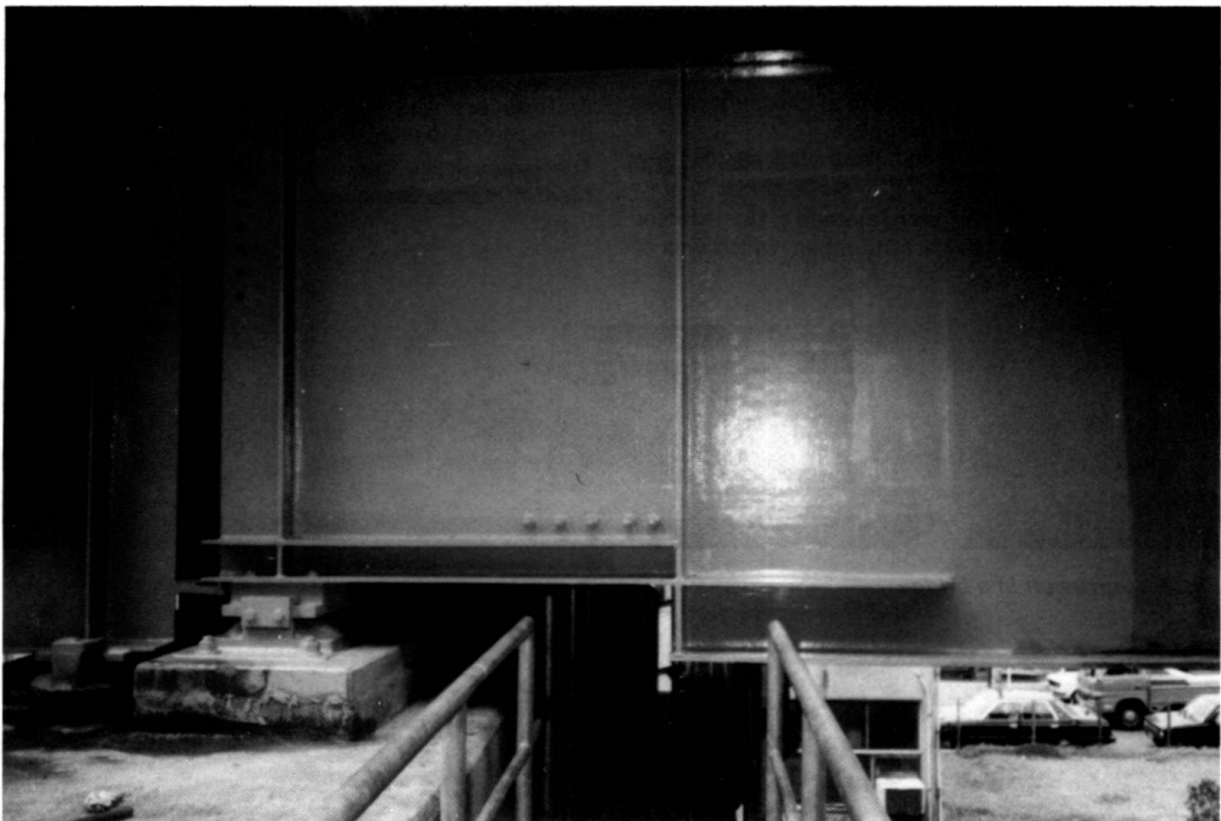
The existing bridge after the repair is shown in Fig. 4.

Fig. 4 Existing bridge after remedy
