Zeitschrift: IABSE structures = Constructions AIPC = IVBH Bauwerke
Band: 12 (1988)
Heft: C-46: Repair and rehabilitation of bridges: case studies I

9. The Bridge in the Radnička Street in Belgrade (Yugoslavia)

Owner: The City of Belgrade
Designer: Construction: Directorate for Bridges, Belgrade
 Rehabilitation: University of Belgrade, Department of Civil Engineering
Contractor: Construction and rehabilitation: Mostogradnja, Belgrade
Date of construction: 1968
Date of rehabilitation: 1984

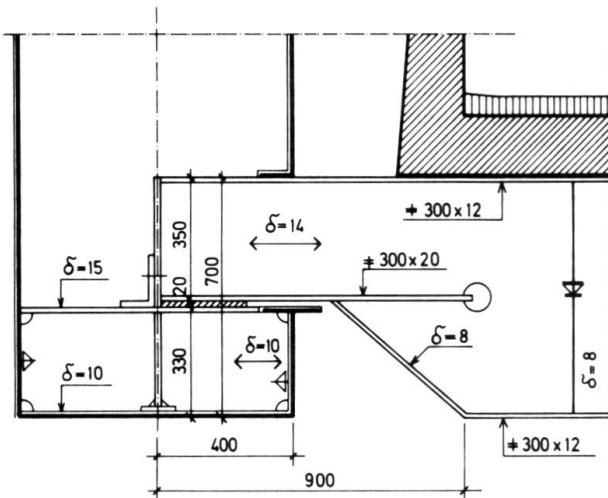
As the direction of lateral girders did not coincide with the skew position of the columns, unequal deflections of the lateral girders ends used to take place whenever a vehicle crossed the bridge and those girders were the supports of reinforced concrete deck slabs, Fig. 3.

The permitted movement of heavy vehicles by the right main girder only, still increased the unequal deflections of the lateral girders ends causing torsion and additional inconvenient stressing of reinforced concrete deck slabs.

Those slabs were connected to the upper chord of the lateral steel girders by tins anchored into the mass of concrete with four screws on both supporting edges. In the course of time, the connection was weakened and permanent damages of bridge decks above lateral girders took place. The lateral joints in asphaltic bridge deck, placed on each 2 m along the length of the bridge caused, beside uncomfortable drive, constant unforeseen dynamic impacts to the structure of the bridge. The repair of the bridge deck was practically impossible.

Fig. 3 Unequal deflections on lateral girders ends by which reinforced concrete deck slabs were supported

That was why, in 1981, rehabilitation of the bridge had to be done. All prefabricated reinforced concrete bridge slabs were replaced by the new slabs with the increased reinforcement without haunches. Through 1 cm thick rubber strips and arbolite substratum the slabs were elastically supported by the lateral girders. The interconnection of slabs was also elastic, achieved by four longitudinal bars sealed by epoxy putty. The strains between the slabs were sealed with a soft material. The basic idea was to enable independent deformation of individual slabs when vehicle crossed the bridge.

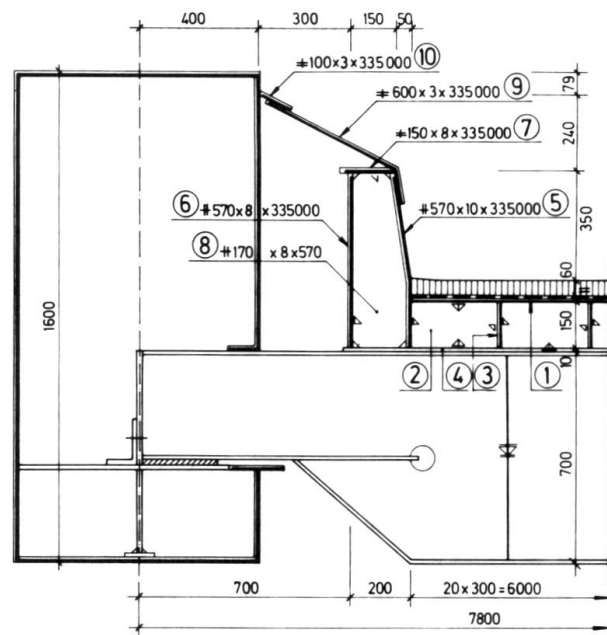
Fig. 4 The cross section of the bridge after rehabilitation

A relatively expensive but from the engineering point of view the most correct alternative solution was applied. The reinforced concrete bridge deck slabs were replaced by an orthotropic steel plate. However, due to the required minimum traffic brake and due to the existing connection between lateral and main girders, a modified orthotropic steel plate instead of the classical one was applied. Prefabricated, 10 m long assemblies of the orthotropic plate were delivered to the site and, in order to facilitate erection, their width was half the width

of the bridge so that the medium longitudinal seam was welded on the site. The connection of the orthotropic plate with the upper chord of the lateral girders was achieved by welding to the lower flange of the orthotropic plate, (Fig. 4).
