Zeitschrift: IABSE structures = Constructions AIPC = IVBH Bauwerke
Band: 12 (1988)
Heft: C-46: Repair and rehabilitation of bridges: case studies I

Artikel: Rehabilitation of Girna Bridge (India)
Autor: Manjure, P.Y. / Rohra, M.R.
DOI: <https://doi.org/10.5169/seals-20930>

11. Rehabilitation of Girna Bridge (India)

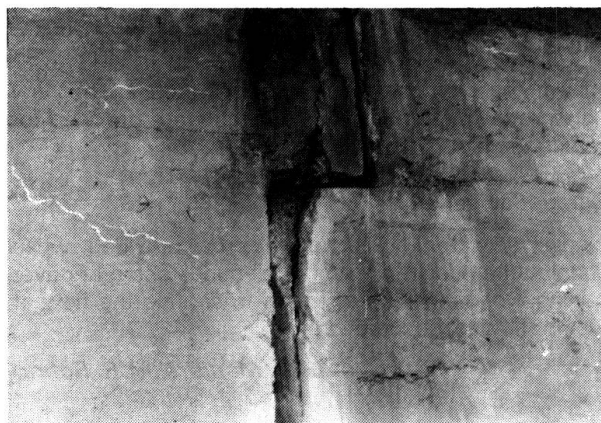
The distress mainly was in the superstructure. In the year 1980, it was observed that the concrete in the zone of articulation is substantially damaged (see Fig. 1). The factors contributing to the damages are outlined below:

- i) Plate bearings could not function due to jamming and absence of expansion gap.
- ii) The main reinforcement in the cantilever portion was found having excessive cover.
- iii) Concrete in the articulation zone was not of adequate quality.

In a particular span (No. 6), distress noticed in suspended span at articulation was of higher magnitude. Large chunks of concrete were found separated in the span from the cantilever tips and the suspended span had therefore settled by about 40 mm. In most of the articulation tips, wide cracks had developed.

Fig. 1 Distress at articulation

Replacement of steel plate bearings by Neoprene Bearings and repairs to damaged concrete portion at the articulation were considered essential. For this purpose, it was necessary to lift the suspended spans and re-concrete the cantilever tips. Lifting of suspended spans was required to be done from the deck level since height of the superstructure was about 15 metres from river bed (see Fig. 2).

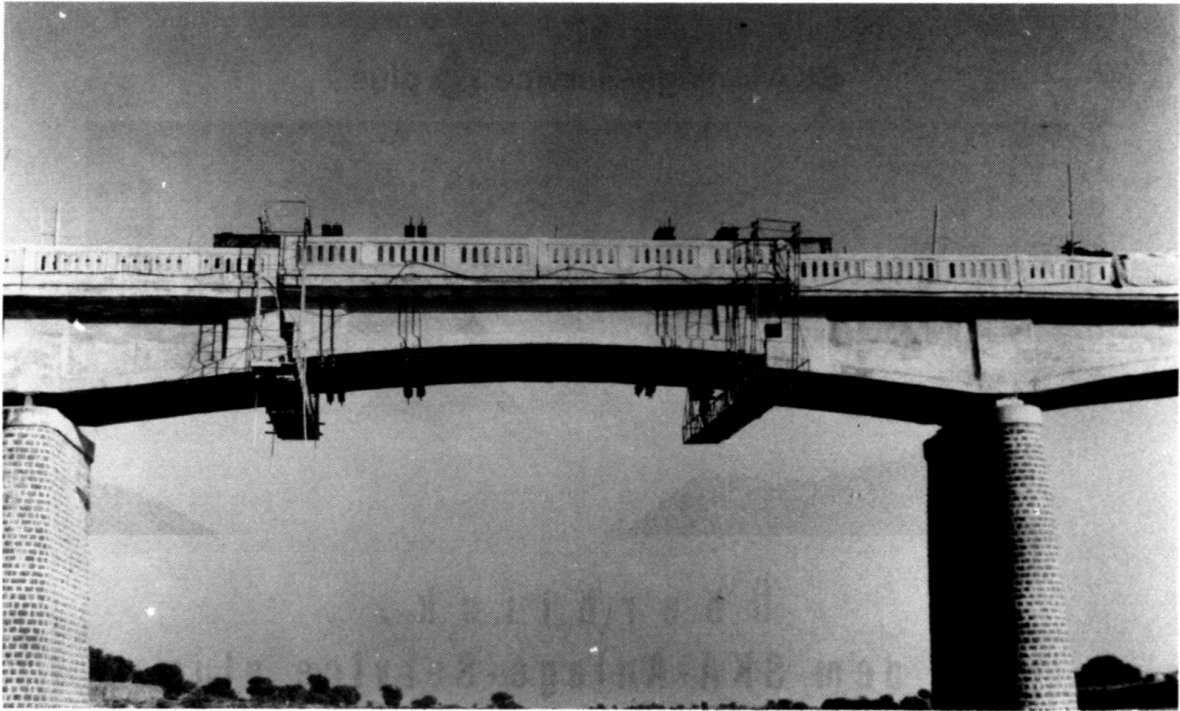
Fig. 2 Lifting arrangement for suspended span

Fabricated steel girders were placed in line with reinforced concrete beams over articulation portion. These steel girders were connected to reinforced concrete beams by means of Alloy steel suspenders at two locations. The hydraulic jacks were placed under the projecting portion of steel girders over the cantilever beams. All hydraulic jacks were connected to a common hydraulic circuit.

Lifting of the suspended span could be achieved by pressurizing the hydraulic circuit. It was possible to obtain almost uniform lifting, by controlling the valves on the circuitry. The span was raised by about 40 cms. Specially fabricated light weight platform was suspended from the deck for providing access to the articulation zone. Damaged concrete was removed by using pneumatic tools. Additional reinforcement was welded to the existing reinforcement (see Fig. 3) and re-concreting was done by using epoxy bond layer at the interface of old and new concrete. At this face, subsequently, epoxy was injected through the inlets provided at the time of concreting.

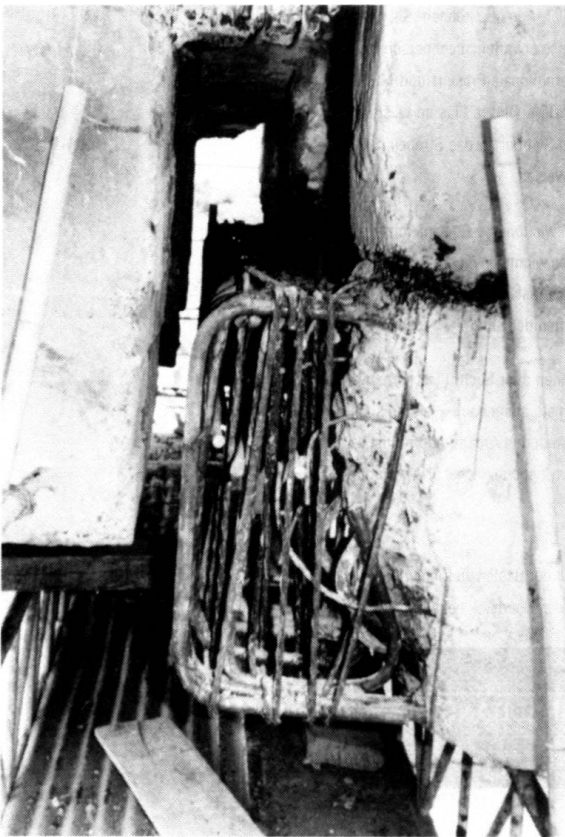
Fig. 3 Cantilever tip is broken and additional reinforcement is provided

In one span, external prestressing rods were provided to prevent separation of old concrete to new concrete besides other measures.

Neoprene Bearings were placed in position and the span was lowered onto these bearings after the new concrete has attained minimum strength for dead load reaction. The prestressing rods were grouted after 3 months or so, to enable monitoring at articulation during this period. These rods were restressed to make up slight loss of prestress and then grouting was carried out.
