Artikel: Repair of scoured substructure (Japan)
Autor: Morinaga, Norio
DOI: <https://doi.org/10.5169/seals-20932>

2. Repair of Scoured Substructure (Japan)

Case 1 Reinforcement with piles; Iwaide Bridge, Wakayama

Case 2 Repair by reinforced concrete lining; Natori Bridge, Miyagi

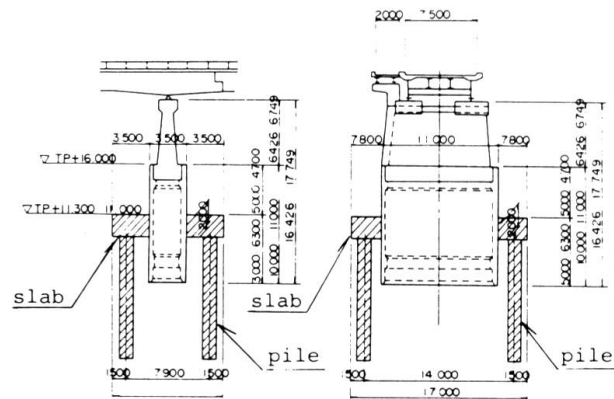
Fig. 2 Repair method (Iwaide Bridge)

The substructure has been scoured to a depth of 4 m average up to 6 m maximum from the effects of dredged riverbed and embankment located upstream. In the worst case, the depth of embedment was reduced to 5 m from the original 11 m. To prevent a further decrease, measures were taken in 1970 by temporarily placing protection blocks. Then in 1979 the caissons were checked again for its stability. To completely solve the problem, the substructure was reinforced by underpinning and constructing a new slab connected with the existing caisson. The repair job was performed on 7 heavily scoured substructures among a total number of 12.

For reinforcement of caisson with reduced depth of embedment, a cast in place pile method was chosen for underpinning, under consideration of geologic condition, clearance below girder during work an economy.

With the cast in place piles, four Benoto piles of 1.5 m diameter and 11.5 m length were placed at four sides of the caisson. The caisson and piles were connected by placing a 2 m thick slab on top to make a new footing (Fig. 2 and 3). To determine the dimension of slab and piles, the structure was analysed to resist working forces together with the existing bridge. The caisson and slab was connected by having the upper and lower steel reinforcements from the slab of 29 mm diameter and 3.5 m length embedded 30 cm deep with resin into the sides of the caisson.
