4. Rehabilitation of Wakamiya Railway Bridge (Japan)

Owner: Central Japan Railway Company
Engineer: Central Japan Railway Company
 Railway Technical Research Institute
Work's duration: 3 months
Service date: March of 1972 for up-bound line

The article describes the rehabilitation of a railway concrete slab girder bridge with double reinforcement by rigid concrete frame.

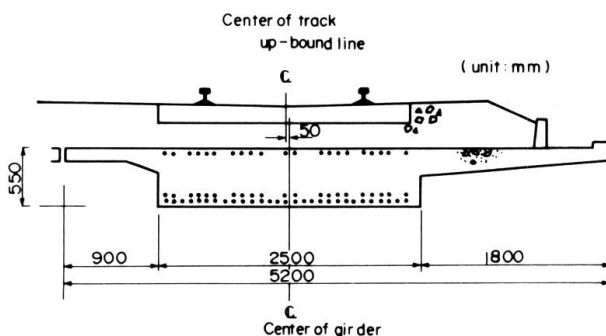
Fig. 1 Section of the girder of Wakamiya Bridge

The Wakamiya bridge (Fig. 1), located at 439 km from Tokyo, was damaged as follows:

- 1) The bridge deflected vertically from 3.5 mm to 4.7 mm at the center of the span under a test train load. The ratios of deflection to span length are 1:2,860 and 1:2,130 respectively. These ratios are nearly equal to the specified value.

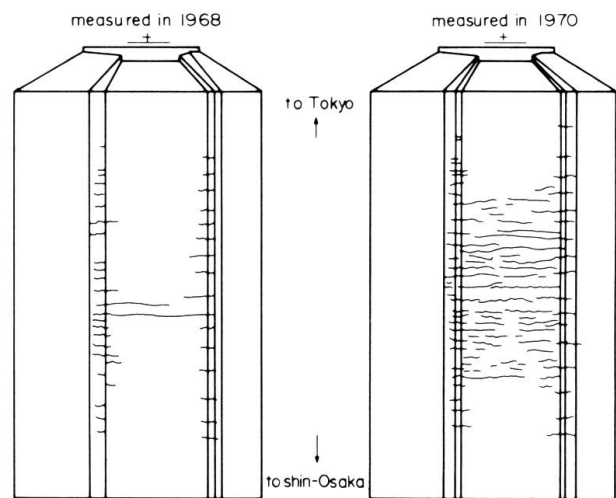
Fig. 2 Crack distribution on the concrete surface of a girder of up-boundline

- 2) The maximum width of cracks on the surface of the concrete grew to 0.2 mm but most of them were 0.1 mm wide. Cracks opened on average by 0.04 mm under train load and returned by 0.01 mm.
- 3) The crack distributions on the concrete surface in June 1968 and in October 1970 are shown in Fig. 2. The number of cracks under repeated loading increased in about two years.
- 4) The ratios of the measured stress and deflection under test train loading are shown in Fig. 3, where the deflection ratio is the value of the deflection at the center of the span at each speed of test train to the value of the deflection at the speed of 158 km/h. The maximum increasing ratio amounts to 1.7, while the specified value is 1.43.

The cause of damage seems that the frequency of the bridge vibration under repeated train loading approached the natural frequency of the bridge and that the resonance of the bridge was induced. The resonance seemed to have increased the deflection and to have caused many cracks.

The countermeasure to this damage is to avoid the resonance of the bridge. This is attained by setting the parameter $v/2fl$ equal to less than $1/3$, where v : train speed, f : natural frequency of the bridge and l : span length. As the natural frequency increases according to the increase of the cross section of the bridge, it is possible to avoid the resonance. In the case of Wakamiya bridge, the slab girder was strengthened by a concrete rigid frame. The general view of reinforced Wakamiya bridge is shown in Fig. 4.
