Artikel: TIG arc remelting as a repair method for steel railway bridges (Japan)
Autor: Masuda, Y. / Sakamoto, K.
DOI: <https://doi.org/10.5169/seals-20935>

5. TIG Arc Remelting as a Repair Method for Steel Railway Bridges (Japan)

Owner: Central Japan Railway Co.
Engineer: Central Japan Railway Co.
 Railway Technical Research Institute
Date of Construction: 1964
Date of Repair: 1987

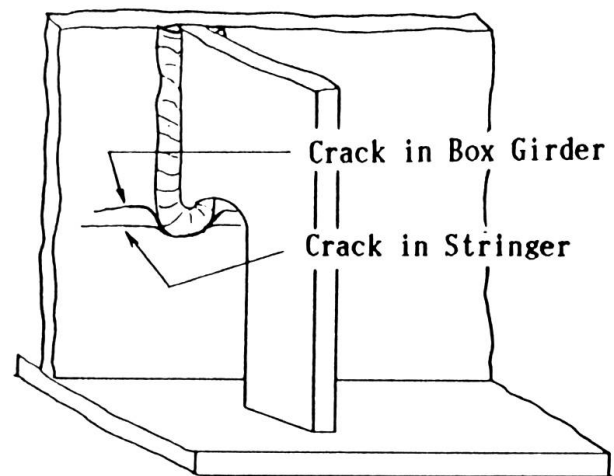
Fig. 2 Schematic of Crack Propagation

All these cracks were initiated at the stiffener end and the schematic of crack propagation was shown in Fig. 2.

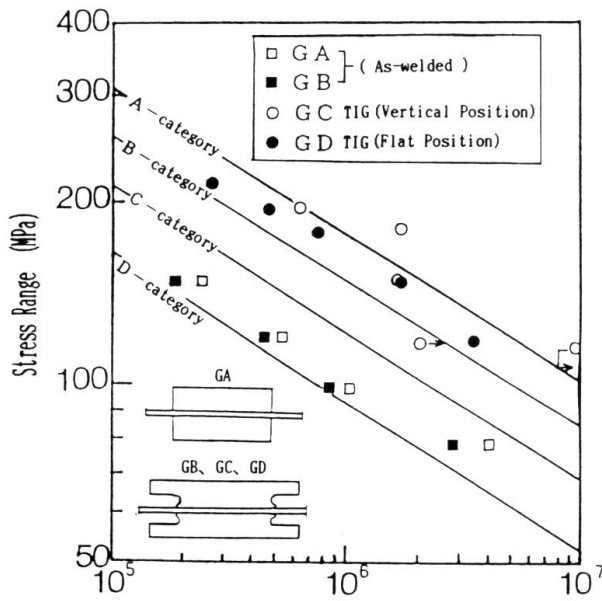
Fig. 4 Results of Fatigue Test

Fatigue tests were performed to confirm the effect of this treatment on improvement of fatigue strength. The fatigue strength of a joint subject to TIG arc remelting was much higher than that of an as-welded joint as shown in Fig. 4.
