5. TIG Arc Remelting as a Repair Method for Steel Railway Bridges (Japan)

Owner: Central Japan Railway Co.
Engineer: Central Japan Railway Co.
 Railway Technical Research Institute
Date of Construction: 1964
Date of Repair: 1987

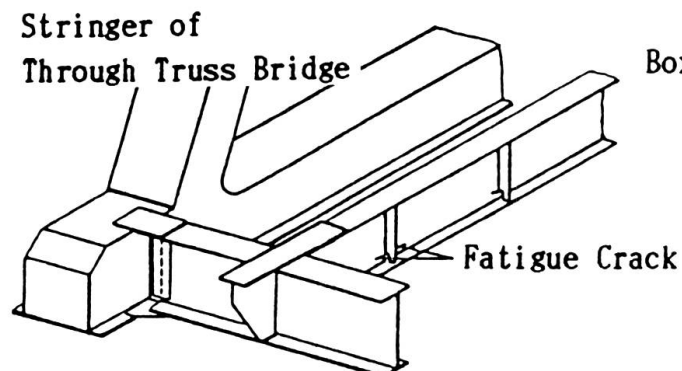
Fig. 1 Fatigue Crack at Stiffener End

Fatigue cracks have been detected at the toe of fillet welded joints of stiffener ends in the web plates of stringer beams of truss bridges and box section plate girders (see Fig. 1). The first fatigue crack was found in 1975. The rates of the number of bridges having cracks detected to that of the same type of bridges are seven percent for truss bridges and five percent for box girders.

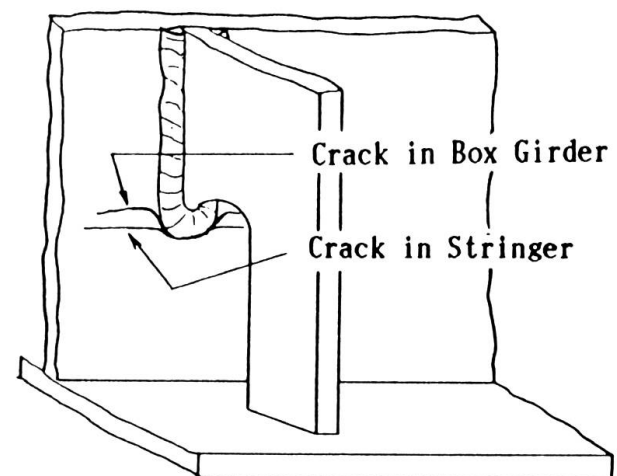
Fig. 2 Schematic of Crack Propagation

All these cracks were initiated at the stiffener end and the schematic of crack propagation was shown in Fig. 2.
