**Artikel:** Ohara Bridge fatigue crack repair (Japan)  
**Autor:** Miyazaki, Shoji  
**DOI:** <https://doi.org/10.5169/seals-20936>

### 6. Ohara Bridge Fatigue Crack Repair (Japan)

Owner: Toyama Prefecture  
 Engineer & Contractor: Kawada Industries  
 Work's duration: 6 months  
 Date of repair: 1984 – 1985

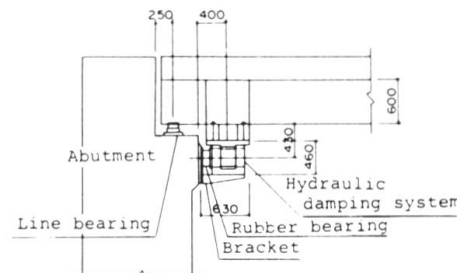
Fig. 7 Damper bearing

The fatigue cracks in the gusset plates of intermediate posts were mainly caused by excessive stress concentration at the corner section. This stress concentration was caused by a relatively large longitudinal displacement between stiffening girder and arch rib, which was created by the movability of both end supports. This was confirmed from displacement obtained in a loading test on the actual bridge, results from stress measurements, and the results of 3-dimensional finite element method analysis (Fig. 6). Therefore, as repairing method, new damper bearings were installed on the top of both abutments for reducing the relative longitudinal displacement (Fig. 7). This damper bearing comprised a rubber bearing, return spring and special hydraulic damping system. The supporting condition provides movability at both support bearings for static movement such as temperature effect and resists only to vertical movement caused by live load, giving elastic restraint toward longitudinal movements. Moreover, improvement schemes by making rigid joints or by providing hinges at the gusset plates of intermediate posts were reviewed, but the former indicated an adverse influence upon arch rib and the latter was found to be uneasy to work with. In addition, the compression stress was found to be primary, and the relief of residual stress by the outbreak of cracks was found to be expectable, so both improvement schemes were not adopted this time.

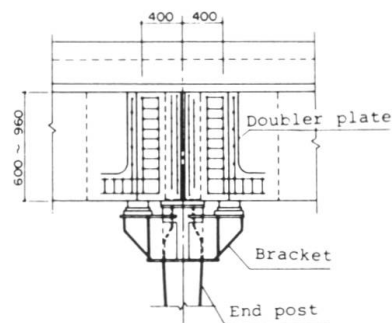
Fig. 8 Doubler plate added to web

be the main cause of the fatigue cracks. This was also confirmed by the loading test on the actual bridge. In the repairing method adopted, it was first necessary to reduce the out-of-plane displacement of web and thus lateral bracings were added near the location of web. As repairing measures against the cracks in web, three schemes were reviewed: making rigid connections or hinged connections at the joints, or repairing cracked portion by double plates. In consequence, the scheme of repairing the cracked portion by double plates was adopted from the viewpoint of easier work and appearance (Fig. 8). It was decided to leave the steel brackets, installed during temporary repair, as they were.
