Artikel: Fujigawa Bridge rehabilitation project (Japan)
Autor: Matsuo, Yoshio
DOI: <https://doi.org/10.5169/seals-20937>

7. Fujigawa Bridge Rehabilitation Project (Japan)

Owner:	<i>Shizuoka Prefecture</i>
Contractor:	
Substructure:	<i>Sumitomo Construction</i>
Deck replacement:	<i>Japan Bridge</i>
Superstructure:	<i>Yokogawa Bridge Works</i>
Work's duration:	<i>6 months</i>
Date of repair:	<i>1987 – 1988</i>

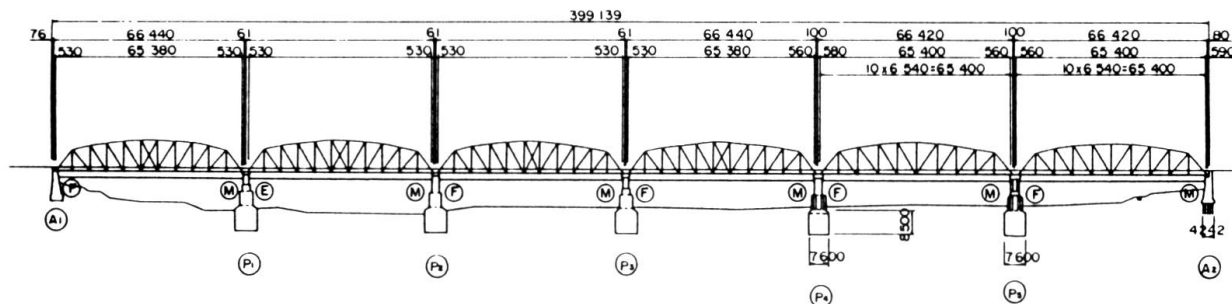
Fig. 1 Elevation

The Fujigawa Bridge, completed in 1924, over the Fuji River on Route 1 is a bridge with six-span curved chord pratt truss having a bridge length of 300.1 m, roadway width of 7.3 m and span of 65.4 m (Fig. 1). Route 1 is the most important road in Japan, and 60 years after completion of the bridge, the daily traffic flow was 21 000 vehicles, though bypass roads had been completed upstream and downstream of the bridge.

After many years of use, such problems as cracked concrete decks, corroded outer stringers, overstressed and deflected stringers, and scouring at the piers due to the lowered river bed of the Fuji River have occurred. Also, as a result of the increased traffic flow, traffic congestion caused by right turning cars holding the traffic had become a big problem.

To solve these problems, the substructure of the bridge was reinforced, and the stringers and deck on four spans to the left bank were replaced. Moreover, two spans to the right bank were replaced in order to install a right turning lane by the method that was chosen to complete the job with the least disturbance to traffic.
