Artikel: Strengthening of bridge slab at Kami-Imasu Bridge (Japan)
Autor: Inokuma, Yasuo
DOI: <https://doi.org/10.5169/seals-20938>

8. Strengthening of Bridge Slab at Kami-Imasu Bridge (Japan)

Owner: Japan Highway Public Corporation
Engineer: Japan Highway Public Corporation
Date of Construction: 1964
Date of Repair: 1976

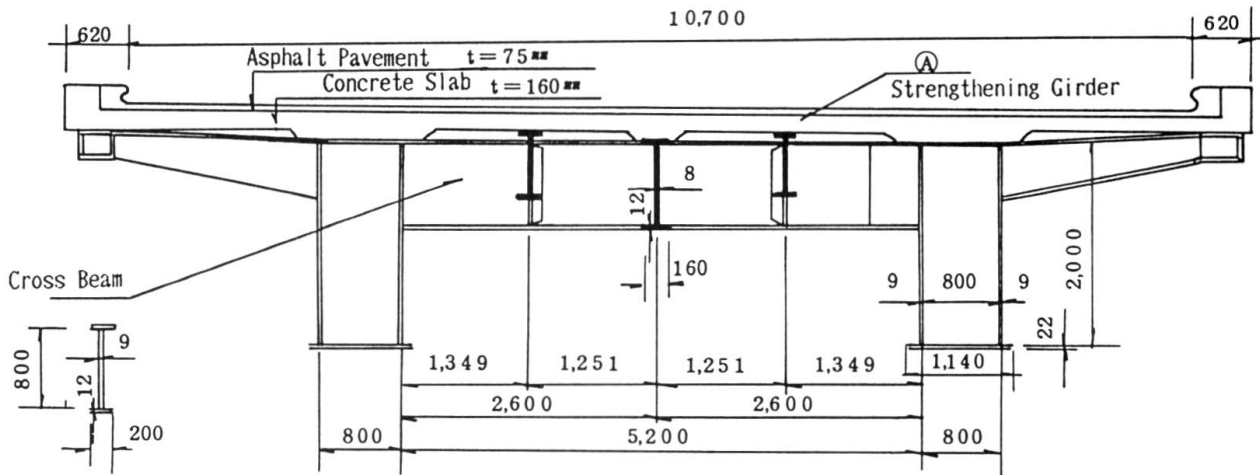
Fig. 1 Structure

After ten years of service, cracks in the slab increased to such an extent that it had to be repaired and strengthened. Finally it was decided to install stringers in between the original main box girders and the original central stringers as shown in Fig. 1. The reasons for the adoption of this method are as follows:

- 1) The traffic volume was so large that it was difficult to conduct the repair work on the upper side of the slab.
- 2) It was expected to be sufficiently effective on decrease of the bending moment of the slab.
