## 9. Rehabilitation of a Lenticular Steel Truss in New Jersey (USA)

**Engineer:** A. G. Lichtenstein and Assoc.  
Fair Lawn, NJ

**Date of repair:** September 1983 – April 1984

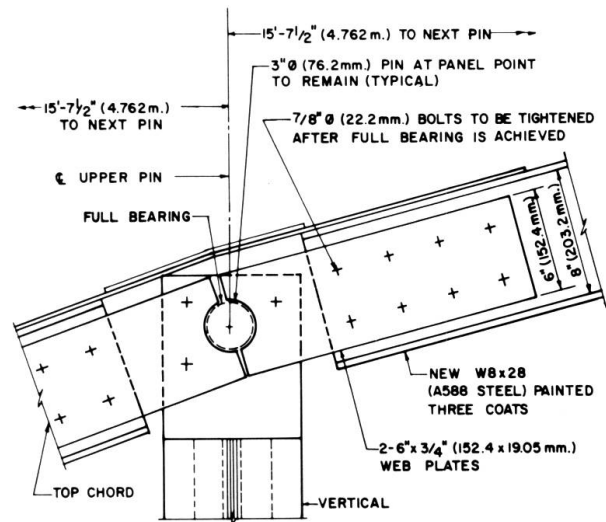
Fig. 1 Section along top chord

An indepth inspection of the bridge was conducted by the Consulting Engineer including non destructive testing of the eye bars, pins and other main connections of the bridge. All the elements of the trusses have been found to be in good condition except the *top chord*. The existing channels in the upper chord have completely corroded (holed through in many places) so that the bridge could barely support its own weight. The bridge was closed to traffic.

The assignment then was how to reconstruct the upper chord economically without changing the historic appearance of the bridge. This challenge was met by the interesting idea of installing new high strength steel beams between the existing corroded channels in the top chord and transferring the stresses from these channels to the new beams via specially designed web plates and bolts. A new steel beam was hoisted in this space between the channels and kept in place by bolting to the top cover plate of the upper chord. The contractor then installed the web plates which were detailed to have a perfect half round contact surface on one side, abutting the existing pin. After these web plates were bolted to the new beam on both sides, the contractor jacked these web plates in a horizontal direction so that contact between web plates and the pins was as tight as possible. In this way, a new upper chord was created, hidden within the confines of the old deteriorated upper chord without changing the distinctive appearance of the parabolic Lenticular Truss.

replaced; the sidewalk timber planking was replaced where necessary and hand railing repaired; tensioning of the tie rods in the King Posts of the floor beams; and reinforcing the tower legs at the piers and abutments. The entire bridge was sandblasted and painted with two coats of paint. Fig. 1 and 2 describe the Repair details of the upper chord, and Fig. 3 the King Posted Floor Beams.

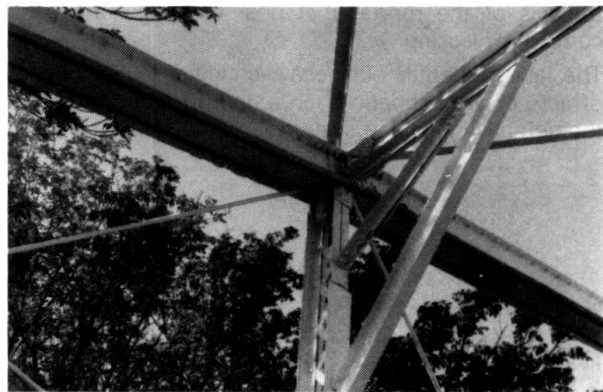
*Fig. 5 View of upper chord with new member in place*
