10. Repair and Rehabilitation of Roma-Viterbo Railway Bridges (Italy)

Owner: A. CO. TRA. L. – Azienda Consortile Trasporti Laziali

Design: Prof. Ing. Giorgio Croci

Contractor: NICIS S. P. A. – Roma

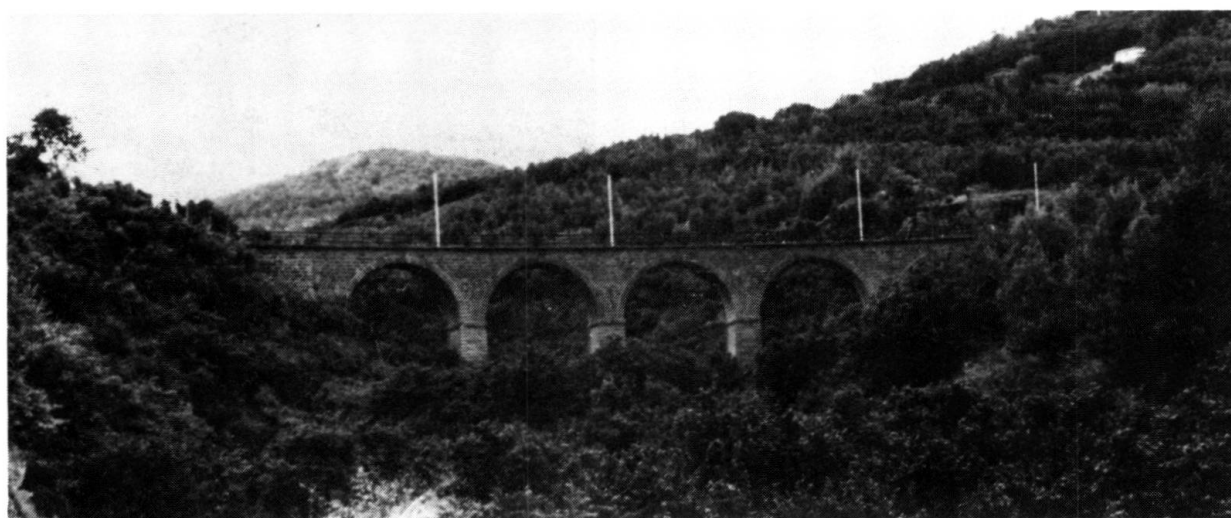
The main cracking manifestations are located in correspondence of the connection zone between the external hanging and the arcades involving the almost longitudinal development of viaducts.

These crackings are located almost exclusively on the external side of the curves because of centrifugal actions (see fig. 1).

Fig. 1 Global view of the viaduct

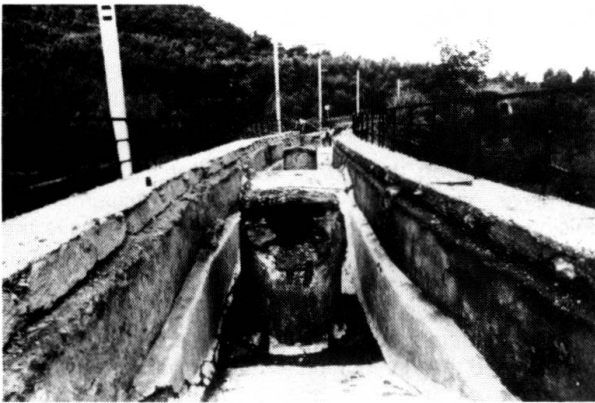
Fig. 2 A view of the inside of viaduct after removing of filling

The structural consolidation interventions consist in the realization of a reinforced concrete structure adherent on the existing masonry, after removing the internal filling (see fig. 2).

The slab on the extrados of the arcades has a thickness variable between 15 and 25 cm; the internal walls are 15 cm thick and follow the internal configuration of existing structures.

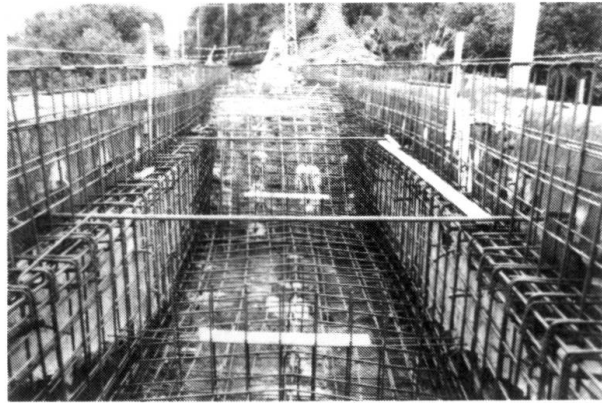
Fig. 3 Arrangement of steel-bars

The above-mentioned structures have been jointed with the existing masonry by means of injections of reinforced concrete both on the walls and on the vaults.

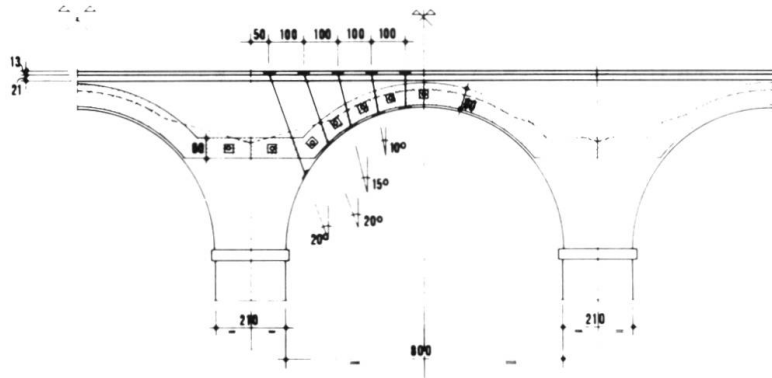
Fig. 4 Arrangement of prestressing cables

Relating with the requirement of non-interruptions of railway traffic, a different intervention of consolidation, which foresees the insertion of a prestress cables system, arranged according with the schemes in fig. 4, 5, has been studied.

The cables included in the vertical walls with an appropriate inclination supply a bending moment which compensates the moment due to centrifugal actions.

The horizontal cables arranged along the arcades tend to equilibrate the radial translation.

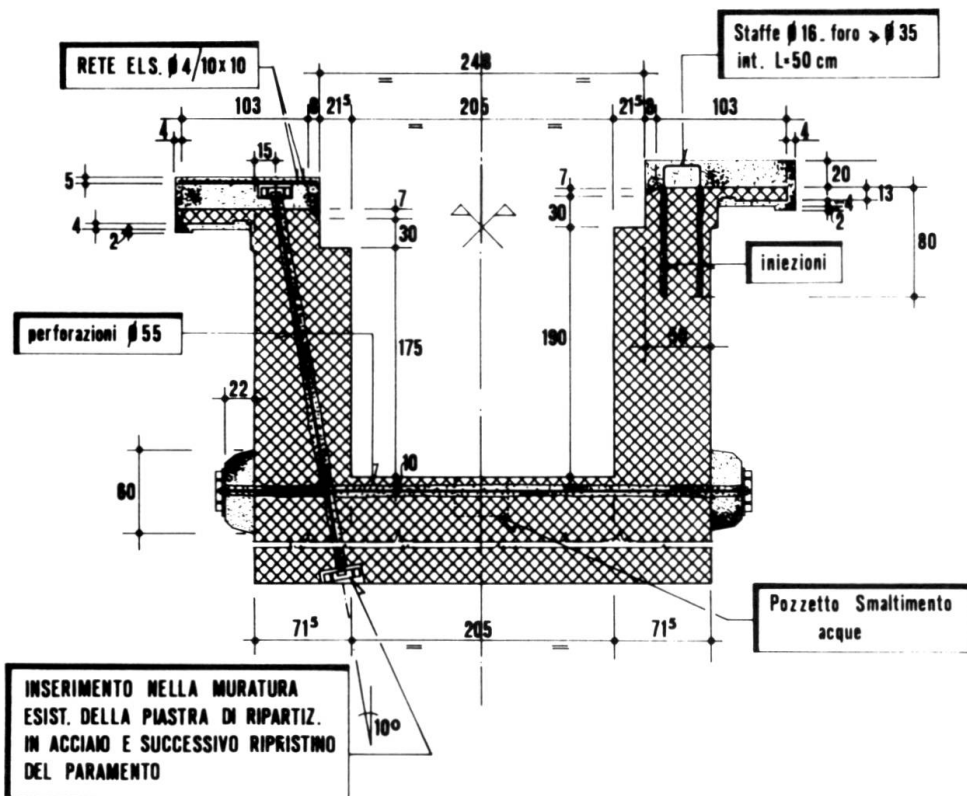
Fig. 5 Cross section on bridge-pier

In correspondence with the bridge, piers have been realized with 2 transversal stiffening walls to resist to centrifugal actions.
