The Collapse and Reconstruction of a Prestressed Concrete Box-Section Girder

Hugo Bachmann

Werner Horisberger,

During the construction of a prefabricated hall roof, a 25 m long prestressed box-section girder collapsed. The major cause of the failure was an inadequate structural design of the support regions. There was no transverse end beam present and support bearing points were not placed beneath the webs of the girder. The resulting transverse bending together with insufficient end anchorage led to the collapse. 45 similar beams, of which half were already erected, were in consequence locally strengthened in the support regions. Thus an original remedial solution, scarcely externally visible, was developed and tested through an on-site load test.

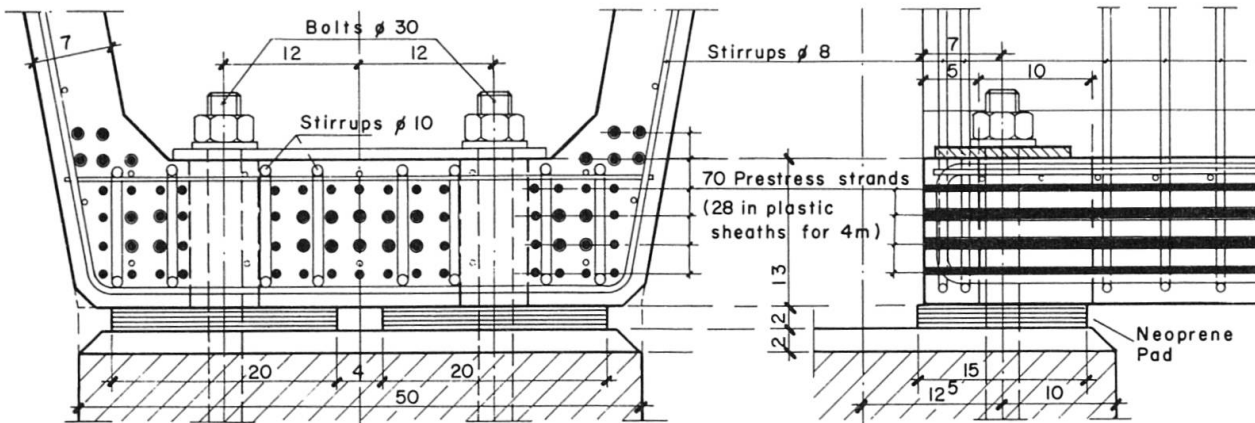
Fig. 6 Layout of the support region. Support in extreme situation.

end. However this value could be reduced to nearly 7 cm when measurement variations were taken into account. This was the case with the collapsed girder. The workers on site informed that the bolts had scarcely fitted through the holes in the girder. In the transverse direction the support points did not sit beneath the webs, but were about 10 cm within the cross-section.

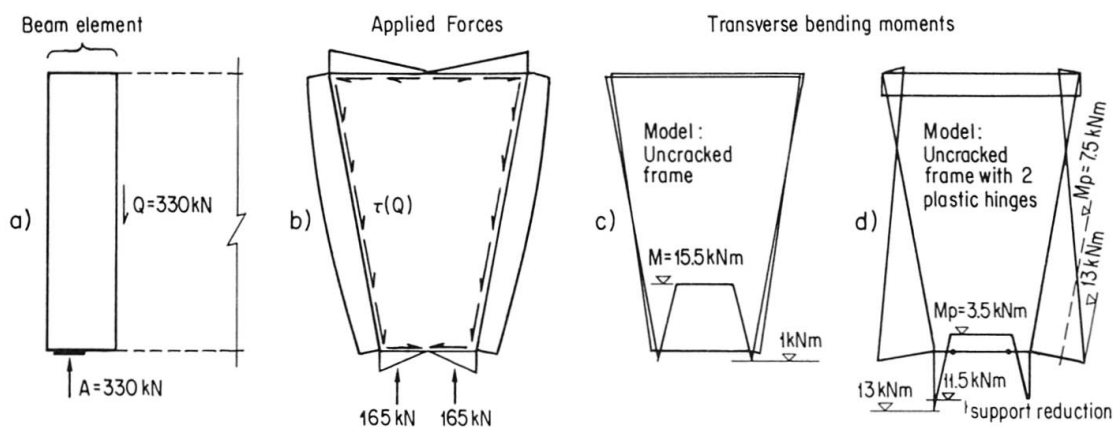
Firstly the transverse bending should be estimated for a concentric loading of the basic structural system's dead weight i.e. for a support reaction of 330 kN. A beam element at the end of the box-section girder, shown in Figs. 9a and 9b, is considered for this purpose. A closed frame is formed which is acted upon by the shear flow of the shear force and by the support reactions. Since both support bearing points are not located beneath the webs, considerable transverse bending moments arise. These, for the assumption of an uncracked section, are shown in Fig. 9c. The moment in the bottom flange comes to 15.5 kNm. With the reinforcement present over a locally supported width of 30 cm the corresponding yielding moment comes to only 3.5 kNm. This means that over both the support bearing points a plastic hinge must be assumed to occur. When one calculates for the remainder with the assumption of an uncracked frame, then the moment diagram of Fig. 9d results. Here the existent yielding moment in the web of 7.5 kNm is considerably exceeded. Thus a possible equilibrium condition can likewise not be found. That the beam did not collapse earlier with a smaller load therefore requires some explanation:

Due to the formation of the plastic hinges at the support bearing points considerable displacements arise. These cause a certain shifting through the neoprene pads of the produced reaction forces towards the webs. Thus the transverse bending is significantly reduced.

Fig. 9 Transverse bending of the support region after placement of the slab units on both sides (concentric loading).

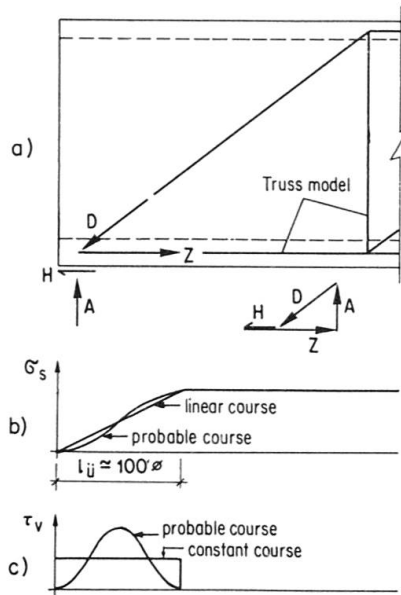
In Fig. 11a the force system in the web plane of the support region is schematically shown i.e. with a truss model that simplifies the actual situation. The inclined compressive force D stands in equilibrium with the tensile chord force Z and the support reaction A . If in addition there acts an external support force H , e.g. a secondary reaction, then Z must be increased with respect to H . If one takes an angle of inclination of 40° for D and ignores a possible H , then for a support reaction of 330 kN there results a Z of approximately 390 kN.

Fig. 11 End anchorage: internal forces following from the introduction of the support reaction (truss model); steel stresses and bond stresses from the prestress force.

These stipulations were in the discussed case either not at all or insufficiently fulfilled. The wires were cut through one after another with a power cutter. This led to a considerable disturbance of bond. Between various prestressed wires and parallel running end stirrups present the spacing was only a few millimeters. This did not everywhere keep to the well-known rule which states that the spacing of the placed steel should not be less than the the maximum aggregate diameter (here 15 mm).

From these points it can be assumed that the steel stress at the girder end was under proportional and only further into the girder interior increased to over proportional (Fig. 11b). Correspondingly the bond stress at the girder end was relatively small (Fig. 11c). With plausible assumptions the anchorage force comes within the region of 270 to 380 kN. Here the vertical end stirrups \varnothing 8 mm lying parallel to the prestress wires were not investigated. The bond of this steel with the concrete must, in consequence of the small spacing, have been relatively bad.
