**Zeitschrift:** IABSE proceedings = Mémoires AIPC = IVBH Abhandlungen  
**Band:** 11 (1987)  
**Heft:** P-106: Flash floods on bridge piers

**Artikel:** Flash floods on bridge piers  
**Autor:** Krumdieck, Alfonso  
**DOI:** <https://doi.org/10.5169/seals-40366>

## Flash Floods on Bridge Piers

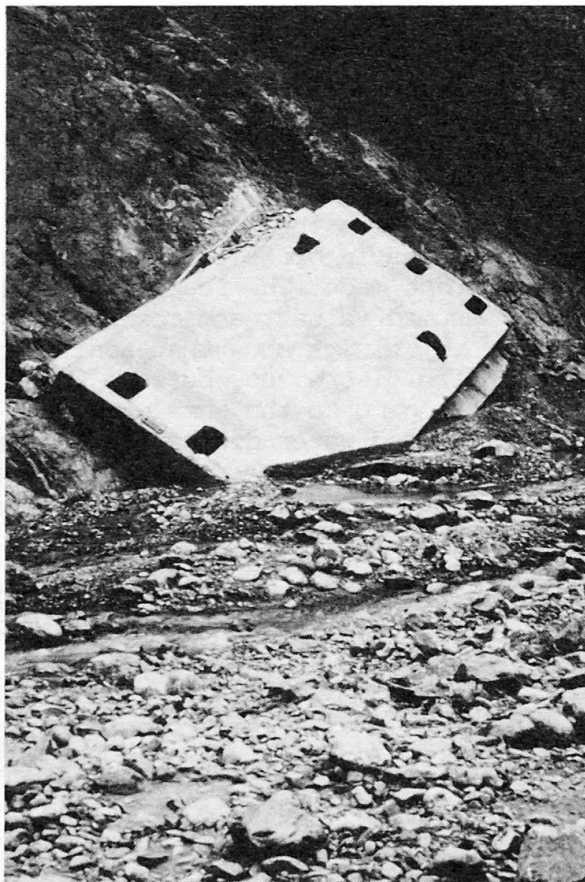
Huge quantities of bed material were reported to have been dragged along the river bed. The peak velocities which occurred during the event could not be directly measured. From eye witness accounts these were estimated to be about 30 to 60 km/h, however these must be judged critically. Taking into consideration that huge bridge slabs of 200 tons of weight or more were moved hundreds of meters downstream, it can be safely assumed, that peak velocities of approximately 50 km/h occurred, (see Fig. 2).

FIG. 2 200 Ton Bridge slab after the flash flood.

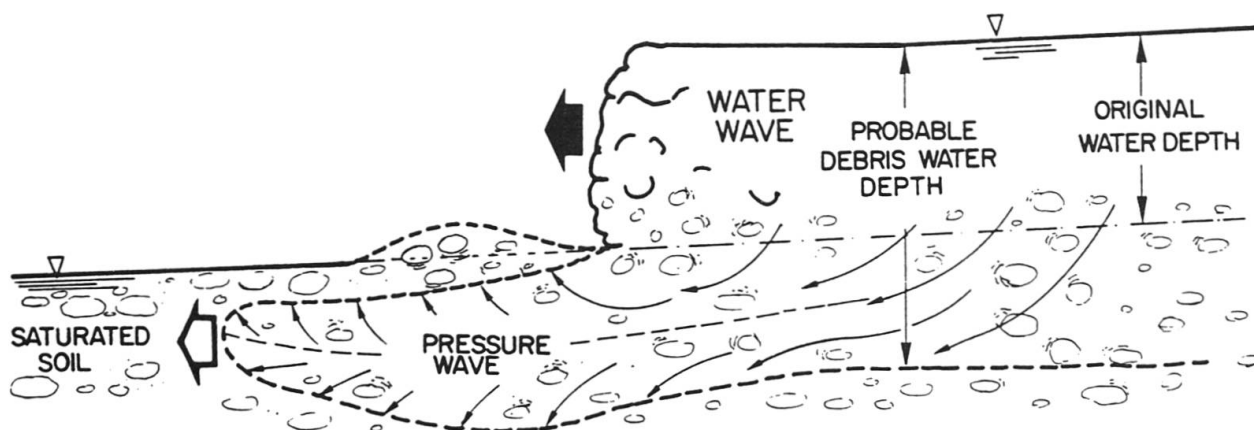
Wave-induced pore pressures and soil liquefaction in front of a water wave produced in saturated soils have been reported in recent years by several authors (e.g. Sleath [7]; Madsen [8]; Nataradja and Singh [9]; Zeevaert [10], etc.) Similarly in this case, it is postulated that the incoming water wave in the wadi bed generated a pressure wave in the saturated soil. This pressure wave has the ability or property to travel through the saturated granular soil at a velocity which is greater than the velocity of the water wave on the surface of the river bed (see Richart et al., [11]). Therefore, the pressure wave will have to travel in a pulsating or intermittent form in front of the water wave (see Fig. 3).

FIG. 3 SCHEMATIC VIEW OF A FLASH FLOOD WAVE.

The pressure wave will increase the magnitude of its pressure when the water wave increases in size. If the size of the water wave continues to grow, there is a moment in which the pressure wave will reach a value equal to or greater than the effective confining pressure and the shear strength of the soil will become zero, i.e. it fluidizes. Fluidization, as opposed to liquefaction, is a mechanism by which a cohesionless material achieves a viscous liquid-like condition by forcing a fluid from an external source upward through the sediment, until the immersed weight of the grains is balanced by the total fluid drag, (Othmer [12]; Leva [13]; Kunii and Levenspiel [14]).

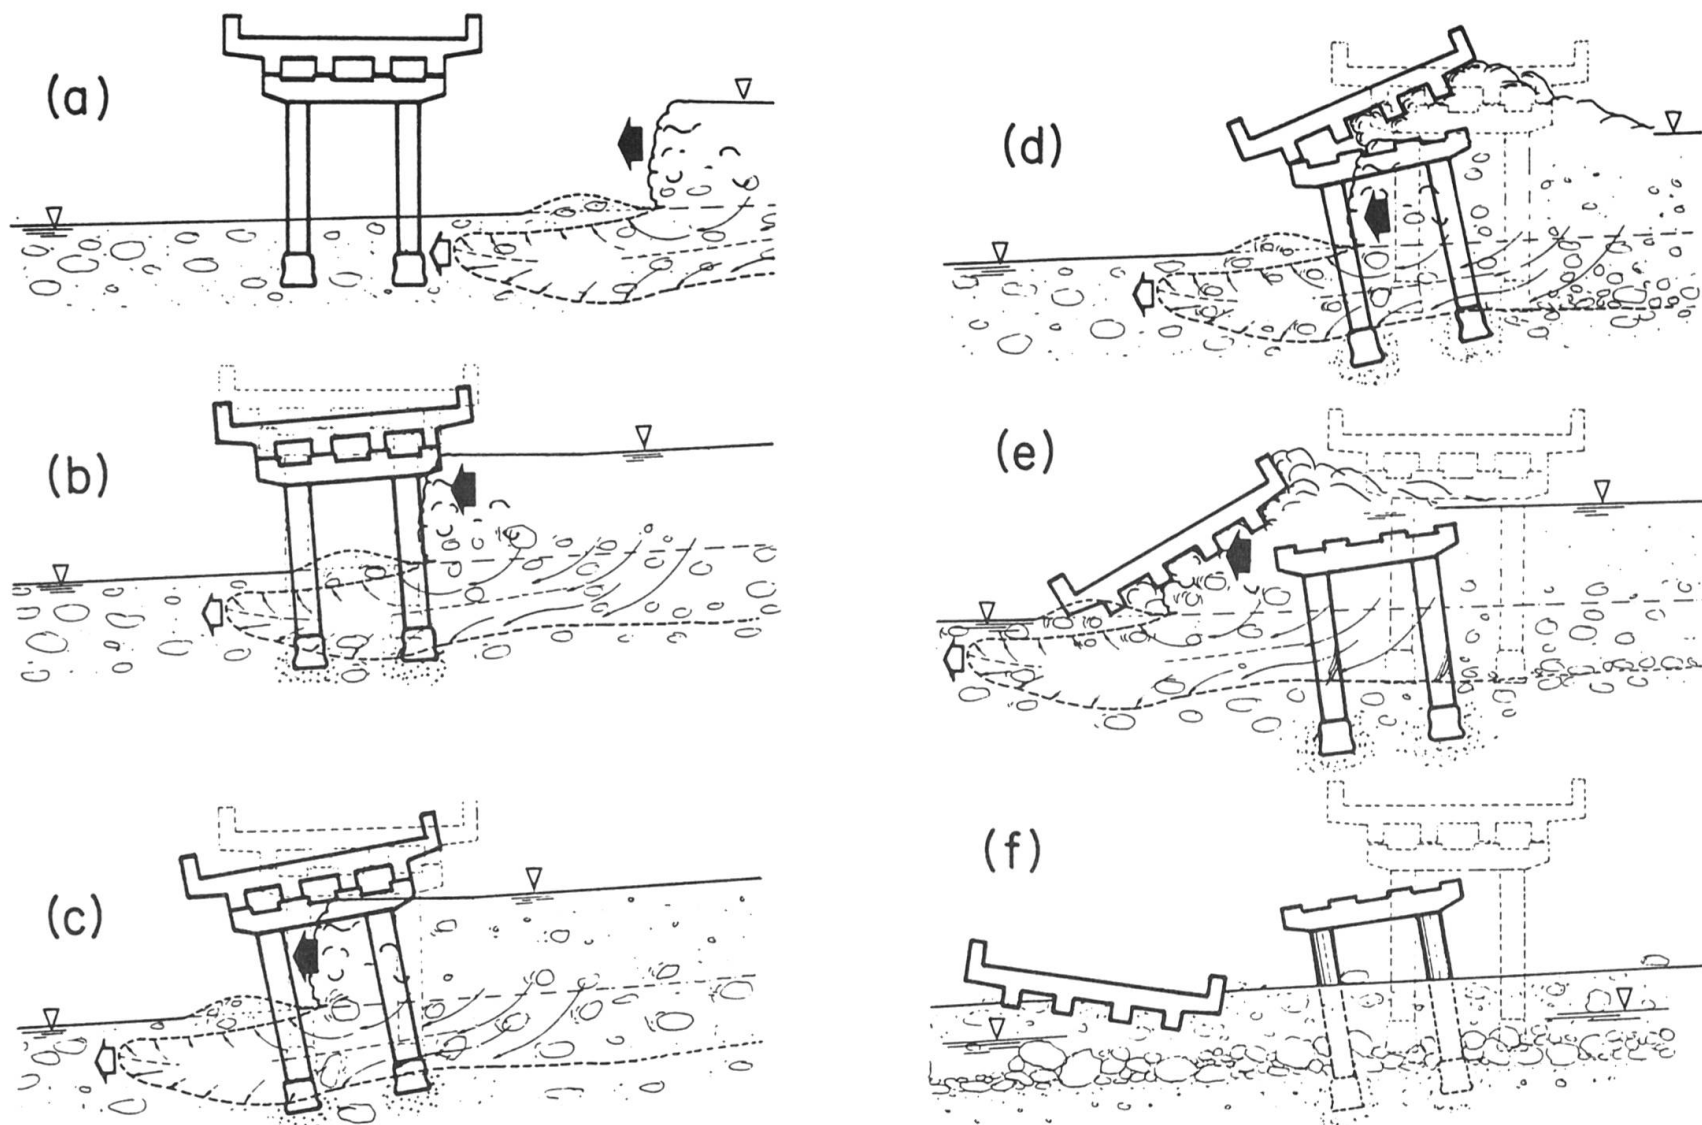
It is postulated that this temporary fluidization of the soil in front of the water wave caused those piers to collapse or to sink before erosion had time to act. This temporary fluidization of the soil is also the reason which allows the incoming water wave to enrich and to reinforce itself with not only the water retention pirated from the saturated soil, but also with the fluidized soil debris as well. This explains why the measured discharge runoff can be, in certain cases, far greater than the calculated discharges from the rainfall records alone.

Figure 4 gives a schematical interpretation of the sequence of events suffered by at least one of the bridges of the catastrophic flash flood that occurred on February 13, 1982. The photographs of figures Nr. 5, 6 and 7 taken after the catastrophe, demonstrate that the piers have sunk and moved several decimeters and meters but were not broken, and the displacements are evident.

FIG. 4 SCHEMATICAL VIEW OF PROPOSED FAILURE MECHANISM

1. To check with a thoroughly soil mechanics investigations, the possibilities that the soil may have on its surroundings to become fluidized in any time of the usefull life of the bridge.
2. The foundations of the bridge piers should be deep enough.
3. To provide pier protections, inclusive for the part below the surface of the river bed.
4. The design height for the bridge slabs should take into consideration the possibility of an incoming flash flood peak.

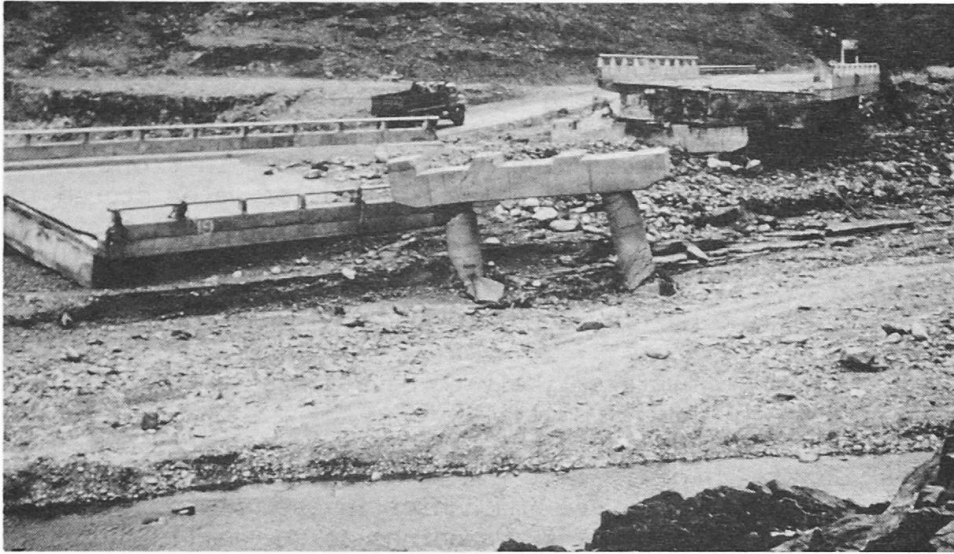
FIG. 5 Bridge destroyed by the flash flood of February 13, 1982.

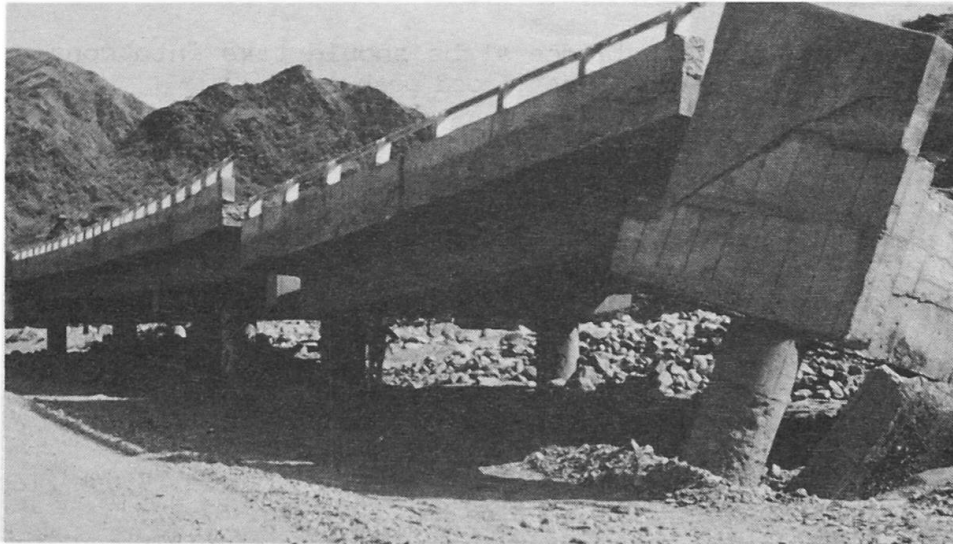
FIG. 6 Piers sunken due to fluidization of the river bed.

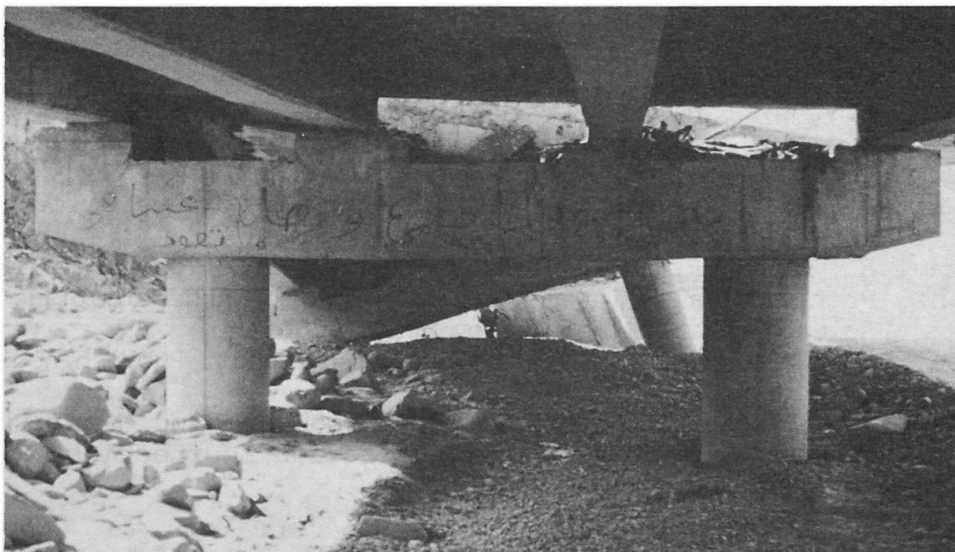
FIG. 7 Support structure damaged by the flash flood.
