Artikel: Some remarks on the service behaviour of steel railway bridges

Some Remarks on the Service Behaviour of Steel Railway Bridges

R.A.P. SWEENEY

CN Rail

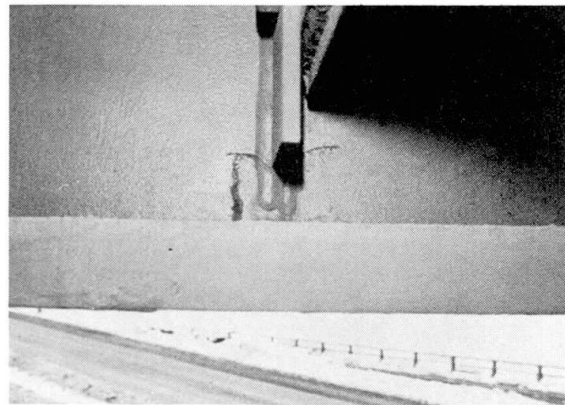
Fig. 4 "U" shape crack

The first group of problems to turn up on our railway on welded structures were cracks at the bottom of stiffeners on skewed structures. Figure 4 is typical of this detail with a diaphragm or brace frame attached to the stiffener. Note that the stiffeners are not extended to the bottom flange. This was in blind obedience to the dictum of an early researcher in welded construction that one should not weld to the tension flange. Because of the stresses introduced by the differential deflections of the connected girders, and to small out-of-plane movements, the first cracks appeared in less than 5 years on heavily travelled lines.

The crack would start at the bottom of the stiffener and form a "U" shape crack around the bottom of the stiffener. If the original stiffener-web weld was of good quality, this crack would turn out into the web and slow down considerably.

Unfortunately in many cases the only adequate cure is not to have the detail in the first place. If the crack isn't going to go anywhere, and if it has not damaged the structure too severely, it is best left alone as the retrofit may make things worse. Cracks at the bottom of stiffeners tend to be in this category.

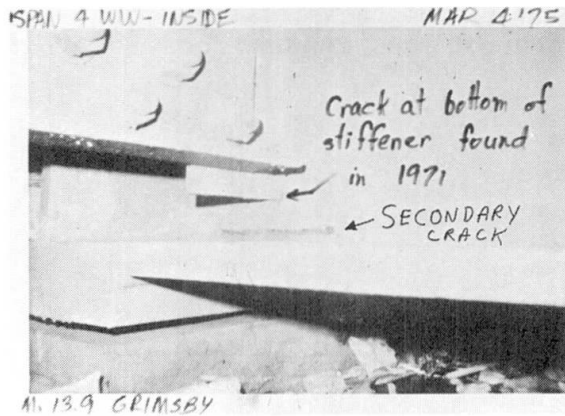
Fig. 5 Secondary Cracking

After cracks have occurred as described above, the next point of rigidity is between the web and flange. If there is any out-of-the plane of the girder motion, it is only a matter of time before cracks will occur in the web to flange weld below the stiffener (Figure 5). Stopping these cracks is very important.

The skewed multi-beam composite structure shown in Figure 5 cracked due to a fatigue related failure. Throughout the repairs, which were delayed for over a year, regular train traffic was permitted. This could

Repairing the cracks that occur between the flange and web is extremely important. The general procedure for any crack is to:

1. Use a chisel to vee out the crack,
2. Fill the resulting groove using a proper electrode, and
3. Grind flush.

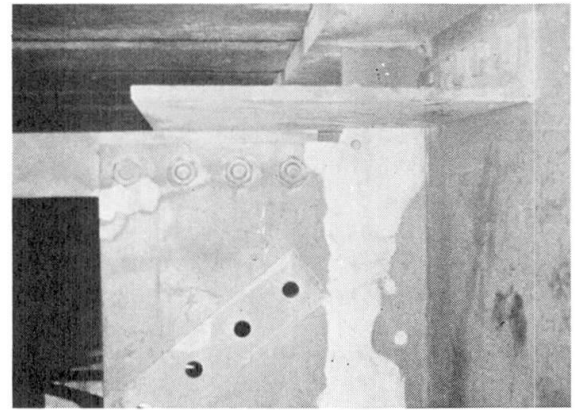
Fig. 6 Gusset to Stiffener

Another detail that has given trouble is the connection of brace frame angles to stiffeners (Figure 6) with the gussets groove welded to the stiffener. Referring to Figure 7, the critical detail has a zero radius. The stress causing crack growth is the lateral force from trains. Since maximum lateral impacts often occur due to hunting (side to side snaking) of empty cars, it took less than five years for these cracks to develop.

In the case of the gussets groove welded to the stiffener, since these developed in less than 5 years, they could be expected to re-occur in the same time frame if repaired. It was decided to replace the butt welded detail with a bolted detail for the brace frames. Prior to doing this, all cracks were repaired by welding and the top and bottom three inches of the stiffener where the gusset place was removed were ground smooth to get rid of any incipient cracks.

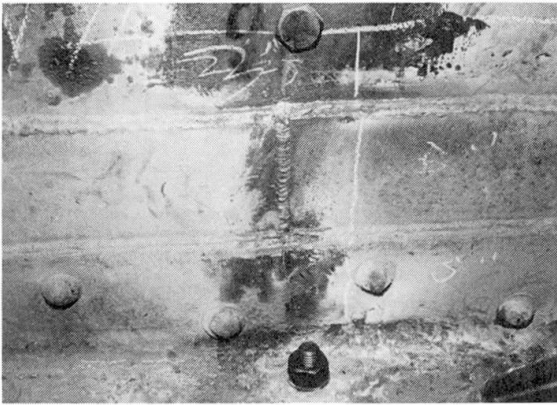
Fig. 8 Crack in Patch Plate

In the late 60's, it was decided to repair the corrosion that occurs in deck plate girders at the web-bottom flange junction on a number of our structures. Because of the production operation, patch plates were of various lengths, and were butt welded as required. After 10 years these welds started to crack under very low stress ranges. The maximum measured stress range was 36.2 MPa (5.25 ksi) with a mean peak per train of 31.92 MPa (4.63 ksi). There was little if any apparent dynamic augment.

The cracks (Figure 8) in these welds were very hard to detect and were not detected until they had propagated from the patch plate welds into the web.

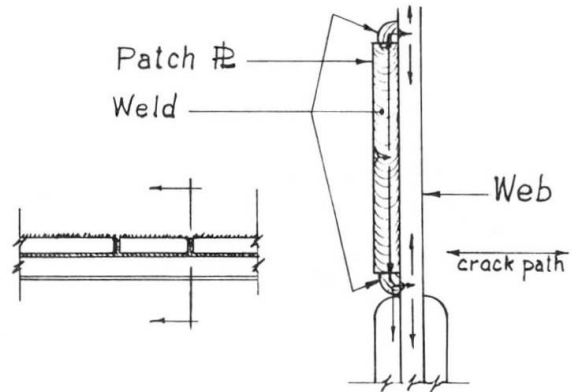
Fig. 9 Crack Growth

1. Crack initiation at a flaw.
2. Crack growth (Figure 9) in the weld upward and downward in those welds that did not have full penetration and horizontally into the web for those that did.
3. Growth from the level of the horizontal fillet welds into the web and bottom flange leaving multiple cracks.

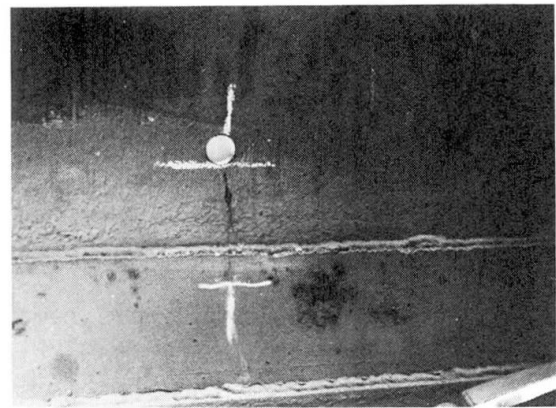
Fig. 10 Cracked Through

Figure 10 shows the same location looking from the inside of the girder. Note that there is no butt weld on the inside at the location of this crack. The crack has propagated from the opposite side.

Four crack fronts have been illustrated from the same initial crack. Depending on the degree of penetration, more crack fronts could theoretically develop. Hence, the repair procedure cannot consist solely in repairing the visible cracks as there may be other hidden cracks.

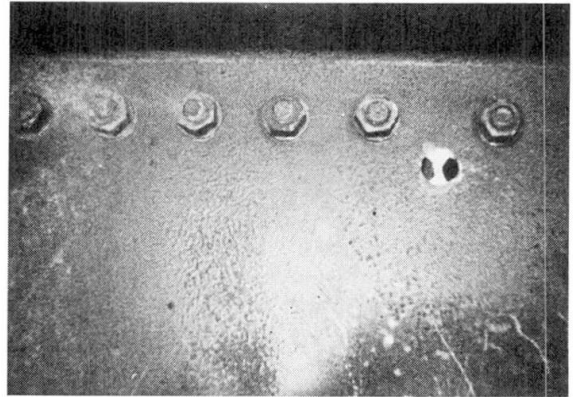
Fig. 12 Other Side

Figure 12 was taken after the two holes drilled from the inside had been reamed to one hole from the outside flush with the stiffener on the inside. The white metal along the vertical centerline of the hole is the stiffener.

In cases where the round hole remains an unacceptable fatigue detail, and where it is physically possible, a high strength bolt can be placed ensuring that the non-burr side of the washer is placed against the steel. The clamping force of the bolt will ensure a better detail and will prevent any further crack propagation should the crack tip have penetrated the far side of the hole. After stopping the crack, attention can then be focused on the repair.

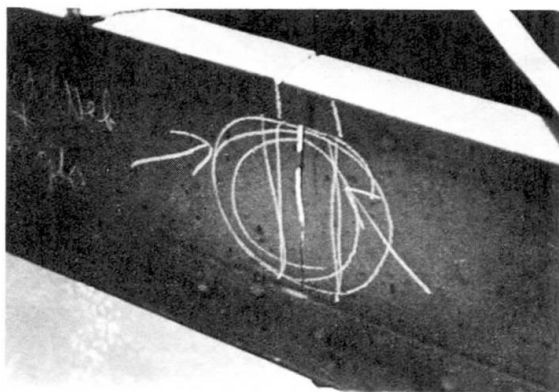
Fig. 13 Crack in chord

Most riveted structures were internally member redundant in that they were fabricated of several components (Figure 3). Their advantage is that cracks do not jump from piece to piece. The chord member of the truss shown in Figure 13 cracked on one side, but not on the other side of the member, and carried rail traffic for some time before detection and repair. In a welded box like member the crack would have propagated all around.

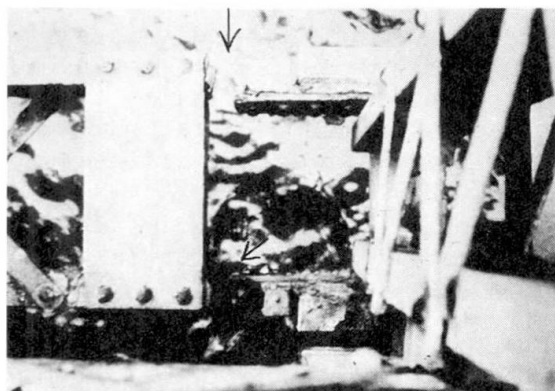
Fig. 14 Chord Severed

Most trusses are multi-load path structures. The truss in Figure 14 had its bottom chord completely severed and yet remained standing because of the alternate load paths provided by the bracing, floor system, etc. The truss shown in Figure 15, which did not have adequate bracing, did not remain standing when one of its diagonals was severed by a shifting load. It is unfortunate that it didn't have sufficient redundancy.

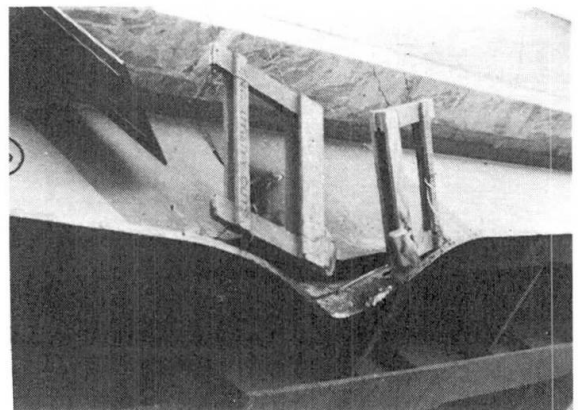
Fig. 16 Hit by Vehicle

A rather striking example (Figure 16) is this multi-beam welded structure with a composite deck which was hit by the top of a backhoe. Although several girders were badly damaged, the structure did not collapse under train traffic. It is known that several trains crossed on the adjacent track after the accident. Imagine what could have happened if that had been a two girder non-composite welded system.

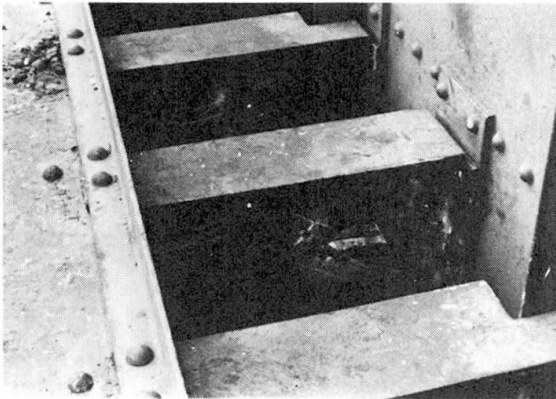
Fig. 17 Torsional loading

This (Figure 17) structure cracked due to torsional loading caused by constant train breaking. Although the floor beams are not welded there is no component redundancy as the beams are rolled. Nevertheless, the redundancy of the deck system has permitted regular train operations for over a year with 4 adjacent floor beams failed.

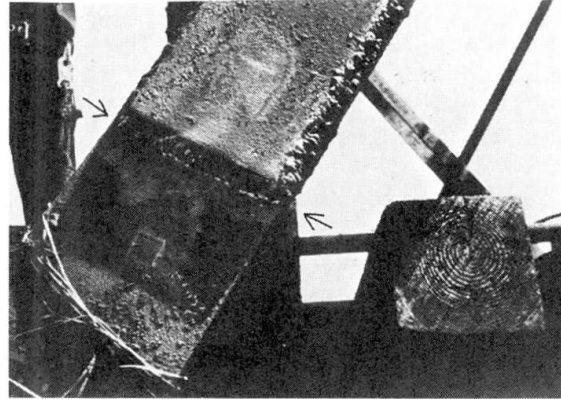
Fig. 18 Eye Bar Weld

The type of repair shown in Figure 18, the addition of welded plates to an eye bar member could be a disaster in a non-redundant load path structure. The crack is illustrated by the light line of magnaflux at the toe of the weld. In this bridge, because of its multiple load paths, collapse will not occur if one of these members cracks through.
