**Artikel:** Restoration and widening of the Tasman bridge

**Autor:** Lee, D.J. / Crossley, B.K.G.

## **Restoration and Widening of the Tasman Bridge**

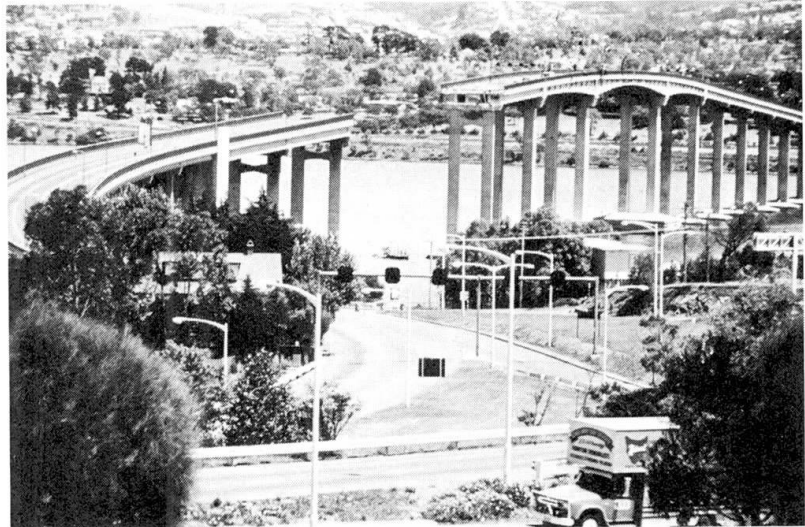
Fig. 1 Tasman Bridge after collapse

In January 1975, the ore carrier S.S. Lake Illawarra, fully laden and displacing 17,000 tonnes, collided with Piers 18 and 19 of the bridge bringing down these piers together with three spans of the eastern main viaduct and leaving a gap of 128 m. The centre one of the three spans fell on the bow of the ship which quickly sank, the tragedy resulting in the loss of twelve lives. The severence of the only road link also caused quite substantial social disruption, as the eastern shore has mainly dormitory suburbs, with the majority of the city's infrastructure being on the western shore.

The consequences of the accident to the remainder of the bridge were relatively minor as it had performed in accordance with design provisions. Span 16-17, the only remaining eastern main viaduct span on the river side of the gap, had remained in position supported by the stay bolts. Pile Cap 20 had suffered severe damage when it was hit by the falling span 19-20, whose trajectory of free fall was intercepted by one end hitting the bow of the ship. The columns on either side of the opening were deflected towards the gap at the top by up to 200 mm and the lower part of the columns was severely cracked. Otherwise the remaining 19 spans of the bridge were undamaged.

As the majority of the bridge was intact, the decision to renovate rather than rebuild was a straight forward one, as not only would it be much cheaper but also very much faster, the latter being of prime importance under the circumstances.

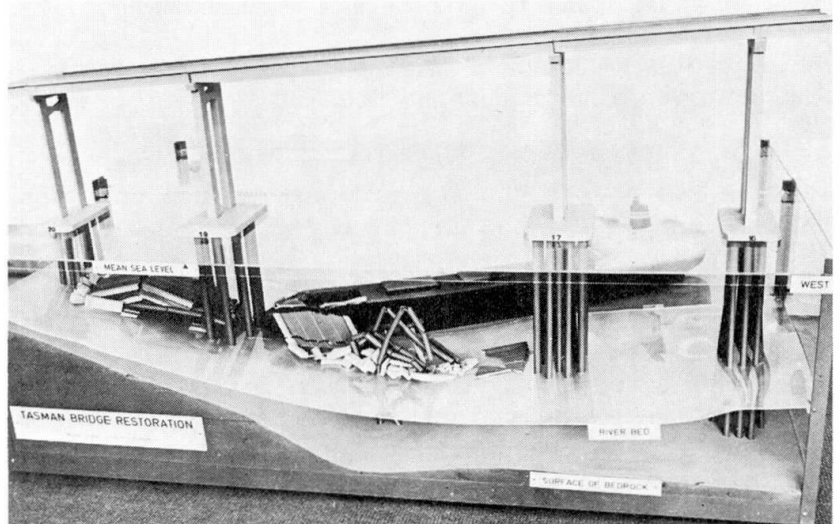
Fig. 3 Debris model

The debris survey took about three months and in the end all the broken bridge pieces were accounted for. A model was built to show the underwater picture (Fig. 3). During the debris survey it is to the credit of the Bridge Commission that pressures to make an early decision on the method of restoration were resisted. Five alternate schemes for reconstruction ranging from a single span scheme to a triple span scheme were examined in some detail. As the underwater scene unfolded the schemes were discarded one by one because debris prevented the placement of new piles, and the selected scheme only became evident at the end of the survey period when a complete picture was available. The only clear space available to establish a new pier was at the site of the original Pier 19 and this involved placement of new vertical piles between the existing broken off raking piles. The decision to delay the selection of a reconstruction method until the survey was completed was vindicated by job performance as no delays occurred due to new piles striking debris.

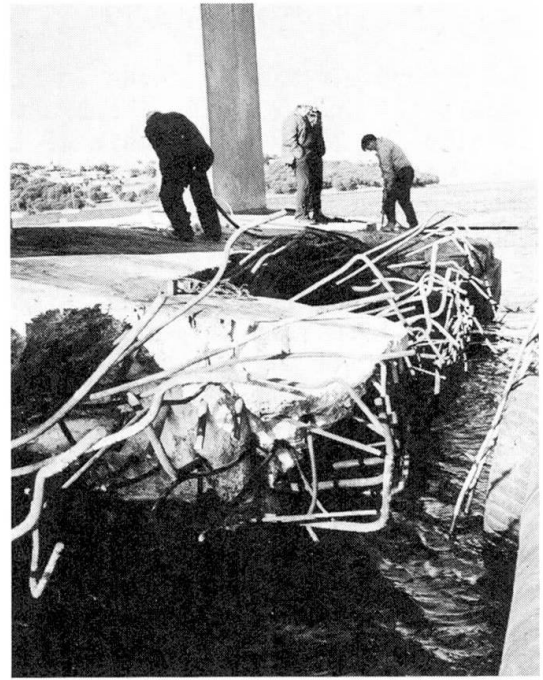
Fig. 5 Damage to Pile Cap 20

The security of Pile Cap 20 was more difficult as it had lost about one third of its volume (Fig. 5) and the remainder was extensively cracked and in some places crumbled. Its load carrying capacity was unknown and although it had to be replaced later it was decided to do temporary repairs before any major work commenced. These were in two parts:-

- Replacement of the concrete which had been removed without attempting to repair or remove and replace the cracked concrete.

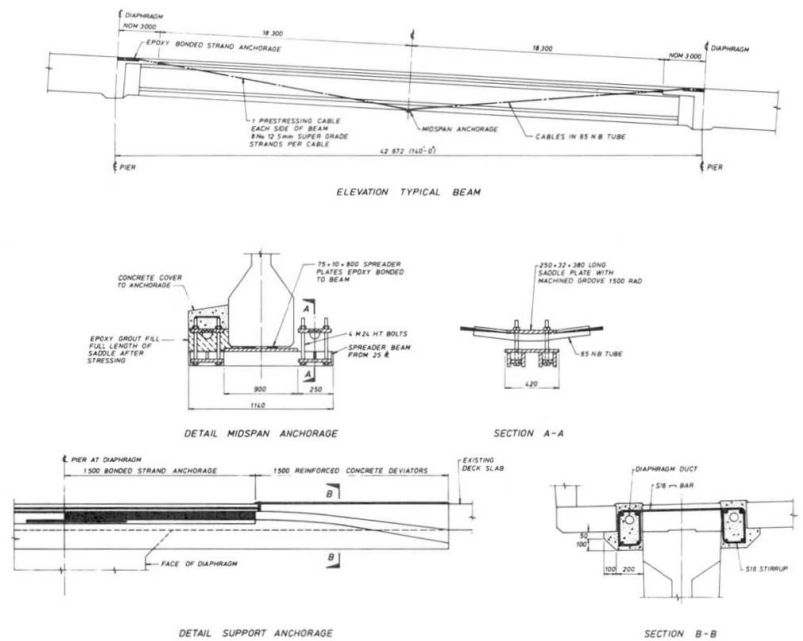
Fig. 13 Beam strengthening details

The 42.7 m span, prestressed concrete beams in the main viaducts were constructed segmentally. Due to the extra load from the widening, the outer beams were in tension at working loads and for serviceability reasons it was decided to

strengthen them by adding external tendons in a "Vee" shape one on each side of the web (Fig. 13). The tendons were 8 x 12.5 mm strands grouted into a 75 mm steel pipe and were stressed by pulling them down at mid span, and anchored by bolting to the mid span saddle to give an uplift force of 38 tonnes.
