## **Restoration and Widening of the Tasman Bridge**

### **D.J. LEE**

### **B.K.G. CROSSLEY**

## **SUMMARY**

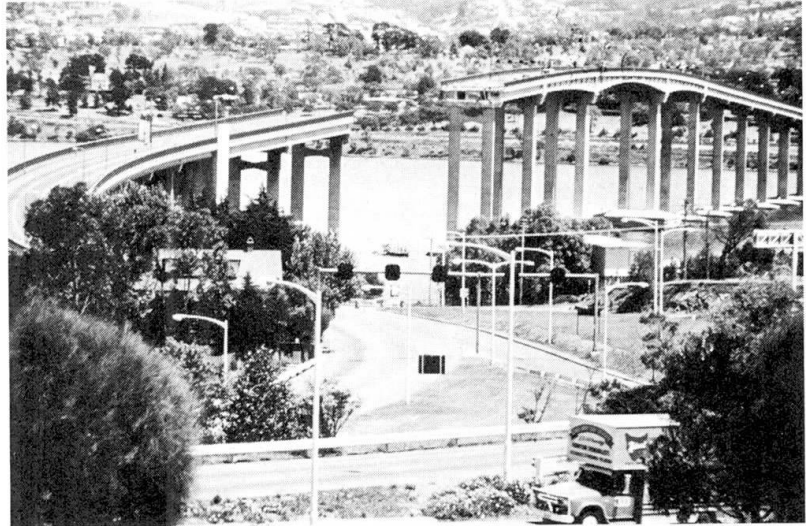
Fig. 1 Tasman Bridge after collapse

In January 1975, the ore carrier S.S. Lake Illawarra, fully laden and displacing 17,000 tonnes, collided with Piers 18 and 19 of the bridge bringing down these piers together with three spans of the eastern main viaduct and leaving a gap of 128 m. The centre one of the three spans fell on the bow of the ship which quickly sank, the tragedy resulting in the loss of twelve lives. The severence of the only road link also caused quite substantial social disruption, as the eastern shore has mainly dormitory suburbs, with the majority of the city's infrastructure being on the western shore.

The consequences of the accident to the remainder of the bridge were relatively minor as it had performed in accordance with design provisions. Span 16-17, the only remaining eastern main viaduct span on the river side of the gap, had remained in position supported by the stay bolts. Pile Cap 20 had suffered severe damage when it was hit by the falling span 19-20, whose trajectory of free fall was intercepted by one end hitting the bow of the ship. The columns on either side of the opening were deflected towards the gap at the top by up to 200 mm and the lower part of the columns was severely cracked. Otherwise the remaining 19 spans of the bridge were undamaged.

As the majority of the bridge was intact, the decision to renovate rather than rebuild was a straight forward one, as not only would it be much cheaper but also very much faster, the latter being of prime importance under the circumstances.

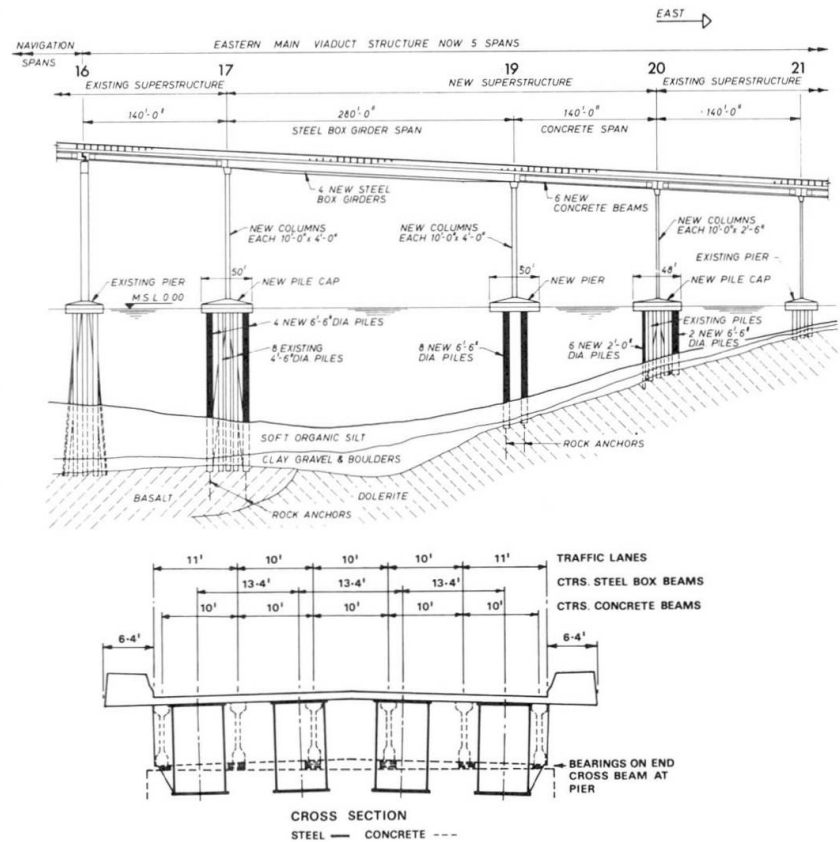
Fig. 4 Details of restoration

The method adopted is shown in Fig. 4 and has been reported on previously by LESLIE [7] and [8]. As the broken 1.4 m diameter piles at Pier 18 (40 m to bed level being the deepest part of the river), rose 15 m above the mud level this pier was omitted and the method involved the replacement of the three fallen spans by two spans; an 85 m steel span 17-19 and 43 m concrete span 19-20. Cross-sections are shown in Figs. 6 and 7. The scheme involved 14 new 2 m diameter vertical piles rock anchored at the base, some of which were to be used both as falsework piles and permanent piles. Foundation conditions were predetermined using one borehole per pile and were good, consisting of almost fresh dolerite at Piers 19 and 20 and partly weathered basalt at Pier 17. At Piers 17 and 20 the existing columns and pile caps had to be demolished and replaced. At Pier 17 additional piles, working in conjunction with the eight existing 1.4 m diameter raking piles, a bigger cap, and heavier columns were required to resist the greater loads from the double span. At Pier 20 there are no additional loads, but it was considered necessary to replace the badly damaged pile cap and columns, and the falsework piles required to achieve this were incorporated into the permanent structure, although not strictly required from a strength viewpoint. As there was a considerable time saving involved, the replacement of the substructure at these two piers was to be undertaken without demolishing the flanking spans (total mass 1,250 tonnes each) supported by them.

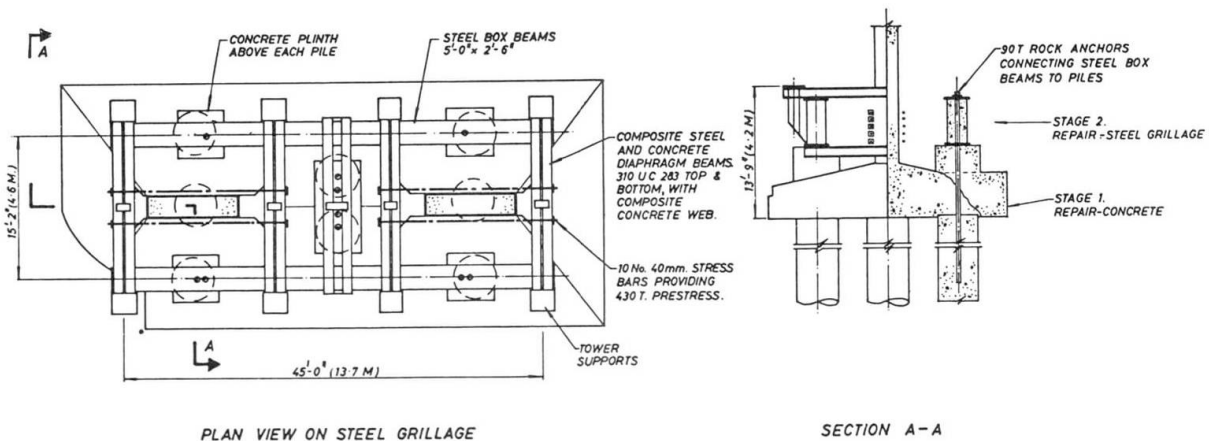
Fig. 6 Pile Cap 20. Temporary steel cap

- Construction of a temporary steel pile cap above the existing cap (Fig. 6). Its purpose was to enable column loads to bypass the existing cap and be transmitted directly into the piles. This action was achieved by stressing the steel cap to the columns and by casting concrete plinths on top of the existing cap, directly above the piles, and stressing the steel cap to the piles by means of rock anchors drilled and grouted into them.

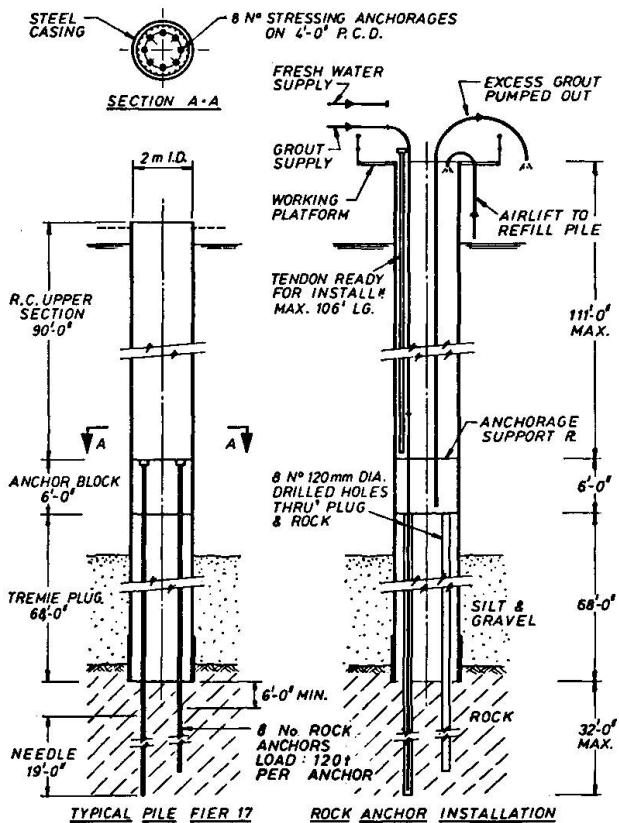
Fig. 7 Pile details

Details of the new vertical piling are shown in Fig. 7. 2 m diameter was selected as being the largest size which could be

reasonably handled. Base fixity to the piles was provided by means of rock anchors. At Pier 19 where all piles are vertical deck deflection under a 45 m/sec. transverse wind is 40 mm being 1 in 1,500 of the deck height above foundation level. The maximum loads per pile at this pier were 10,630 kN and 4,650 kNm.

The principle design features of the piles were; casing designed to be dewatered; reinforced concrete tremie plugs (40 MPa) to give F of S against flotation of 1.1; rock anchors designed for maximum corrosion resistance and each one tested in accordance with FIP recommendations. For safety reasons the test load was 70% UTS and lock off load 54% UTS.

At Pier 17 due to frequent rock joints the anchor holes could not be sealed and the installation method was modified to enable anchors to be grouted in a flooded pile (Fig. 7). Individual holes were kept grout filled while the grout leaking into adjacent holes was flushed out. A reservoir at the top of the plug enabled the grout quality to be monitored by underwater TV camera while visibility was maintained by downward circulation of fresh water.

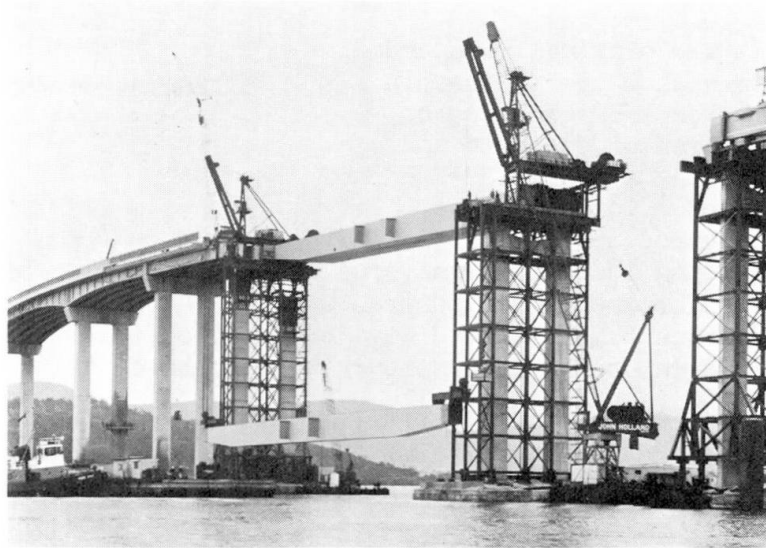
Fig. 11 Box girder erection

The adopted scheme used luffing 'A' frame lifting derricks specifically designed by the Contractor for the purpose (Fig. 11). By using temporary cantilever extensions at the ends of the boxes, they were lifted outboard of the towers as a single unit and positioned on top of the towers. The boxes were towed to site on a barge and then lifted. The operation from mooring of the barge to lifting the girders 40 m, and positioning them on temporary bearings on the falsework towers took about 20 minutes.

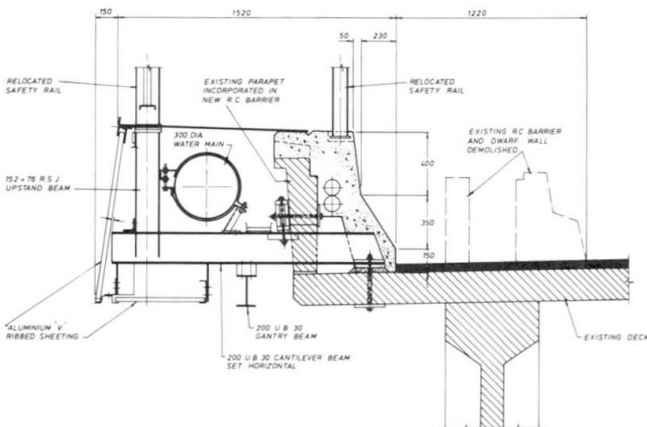
Fig. 12 Bridge widening details

While the bridge was out of service the opportunity was taken to widen it from four to five lanes over its full length. This permitted the operation of a rather more comfortable 3:2 tidal flow system rather than 3:1 as previously. The widening was achieved by cantilevering new footways and using the existing concrete deck for the five lanes (Fig. 12).

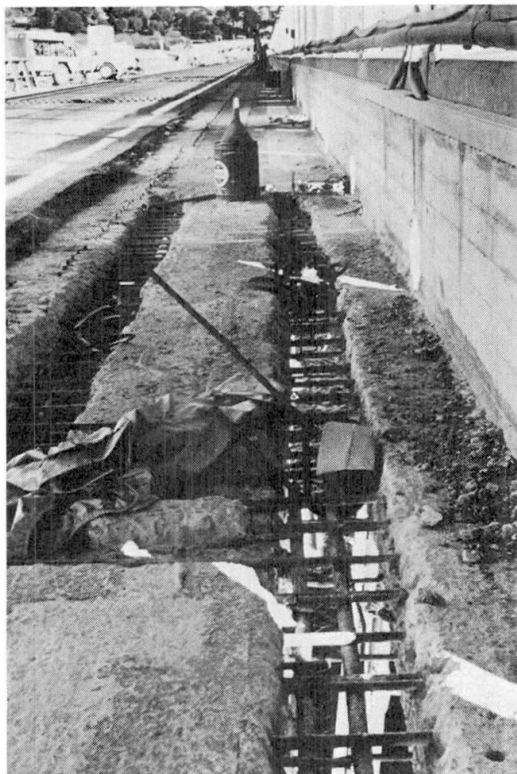
Fig. 14 Slots

It was originally intended to anchor the tendons in the deck by breaking out an area of concrete and casting a traditional anchor block. To reduce the required demolition and avoid cutting the main transverse deck reinforcement, the Contractor, Pearson Bridge (Tas.) Pty. Ltd. proposed cutting a slot 3 m x 200 mm (Fig. 14) into which the bare strands were anchored using an epoxy with fillers. The method worked very well.
