Techniques for Testing, Analyzing and Rehabilitation of Terra-Cotta

Sven E. THOMASEN

Consultant
Wiss, Janney, Elstner Assoc.
Emeryville, CA, USA

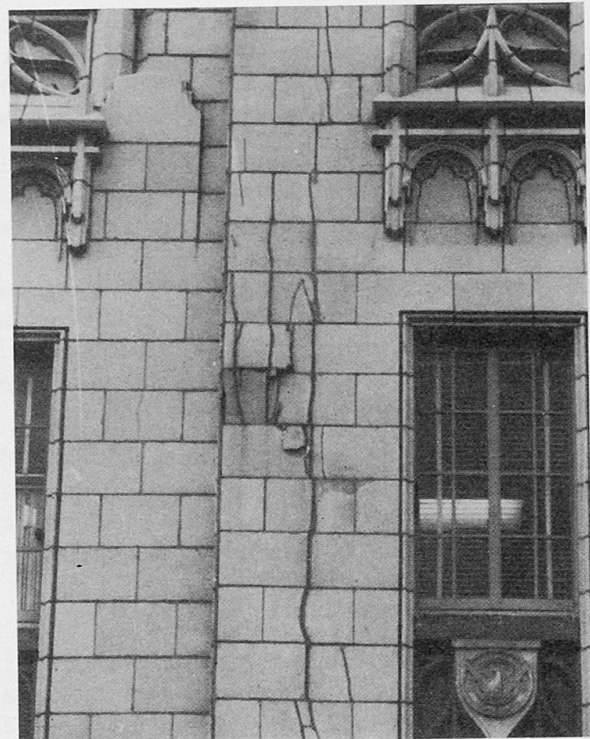
Fig. 2: Expansion failure

Terra-cotta buildings with concrete frames often experience long-term shrinkage of the frames, but most terra-cotta failures result from temperature and moisture expansion of the clay body. Thermal and wet/drying cycles are often associated with permanent lengthening of the terra-cotta blocks, and this, plus the absence of expansion joints in the facade, creates high compressive stresses. Failure can be in the form of buckling of block units, as seen in Figure 2, or crushing at the base of the facade where expansion stresses are combined with compressive gravity loads.

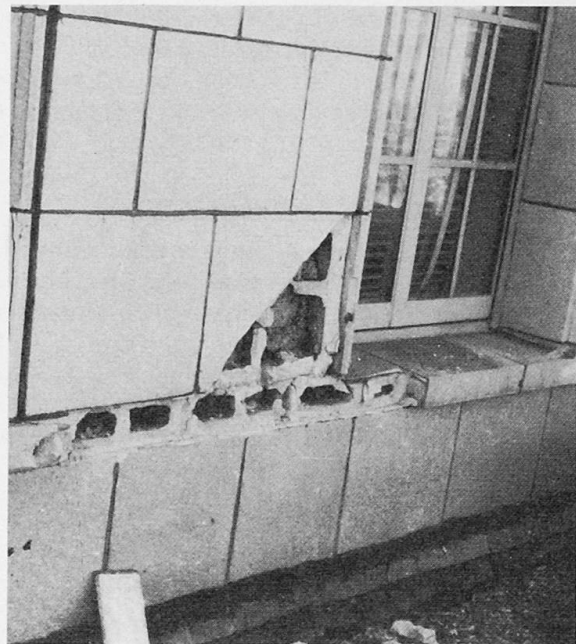
Fig. 4: Inspection opening

Inspection openings, as seen in Figure 4, are the best method to verify the location and the condition of the wall supports, and especially, to detect corrosion of the embedded metal anchors.

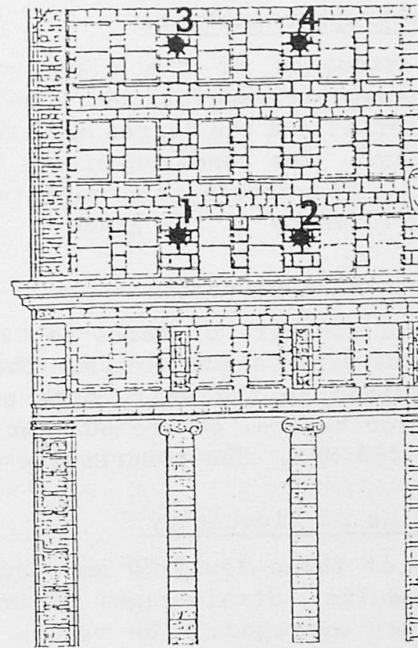
Fig. 5: Strain relief test

STRAIN RELIEF TEST DATA				
GAGE	VERTICAL		HORIZONTAL	
	STRAIN μ cm/cm	STRESS kPa	STRAIN μ cm/cm	STRESS kPa
1	450	9315	50	345
2	283	5858	24	497
3	320	6624	30	621
4	171	3540	7	145

Compressive vertical stresses as high as 23 MPa have been recorded. This is close to the compressive strength of the terra-cotta wall. From multiple strain measurements, a stress map can be made for the exterior elevation. The map is used to evaluate if cutting of expansion joints into the facade will relieve the built-up terra-cotta stresses.

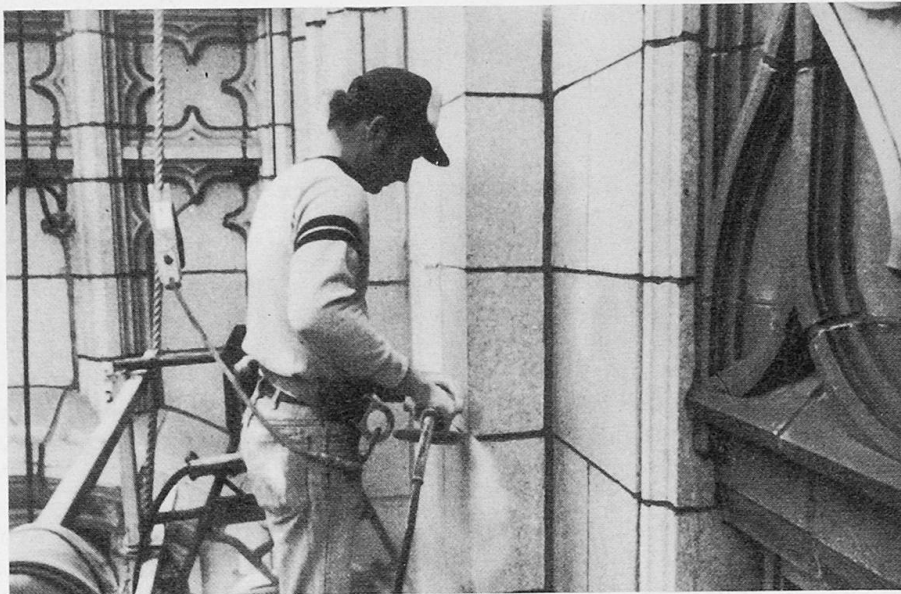
Fig. 7: Cutting of new expansion joints.

Vertical expansion joints are generally cut near corners and wall returns, while horizontal expansion joints are cut below relieving angles, as seen in Figure 7. The joint location is determined from stress measurements of the terra-cotta. The joints are made watertight with elastomeric sealants. Cutting of expansion joints can disturb the fastening of the terra-cotta and will often require the installation of new anchors.
