**Artikel:** Strengthening and/or repairing of existing structures  
**Autor:** Grill, Leon A.  
**DOI:** <https://doi.org/10.5169/seals-35866>

## Strengthening and/or Repairing of Existing Structures

### Leon A. GRILL

Civil Eng.  
Rankine & Hill Assoc.  
Sydney, Australia

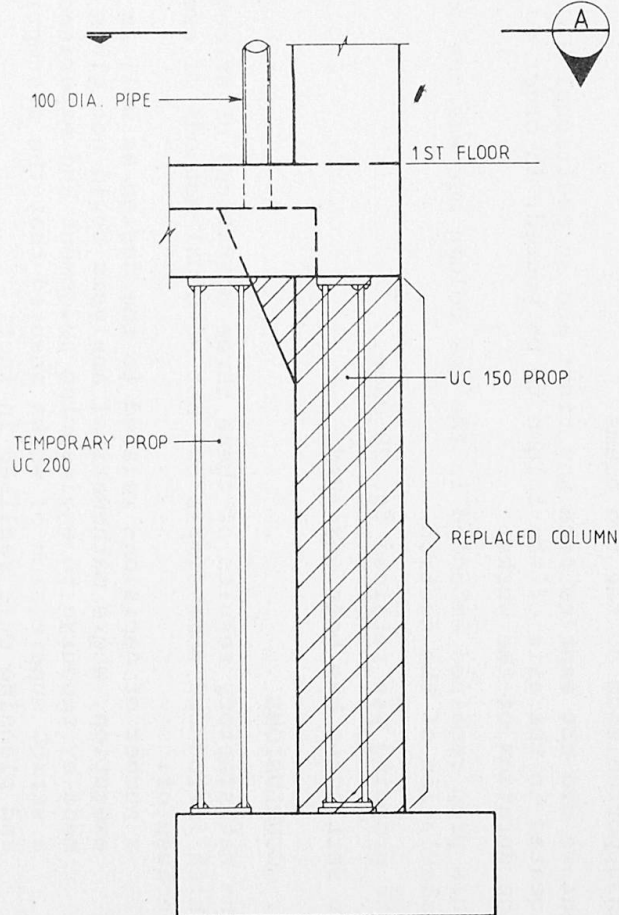
FIG. 5

The corner ground floor column of an eight storey building located in Newcastle close to the sea was suffering severe spalling of the concrete as well as advanced corrosion of the reinforcement.

A closer examination revealed that some of the longitudinal bars had rusted completely.

It was evident that some local repairs and patches made several years before had been unsuccessful and a radical solution was required.

- expose the foundation to support the propping system under the two beams converging onto the column to be replaced. (Fig. 5 and 6).
- erect two temporary props 200 UC 52 with large base plates. Use expanding grout.
- demolish existing column.
- expose and sand blast existing column reinforcement left at the top and the bottom.
- weld new column steel to the existing.
- replace column.

But we did not want to take any risks and an additional U.C. 150 prop was located in the axis of the column to be poured, in order to offer support for the duration of the works.

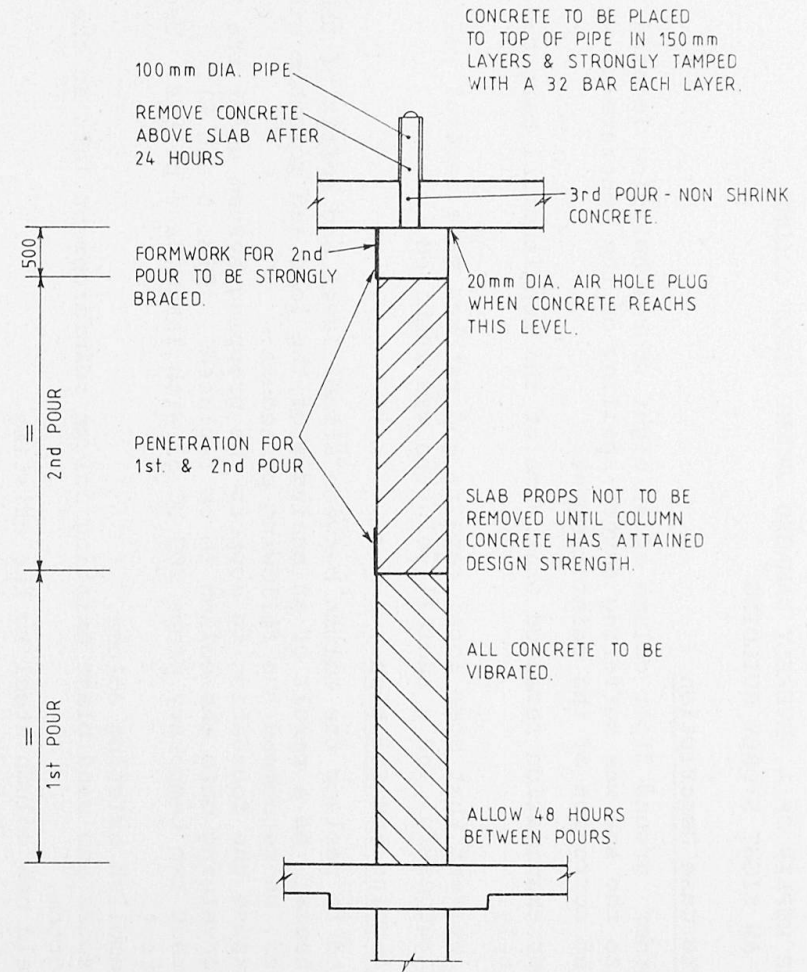
Fig. 4

The technique consisted of pouring the column in three stages. As shown in Fig. 4, most of the column is poured in two stages through lateral openings in the column formwork.

The third and shortest part, at the top of the column, was poured through a 100mm diameter pipe projecting some 900mm above the slab and fixed into a hole through it (Fig. 4). For this third and last pour non-shrink concrete was used and poured to the top of the pipe forming a column of hydrostatic pressure which produced an upward pressure of concrete against the soffit of the slab. It is recommended that the wet concrete in the pipe should be tamped with a heavy rod during the pouring in order to increase the upward pressure.

At the very top of the column's formwork several 20mm holes were left in order to avoid the formation of air pockets between column and slab. Once the cement slurry started to emerge through these holes, they were caulked and the pouring of the pipe finished as described before.
