Repair and Strengthening of Reinforced Concrete Buildings

In 1978, a severe earthquake shook the Peninsula Izu located 120 km southwest of Tokyo, Japan. Several R/C school buildings were damaged. This paper presents the damage, the method of repair and strengthening, and the seismic capacity of the pre- and post-strengthened buildings.

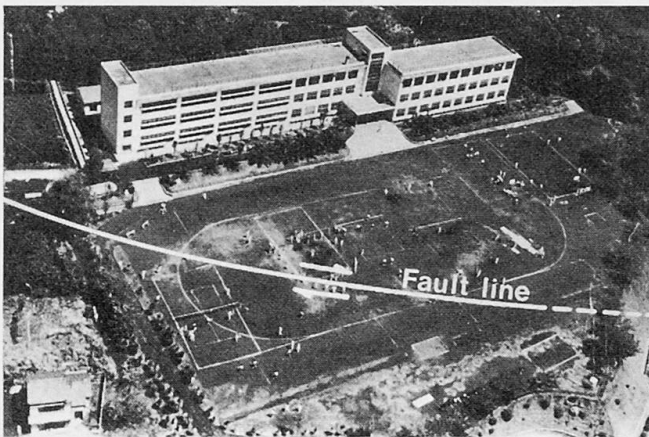
Fig. 3 Bird's eye view of Inatori Junior High School

A short description about earthquake damage is shown in Table 1. Among them, the damage of Inatori junior high school building was most severe, while the frames could maintain structural performance after the earthquake. As shown in Fig.3, a major fault line was found across the ground. A number of cracks were found in columns, beams, walls and slabs. The damage was most significant in the slabs at the center core. The crack pattern showed that the east wing and the west wing moved in the opposite direction (Fig.4).

In the case of Inatori junior high school buildings, the center core was demolished immediately and reconstructed. The expansion joints were newly provided between the center core and both wings. The cracks in the west and east wing were repaired by epoxy injection. Cracks in other buildings were also repaired by epoxy injection.

Considering these analyses and the grade of damage, the following permanent therapy was adopted for two junior high school buildings : 1) Inatori Junior High School - The east wing was also demolished and replaced to new building in 1983. The west wing was strengthened by adding reinforced concrete shear walls in the existing frames(Fig.4,5). By this therapy, the I_s -index of the west wing is estimated more than 1.0. 2) Atagawa Junior High School - This building was also strengthened in 1983 as shown in Fig.6,7,8. Reinforced concrete walls were added in the existing frames. Reinforced concrete cores were newly constructed at the both ends of the building and jointed to the existing part. The penthouse was taken off to reduce the building weight.

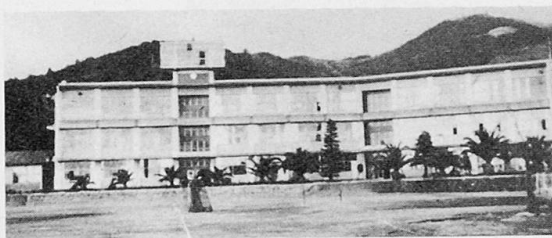
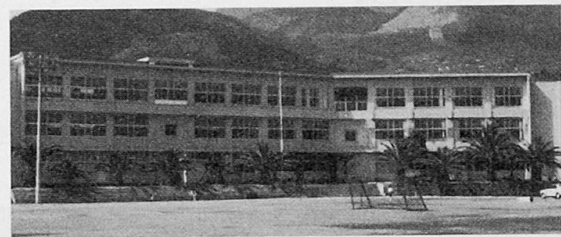
Fig. 6 Overall views of Atagawa Junior High School

Atagawa junior high school building was one of the damaged buildings. A number of cracks were seen in columns, beams and walls. Both ends of the building were sunk several centimeters. By the excavation of ground, it was found that the footing beams at the west end were failed in shear. Seismic performance of other school buildings were quite well, while hair cracks in the structures, and damage to the non-structural elements were found.

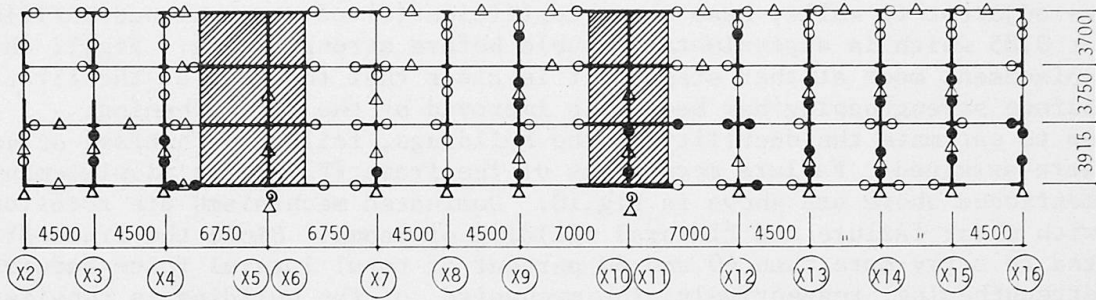
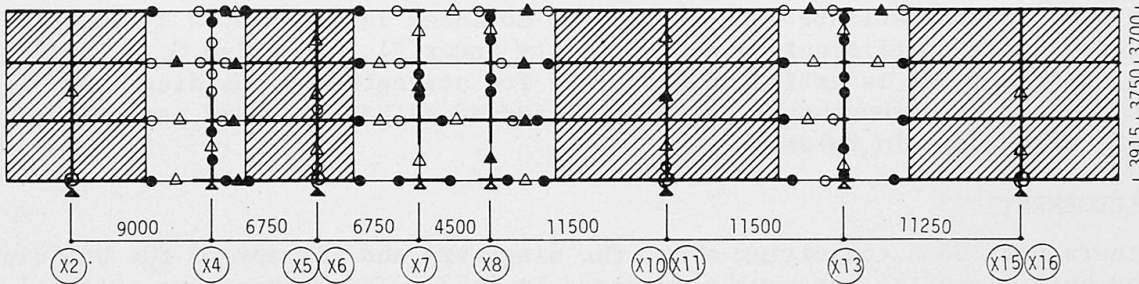
Fig. 10 Failure mechanism of Atagawa Junior High School ($\delta_1=2\text{ cm}$, $R_1=1/200$)

In order to estimate the ductility of the buildings, failure mechanisms of structures were examined. Failure mechanisms of the frame #Y3 at the displacement stage mentioned above are shown in Fig.10. Dominated mechanisms are rotation of walls with shear failure and flexural yielding of beams. Since the frame #Y3 is estimated to carry more than 40 and 60 percent of total lateral force before and after strengthening, respectively, the mechanism of the building is considered as same as the frame #Y3.

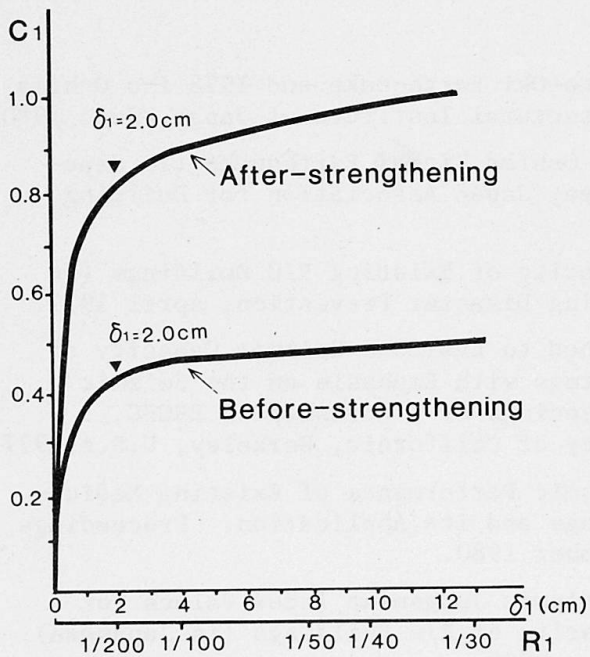
Fig. 11 Base shear coefficient - story drift relationship of Atagawa Junior High School (1st story)

Base shear coefficient-story drift relationship at the first story is shown in Fig.11. At the stage of the displacement of 2cm, where shear failure occurs

in beams adjacent to walls, base shear coefficient(C) of strengthened building is about 0.85 which is approximately double before strengthening. Fig.12 shows the displacement mode at that stage. It is clear that the sway at the first story before strengthening has been also improved by the strengthening.
