# Repair of damaged floor slabs

Zeitschrift: **IABSE reports = Rapports AIPC = IVBH Berichte**

## Repair of Damaged Floor Slabs

### Yoichi HIGASHI

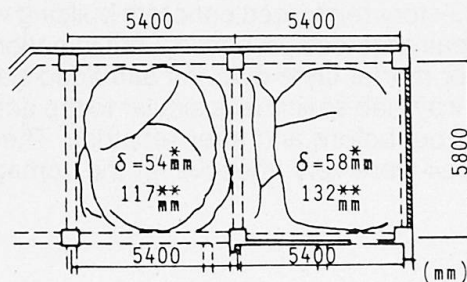
Fig.1 Square slabs with wide span<sup>6)</sup>

- 1) construction year : 1961
  - 2) girder section : 350 x 700 mm
  - 3) design depth : 130 mm
  - 4) natural frequency :  
(12.5-13.0 Hz, before repair)  
(18.2-20.5 Hz, after repair)
- \* : measured deflection at the center  
\*\* : measured depth

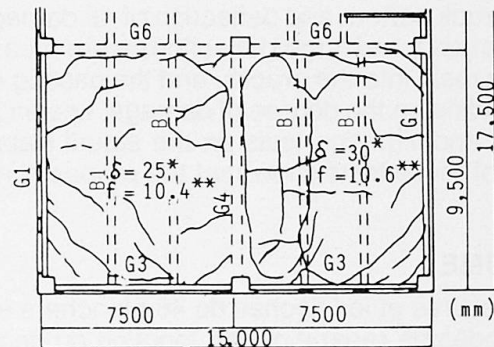
Fig.2 Slabs with beams in a office<sup>6)</sup>  
Building

- 1) construction year : 1972
  - 2) girder section (G1, G4); 350 x 750 mm  
(G3, G6); 400 x 750 mm
  - 3) beam section B1 : 300 x 650 mm
  - 4) design depth : 120 mm
- \* : measured deflection at the center  
\*\* : measured frequency

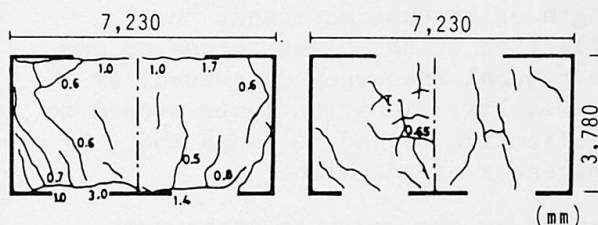
Fig.4 Crack Patterns of the most damaged slab

Figure 4 shows crack patterns of the most damaged slab. Cracks by constrain and shrinkage and by bending moment were mixed in the slab, but almost of wide cracks seemed to be by bending moment, judging from their occurred place. There were many cracks whose width was more than 1.0 mm, and the width of a few cracks along the edges of short span reached 3.0 mm.

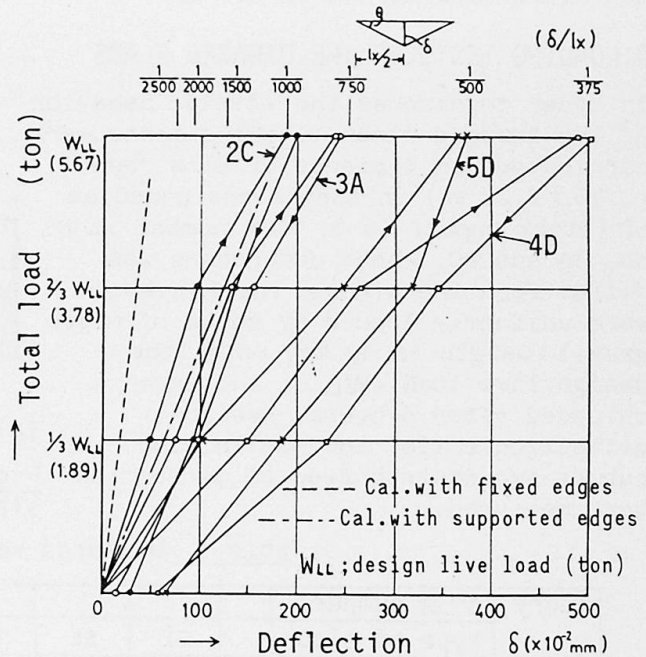
Fig.5 Loading tests results

Figure 5 shows the load-deflection curves of the slabs. The values of calculated stiffness with fixed edges and with supported edges were shown by the dotted lines, in this figure. The stiffness of the slab in 2C, which were damaged little, was intermediate between the both calculated values. But the stiffness and residual deflection ratio showed tendency to be larger, corresponding to their damageness. However, these slabs were confirmed to have enough load capacity, because the slabs were kept in elastic under design live load, as shown in Fig.5.

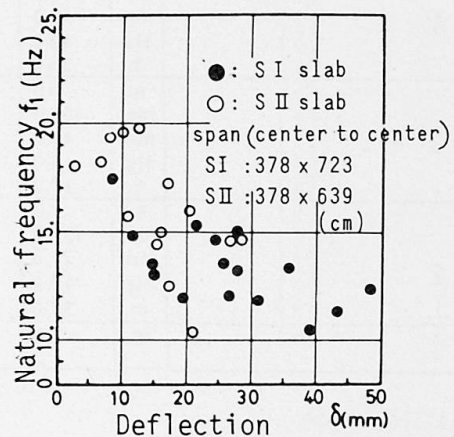
Fig.6 Vibration tests results

The free vebration waves of the slabs were measured by the pick-up for vertical motions, when the steel ball fell on the slabs from a height of 28 cm. Reading the natural frequency and maximum amplitude of the slabs from those waves, the stiffness decreasing of the slab was discussed.<sup>5)</sup> The tests results were shown in Table 1 and Fig.6. It was found that the natural frequency decreased as the deflection of the damaged slabs increased. It showed a similar tendency to the results of other's studies.<sup>2), 6)</sup> Judging from Table 1, as the total length of cracks increased, the deflection of the slabs increased and the natural frequency decreased. As the results, vibration tests seemed to be effective method to judge the damageness of the slab.

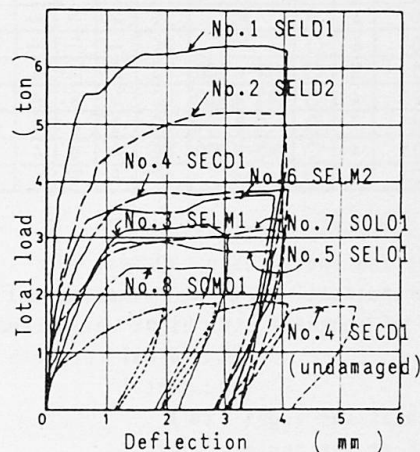
Fig.9 Load-deflection curves of the short-term loading tests

after repaired as shown in Fig.8. The load-deflection curves of the specimens were shown in Fig.9, and the natural frequency by vibration tests and the stiffness and deflection were shown in Table 2. The stiffness of the slabs repaired by injecting epoxy resin into cracks increased by 0.78-0.96 as that of the damaged slab.

Moreover, the stiffness, natural frequency and load capacity of the slabs repaired by casting concrete increased, as the depth of concrete increased. Especially, the stiffness, natural frequency and load capacity of the slabs repaired by casting concrete after injecting epoxy resin were by far more than those of the undamaged slabs. These repair methods seemed to be very effective for the damaged slabs.

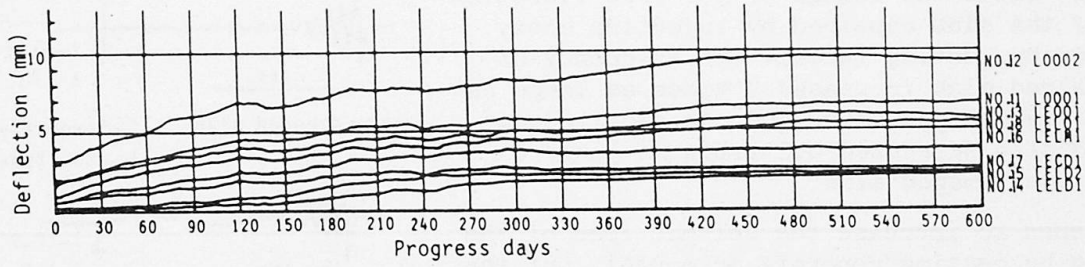
Fig.11 Long-term deflection increasing

The long-term deflection increase of each specimen was shown in Fig.11. The deflection increase of all slabs were almost constant after 450 days. The deflection of No.13 slab repaired by injecting epoxy resin into cracks was 60 % of No.12 slab damaged and was almost equal to that of No.11 slab undamaged. As the depth of casting concrete increased, the degree of the deflection increase became smaller than that of the undamaged slab.

The repair method by casting concrete after injecting epoxy resin into cracks did not only increase the stiffness and load capacity of the damaged slabs under short-term loading, but also was very effective for decreasing the deflection under long-term loading.

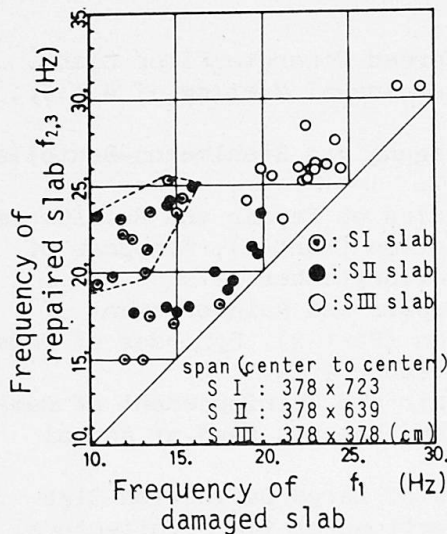
Fig.12 Increase of the Natural frequency of the slabs

Figure 12 shows the change of the natural frequency of the slabs repaired by injecting epoxy resin into cracks. The natural frequency of repaired slabs increased about 20-30% than that of the damaged slabs. The measured results of the slabs repaired by casting mortal or concrete were shown in the dotted lines of Fig.12, and the natural frequency of such repaired slabs increased remarkably.

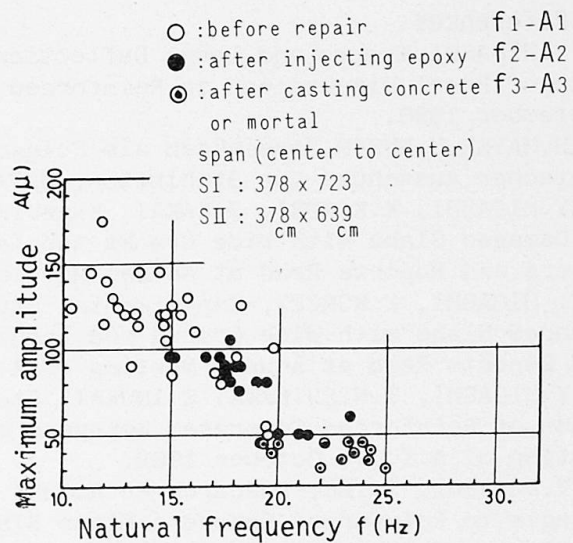
Fig.13 Relations between natural frequency and maximum amplitude

Figure 13 shows the relations between the natural frequency and maximum amplitude of the repaired slabs. The frequency increased and the amplitude decreased by injecting epoxy resin and still more by casting mortal or concrete.

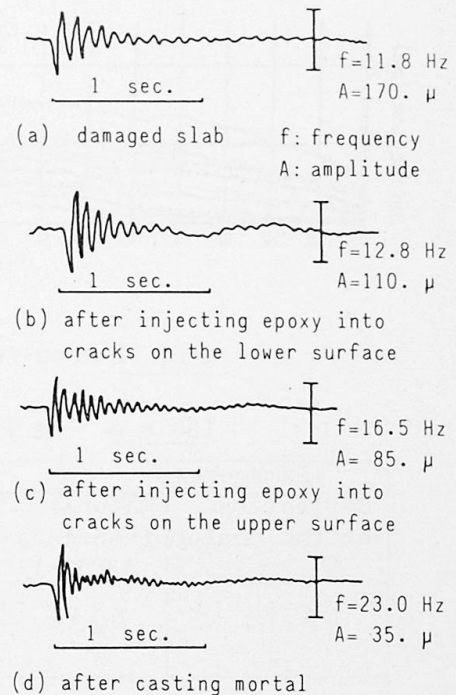
Fig.14 Waves changing of the repaired slab

Figure 14 shows the change of the free vibration waves of the slab repaired by injecting epoxy resin and by casting mortar. The frequency of the repaired slab increased 2 times as large as that of the damaged slab, and the amplitude of repaired slab decreased 0.2 times as large as that of the damaged slab.
