## Strengthening of a Prestressed Concrete Shell Structure

### Hassan HOSNY

In this paper, strengthening of a prestressed concrete shell in a chemical factory, in Cairo, is presented. The valley beams were strengthened by external prestressing cables anchored outside the building in precast end blocks. The shells were strengthened by casting 4 cm thick resin concrete on top of the existing shell.

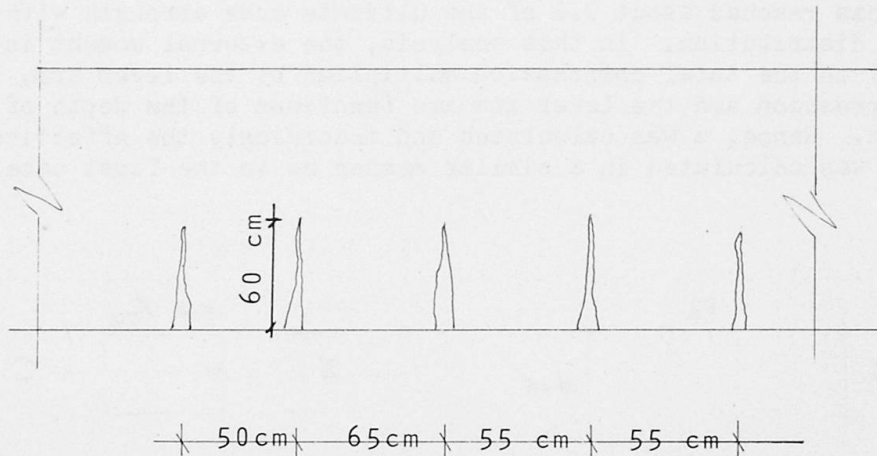
Fig. 2 Cracks At Mid Span Of Beams

- In the webs of the prestressed beams - especially for those of the intermediate beams- several cracks spaced about 50cm between each other were noticed at mid-span. These cracks were extending vertically about 60cm from the bottom surface of the beams with crack widths varying from 0.5 to 3mm on both sides and on the bottom surface of the beams as shown in fig.2.
- In some localized areas of the shells, longitudinal and transversal cracks on the inside face and sometimes on the outside face were noticed. In these areas one can assume that the concrete is linked together along the cracks - which act as hinges- only by the reinforcing bars.

The main reasons for the damages were the miss use and bad maintenance. A steel water tank of two cubic meters capacity was located on top of one of the shells. Plenty of pipe networks were also located on top of the shells. These pipes were not well connected and leakage of water and chemicals was noticed. The gutters over the valley beams, between adjacent shells, were found to be almost filled with mud which prevented proper drainage of water to take place. This mud and water added an extra load on the beams which was not taken in to account in the original design.

Due to the above mentioned reasons, the beams were cracked and the prestressing cables started to corrode. Accordingly, the effective prestressing forces were reduced considerably, followed by rupture of prestressing cables and sudden collapse.

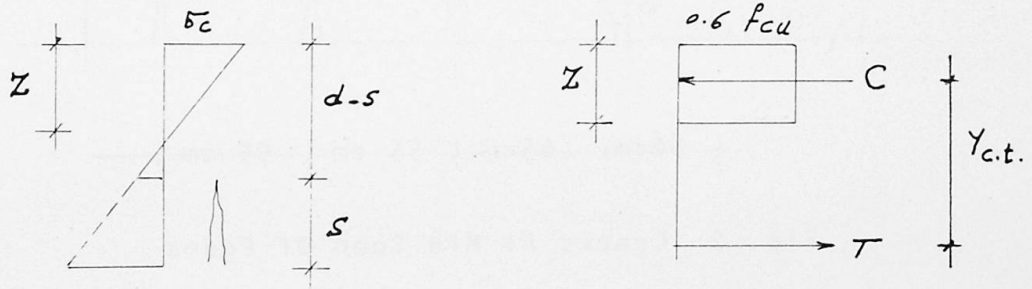
Fig. 3 Assumptions Of Stress Distribution

- In the first case, fig. 3a, the stress distribution was assumed to be linear. In this case it was assumed that the tensile stress at the level of the top end of the crack is equal to the tensile strength of the concrete which can be evaluated. The actual external moment applied on the section was calculated, i.e. it was known. Thus from first principals, the total compression was calculated which is equal to the total tension. The effective prestressing force was accordingly estimated.
- In the second case, fig. 3b, it was assumed that the compressive stress in

the concrete has reached about 0.6 of the ultimate cube strength with a non-linear stress distribution. In this analysis, the external moment is known which is equal to the total compression multiplied by the lever arm,  $Y_{c.t.}$ . Both the total compression and the lever arm are functions of the depth of the neutral axis,  $z$ . Hence,  $z$  was calculated and accordingly the effective prestressing force was calculated in a similar manner as in the first case.

It should be noted that the problem under consideration is not that straightforward and some engineering judgment had to be made. From the crack pattern in the valley beams together with the above mentioned calculations, it was estimated that a maximum loss of about 40% in the original prestressing force has taken place.

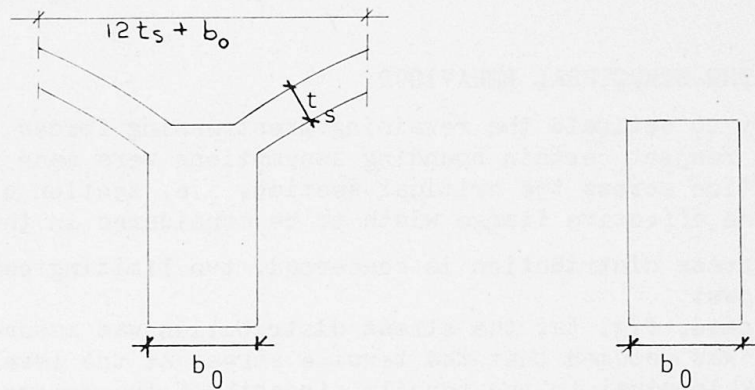
Fig. 4 Assumption Of Effective Flange Width Acting

- The beam was considered to be as a rectangular section without any flanges acting as shown in fig.4a. This case gave the highest value of loss of prestressing.
- The beam was considered to have an effective flange width equal to the web breadth plus twelve times the shell thickness as shown in fig. 4b.
