Artikel: Repair works on the main pavilion at Tohdaiji temple
Autor: Kaneta, Kiyoshi
DOI: <https://doi.org/10.5169/seals-35879>

Repair Works on the Main Pavilion at Tohdaiji Temple

Kiyoshi KANETA

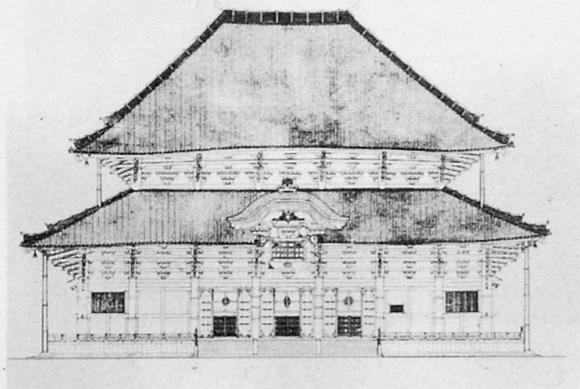
About 80 years ago, it was observed that the roof of the pavilion hang, its eaves had become wavy, and the large beams inside sagged down more than 30 cm. The reinforcing posts set up in the four corners of the pavilion to support the upper and lower roofs, barely prevented the building from collapse, and structurally the entire pavilion was in a very dangerous state. (Fig.1)

Fig.1 Front elevation in 1905

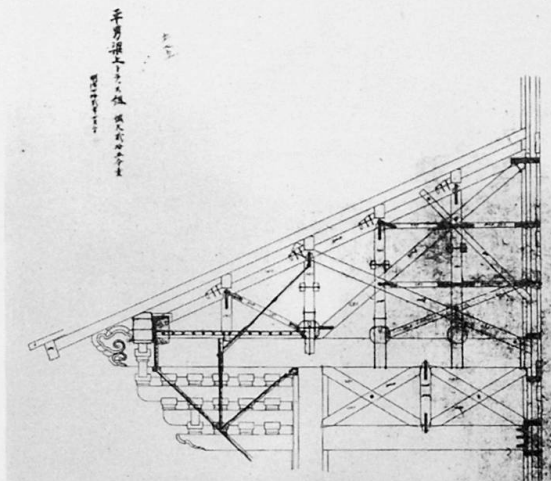
Fig.2 Reinforcement with steel

However, if we closely examine the outward appearance of the pavilion, particularly, the conditions of the square framings of the upper and lower roofs, we note that the flat steel bars which support the square framings from two sides on the outside are themselves bent and are protruding at many places. These steel bars were apparently provided to prevent square bearing blocks and bracket arms from being pushed outward at different places as the square framings and brackets are deformed under the weight of the roofs with long protruding eaves. However, so far as the results of these reinforcements are concerned, they did not necessarily achieve their purpose, and today these ugly-looking flat bars are still there without any structural contribution.

1. Tiles on the ridges of the roofs were fixed with mortar using Portland cement which was imported into Japan for the first time in the 1900s.
2. Flat steel bars were used for the protection and preservation of the square framings of eaves and brackets. (Fig.2)
3. Rafters and extended beams, which are structural members to support the upper and lower roofs, were reinforced by using steel shapes and thick steel plates.
4. Steel frames made of rolled I-beams and channels, together with plates and angles, were embedded in the central parts of the cross-sections of wooden columns to enable them to withstand the bending moments on the columns. (Fig.3)
5. Hot-formed rivets were used to fasten the steel materials.
6. Double Warren steel trusses were provided under the existing huge timber beams in order to strengthen the frame for the large roofs and to enable them to

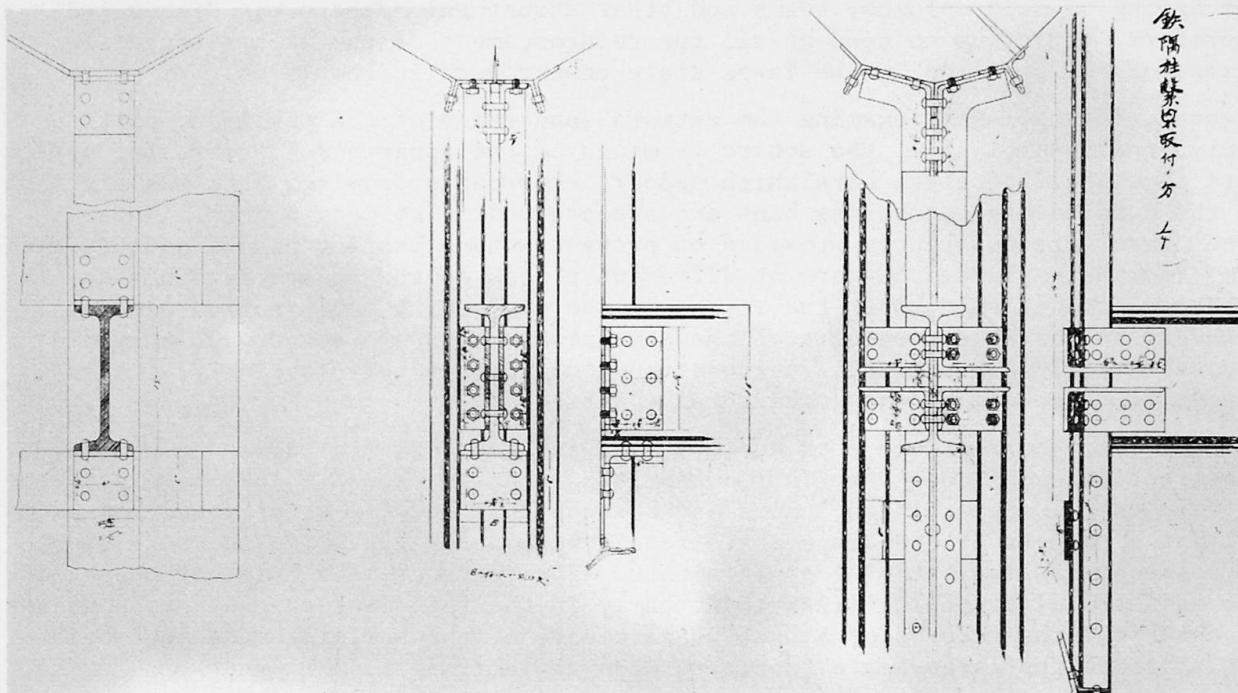
Fig.3 Details of the reinforcement of the wooden columns

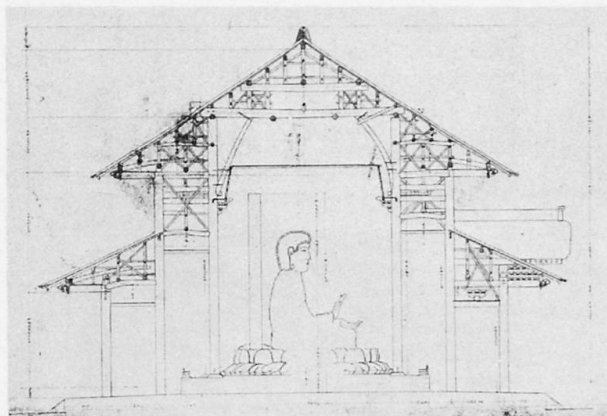
Fig.4 Deformed structural members

bear the loads of the roofs, and further, the ceiling of the main pavilion was hung from these trusses. (Figs.4 and 5)

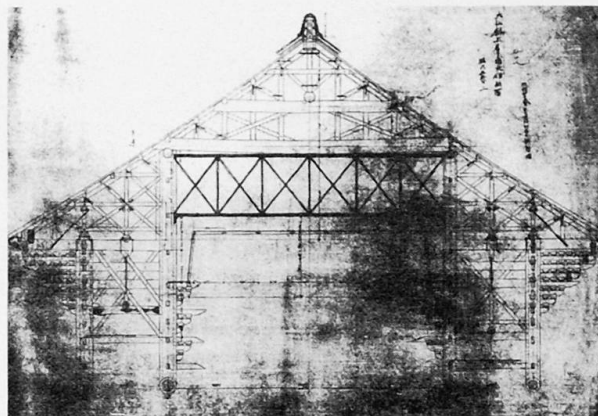
Fig.5 Double Warren truss inserted

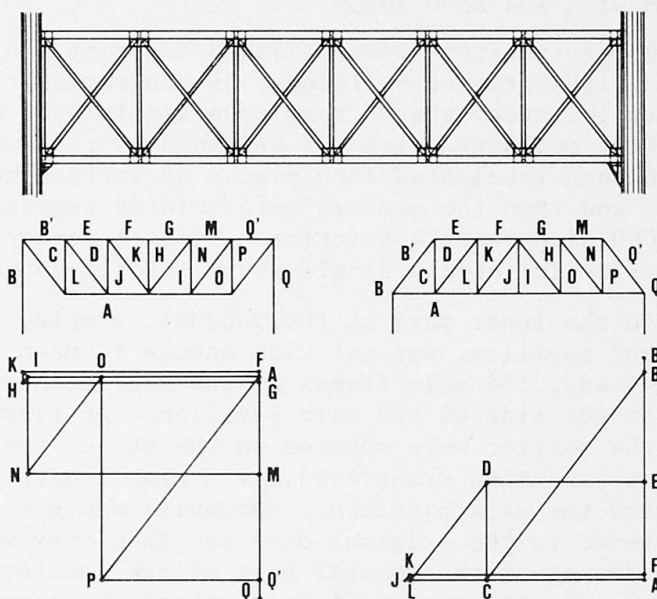
It may be interesting for structural engineers to see how the working stress on the members of the statically indeterminate trusses under the given vertical loads was obtained in that period of 75 years ago. As shown in Fig.6, there are the results obtained from graphical solutions of a Maxwell diagram for two trusses illustrated in the middle of the figure. It should be noticed that these two are the statically determinate trusses, and that each of them was looking like an elementary system of the double Warren trusses to be solved.

The result of the graphical solutions shows us that the Japanese engineer must have applied design vertical loads on both the elementary systems. After comparing the axial forces calculated for the members of the two statically determinate trusses with each other, he has adopted the larger value in either one of them as the stress for choosing cross-sections of the truss members.

Fig.6 The truss and the results of solution

Thus, we can say now that the engineer has tried his own approach of obtaining the approximate values of the working stress on his statically indeterminate structure, without consulting the theories of structures being developed in the European countries at that time. Nevertheless, the author has proved a number of years ago that his results were not inadequate but his values were different from the exact values by only 10.7 % toward the safe side.

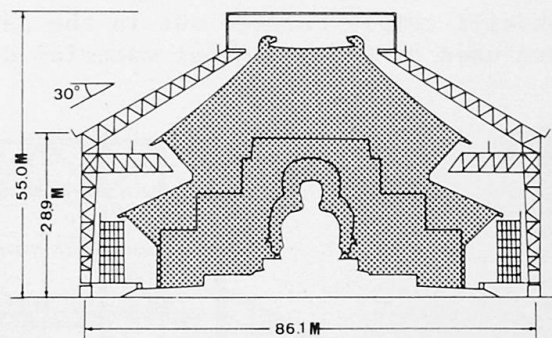
Fig.7 The steel shelter used in 1974-78

Temporary shelters were utilized for many projects of repairing the large-scale traditional timber buildings, as stated later. This time, high-tensile, anti-corrosive steel shapes have been widely used as the principal material of the shelter building which was designed by the author. The wide flange steel shapes have been fabricated into pieces of lattice members of the frames by shop welding, and then the members were jointed together at site by using a total of about 33,000 high-tensile friction bolts. A number of track cranes were employed for the erection of the single-story, single-spanned steel frames. (Fig.7)

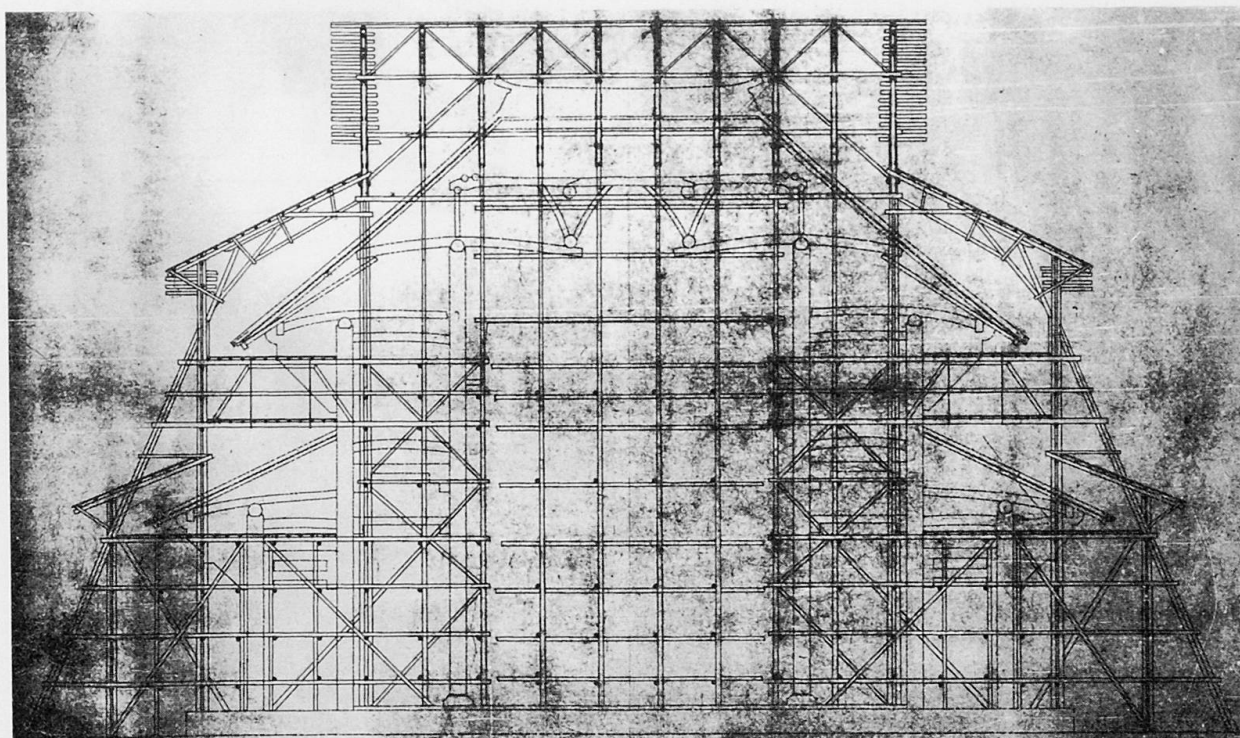
shelter built up for the large-scale repair work on the main pavilion of the Tohdaiji temple carried out in the period of 1905-15, showing us that the logs were used as the principal material and that how the shelter was assembled.

Fig.8 Section of the temporary shelter used for the project in 1905-15
