Zeitschrift: **IABSE reports = Rapports AIPC = IVBH Berichte**

Additional Insulation of Flat Roofs with Thin-Walled Metal Structures

Ingemar HÖGLUND

Patrick ANDERSSON

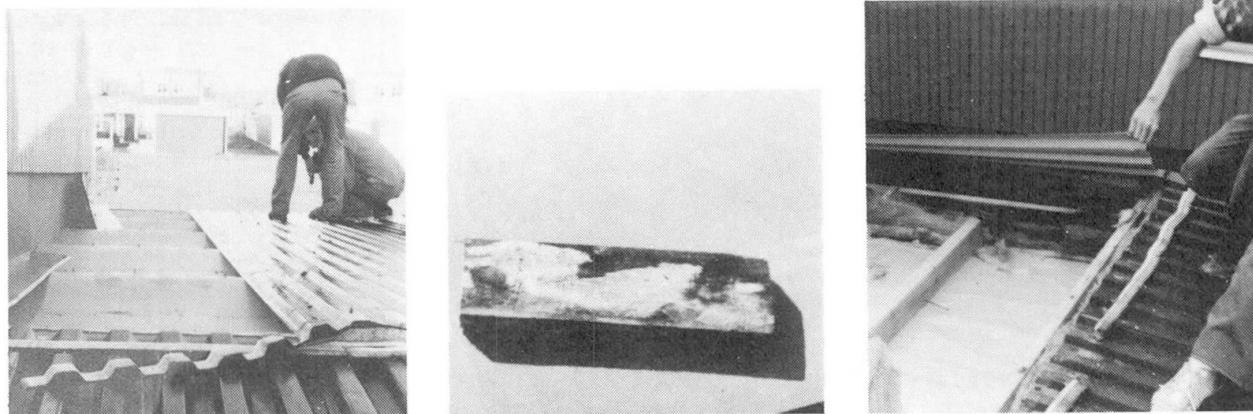
Fig. 1 Moisture damaged flat roof with metal sheeting. Moisture penetration from both the inside and the outside. The fibre board hung down, thus blocking the vented air space. The moisture content in the construction increased and caused mould and rot damage. (Example 1.)

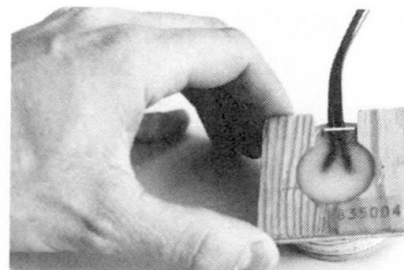
Fig. 2 Moisture-measuring gauge used in the field investigations. The gauge is built into the roof decking. The electrodes, insulated except at the tips, measure the electrical resistance of the plywood. The thermocouple helps to correct resistance measurements for temperature. By using a relation curve of electrical resistance and moisture content in the measuring gauge, it is possible to determine the moisture ratio in the measuring gauge and thereby the moisture ratio in the roof.

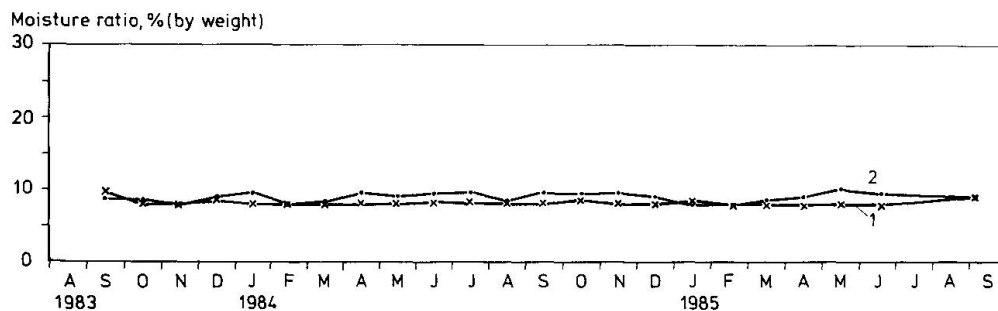
Fig. 8 Example of results. Moisture and temperature are measured both in the air space, line 1 and immediately below the new weatherproof layer, line 2. Since additionally insulating the roof the moisture ratio in the roof has remained for the whole period at a low level, c. 8% in the air space and c. 10% under the new weatherproofing. However, the moisture ratio at one of the measurement points immediately below the new weatherproofing was c. 20%, which indicates that moisture has been enclosed. Moisture is measured by means of built-in moisture-measure gauges; figures refer to the moisture ratio in these rounds.

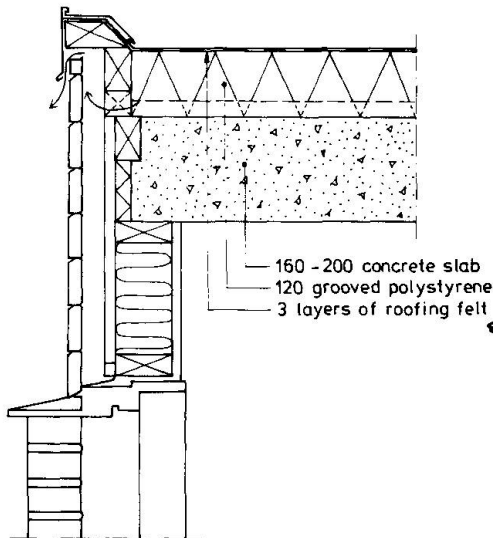
Fig. 9 Attachment to eaves of original roof.

After a time moisture patches appeared on the ceilings and inner walls. The damage was caused by moisture penetrating from outside. Owing to initial shrinking and temperature movement in the polystyrene slabs gaps appeared between these slabs. The roofing felt then split above the gaps and water was able to penetrate the roof.

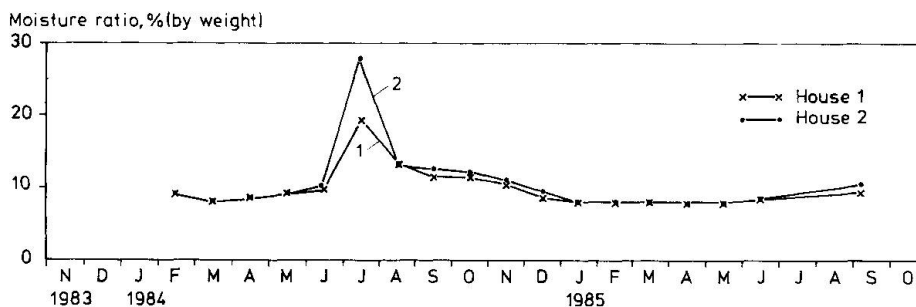
Fig. 11 Example of results. Moisture is measured by means of built-in wooden rounds placed between the concrete slab and the cellular plastic insulation. The large increase in the moisture ratio in June-July was caused by the leaks in connection with raising the steel construction. Apart from this incident the moisture ratio has remained during the whole period at an even and low level (8-10%). The moisture ratio values refer to the moisture ratio in the moisture-measuring gauges.

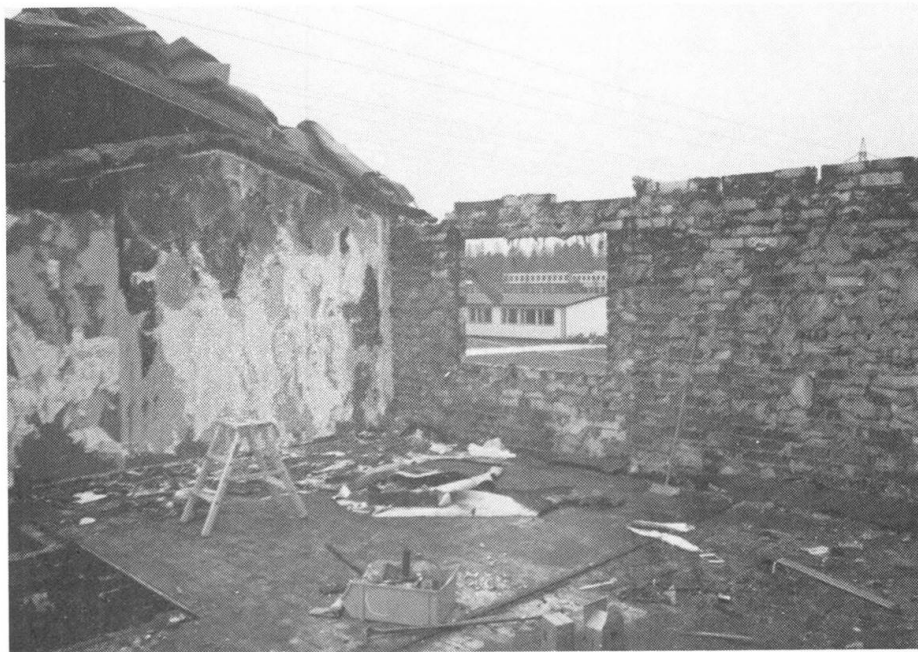
The new method using external additional insulation of flat roofs with the roof ventilation closed off, has also appeared to be efficient in preventing the spread of fire. This was revealed in the autumn of 1984 when there was a fire in one of the investigated housing areas (terraced houses). After the fire, the adjacent houses remained totally intact partially because of the use of this method.
