Autor(en): **Vaes, Felix / Hens, Hugo**

Zeitschrift: **IABSE reports = Rapports AIPC = IVBH Berichte**

Band (Jahr): **49 (1986)**

Condensation in Roofs with Thin-Walled Metal Sheets

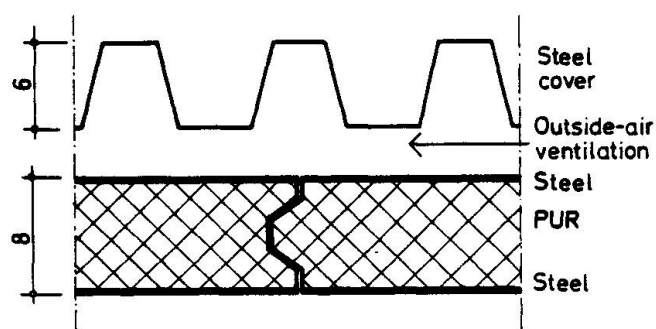
Fig. 1.

The building consisted of two large storage rooms, both with walls and ceilings of sandwich-panels 'steel-PU-steel', the joints between the panels were sealed with a PVC-packing. The roofs were covered with metal sheets, the loft space between ceiling and sheets being ventilated with outside air: figure 1. Both cheese storage rooms were conditioned, one at 6°C and 90% R.H., the other at 12°C and 90% R.H.

In the loft spaces above both rooms (fig. 1) there was severe surface condensation against the metal sheets. The water, dripping on the ceiling, penetrated the joints between the sandwich-panels and damaged the stored cheese.

By long wave radiative losses to the open sky, the night-time surface temperature of a roof may drop 6 to 10°C below air temperature. Having a very low thermal resistance and inertia, the underside temperature of the sheets equals the upside value. So, each time the outside surface temperature falls under the outside dewpoint, condensation goes on, not only at the sheets outside surface but also

In the case of the cheese storage building, convection of vapour to the loft space was very likely: there was an overpressure in both rooms, and the ceiling wasn't airtight. Otherwise water penetration through the joints wasn't possible! With that reality in mind, condensation against the inside sheet surface was a fact, each time the temperature of the sheets dropped below 10°C, the dewpoint of the air in the 12°C-room. A sheet temperature lower than 10°C is, considering the Belgian climate, possible each season. Because of lack of capillarity of the metal sheets, dripping begins shortly after the condensation starts.

- to raise the inside surface temperature of the covering;
- to reduce the vapour transfer by convection;
- to improve the capillary suction of the coverings inside surface.

- spraying, at the inside of each room, an elastic air- and vapourtight layer against the sandwich-panels;

- putting a new roof on top of the loft space, composed of an inside capillar cement bound fibre board, a vapour barrier, thermal insulation and an outside metal sheeting.

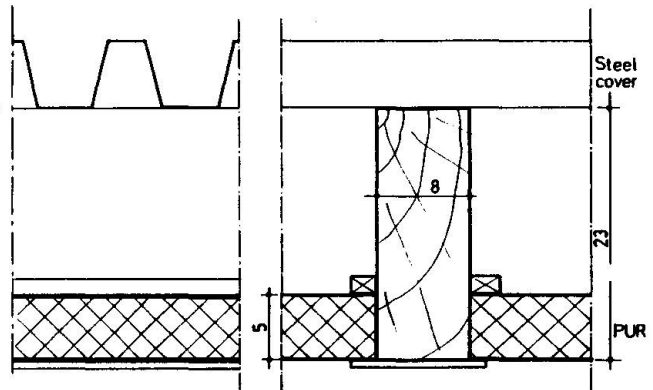
Fig. 2.

An immense hall (~ 300.000 m³) for sugar storage, was built with load bearing wooden arches, the outside walls and roof composed of an inside PU-board, vented air space and an outside thin metallic sheet cladding (fig. 2). The PU-boards were mounted very carefully, as to realise an air- and vapourtight inside leaf and ceiling. The vapour load of the inside air was rather low:

Water drips out of the roof at several places, causing damage to the sugar.

To avoid dust penetration from the outside, the storage building must always be in overpressure. Therefore 25.000 m³ of fresh air is blown through the sugar into the hall, after climatisation. The only way-out is the ceiling that isn't airtight, in spite of the good workmanship. That was clearly observed by endoscopic control, white dust (sugar) floating in the vented air space between PU-boards and sheeting. The reality of condensation was observed during a cold winter period, when ice was formed against the sheeting in the air space. During the following thawning period, the ice melts, giving dripping water. Calculations, using the measured climatic data, showed that the amount of condensate raises from some 0,1 gr/m²h without airflow (diffusion only) to 20 gr/m²h with the measured airflow. Because of long wave radiation and, coupled, the sheetings temperature drop, the problem may appear each season.

A very important financial claim for each day the terminal would be out of use made it impossible to empty the building. Therefore, after sealing all joints between the existing sheets, a new roof was built over the old one, using a PU-thermal insulation and a new metal sheet covering. The extra thermal insulation was taken thick enough to be sure the temperature of the old sheet would always be higher than the dewpoint of the inside air. Because of the increase of the airtightness of the building after the retrofit, it was also necessary to change the air-conditioning.

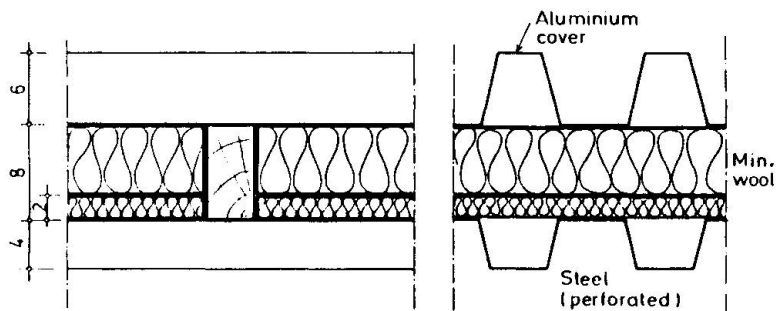
Fig. 3.

The roof of the entrance hall and restaurant of a high school were constructed as indicated in fig.3:

- perforated steel sheet;
- acoustical insulation: mineral wool (2,5 cm);
- thermal insulation: mineral wool (8 cm);
- aluminium sheet.

In wintertime, several times, water dripped out of the roof.

In Belgium interstitial condensation usually is calculated with monthly mean climatological data. This is justified, because of the hygric inertia of most constructions being high enough to blot out peaks in moisture production. However, here, because of the non-existing thermal and hygric inertia of this roof, the momentaneous temperature and vapour pressure situation becomes important. For that reason, the vapour production of 200 students in a hall of 3.000 m³ is large enough to cause, after some hours, transient interstitial condensation against the alu-sheets. When the temperature of these stays lower than 0°C for several days (frost or long wave radiation), in view of the lack of absorption of the sheets severe leakage problems may occur during thawy weather.

A vapour barrier was built in between the two insulating layers. This experience once again proved that the thermal and acoustical function of a ceiling, should be separated.
