Vibration Fatigue of Steel Bridges of the Bullet Train System

Kenji SAKAMOTO

Chitoshi MIKI

Fatigue cracks caused by out-of-plane vibration were observed in steel bridges of the Tokaido Shinkansen. Crack growth behaviour, measured cyclic stresses, evaluation of fatigue damage, and retrofitting methods are described.

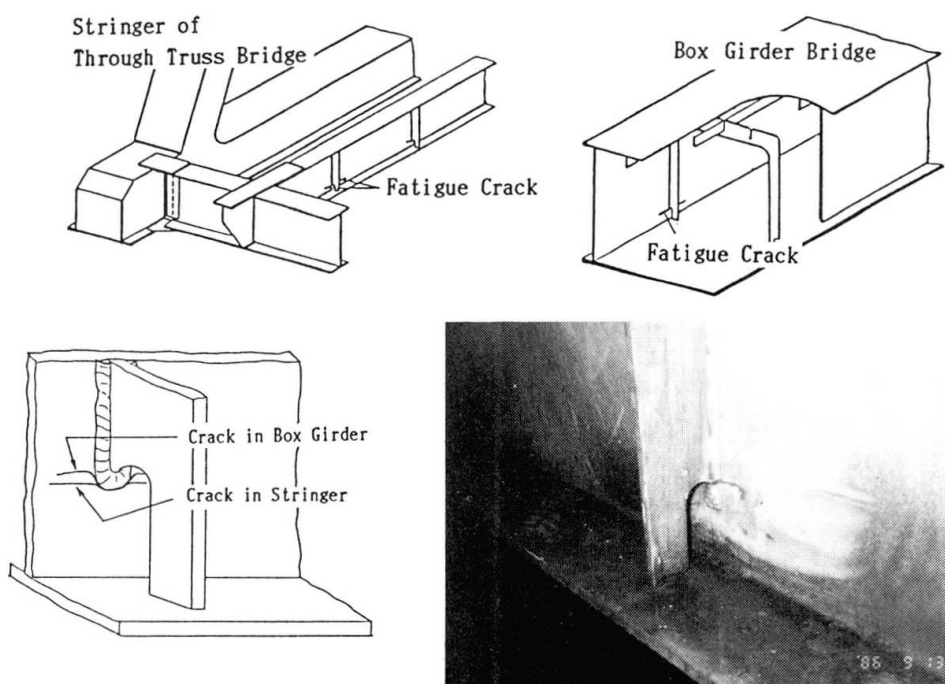
Fig.4 Fatigue crack at stiffener end

Fig. 4 shows cracked girder web. This type of fatigue cracks occurred at the lower end of the stiffener on girder webs of box girder bridges and stringer webs of through truss bridges. Characteristically, no crack has occurred at the end of the stiffener to which floor beams or sway bracings are connected. These fatigue cracks began to be observed in 1978. To date, cracks have been observed in about 10,000 details of about 200 box girder bridges and in about 100 details of five through type truss bridges. Countermeasures were taken against all parts of through type truss bridges which were considered to undergo cracking.

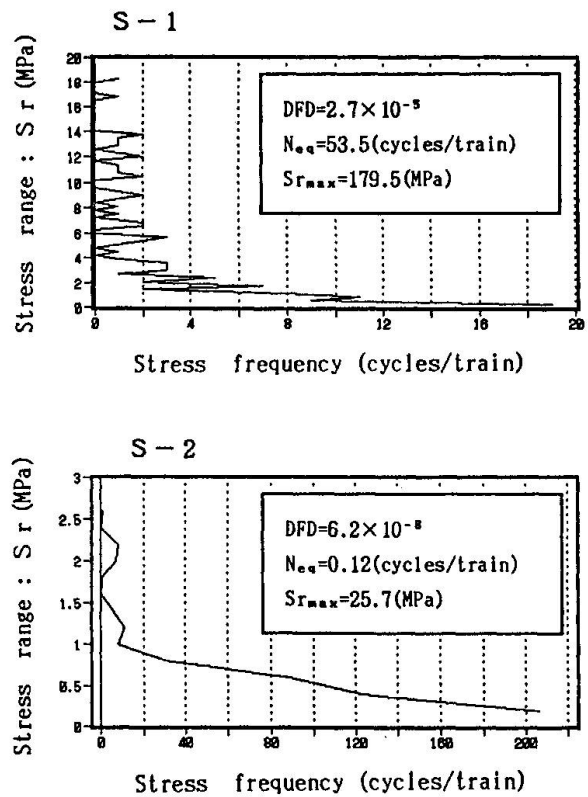
Fig.9 Stress frequency and Degree of Fatigue damage (DFD)

Fig.9 shows the stress histogram and the degree of fatigue damage of each stress component. The results suggest that fatigue cracks occurred in several years under S-1 stress history.

However, S-2 shows not so high degree of damage.

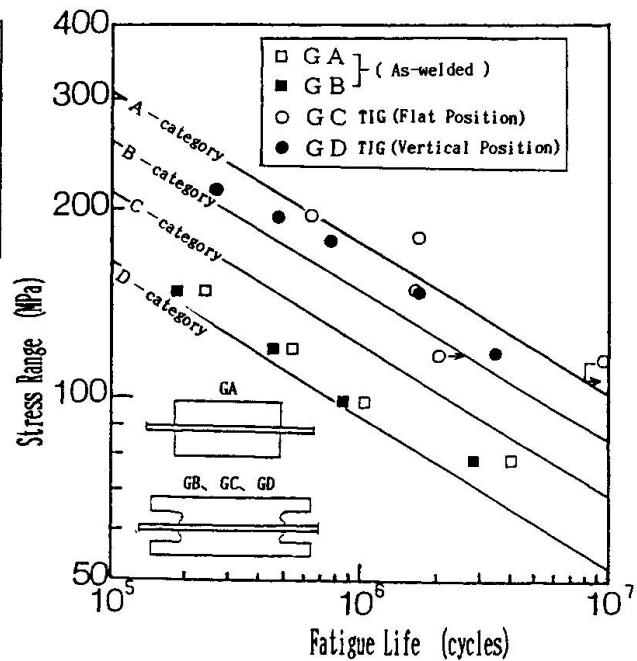
Fig.11 Results of fatigue test

The result of fatigue testing is shown in Fig. 11. It was found that the fatigue strength of as-welded specimens slightly exceeded the category D of the design curve, while the fatigue strength of TIG dressed specimens exceeded the category B curve. The TIG dressing improved the shape of the toe of weld which affects occurrence of a crack and reduces stress concentration, thus improving fatigue strength.
