# Fatigue crack detection and repair of steel bridge structures

Autor(en): **Fisher, John W. / Menzemer, Craig C. / Yen, Ben T.**

Zeitschrift: **IABSE reports = Rapports AIPC = IVBH Berichte**

## Fatigue Crack Detection and Repair of Steel Bridge Structures

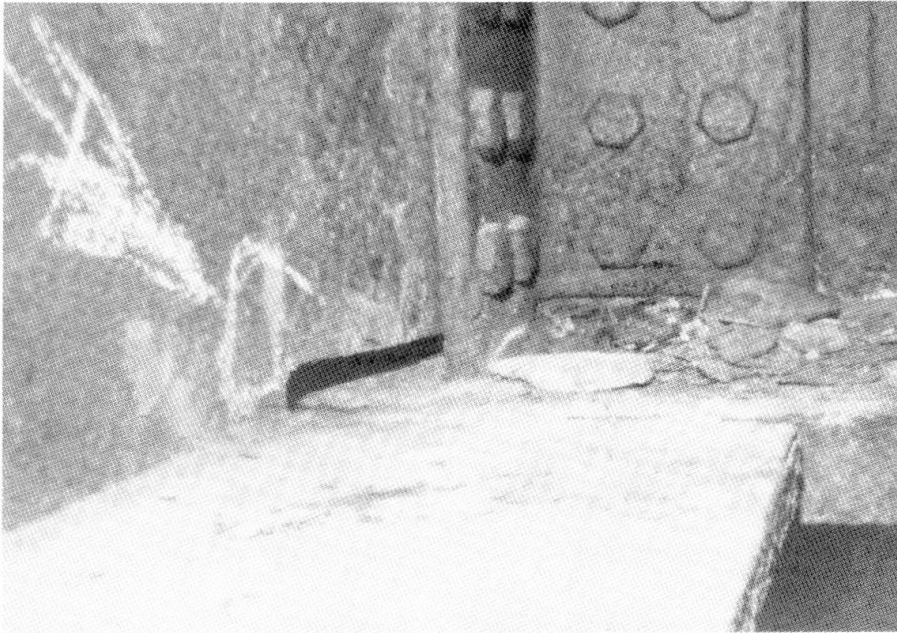
Inspection of the structure revealed several areas which contained fatigue cracks. In addition, lateral displacement of several longitudinal girder bottom flanges was also observed. Fatigue cracks were found along the longitudinal girder web to flange weld at the flange terminations and vertical cracks were observed in the longitudinal girder webs at the reentrant corner of the bottom copes (Fig. 5). Cracking was occasionally observed along the bolt fixity line of the connection angles (Fig. 6).

Fig. 5 Vertical and Horizontal Fatigue Cracks at Bottom Web Cope

Coping by flame cutting the longitudinal girder and floorbeam webs resulted in high tensile residual stresses along the cut edge as well as at reentrant corner. In addition, coping greatly reduced the section modulus for in-plane bending and left an unstiffened segment of girder web between the flange terminations and the bolt fixity line of the longitudinal girders. At locations where the longitudinal girders were not bolted full depth to the connection angles, the girder web could rotate in plane without developing significant compressive forces in the lower portion of the girder. This resulted in no bottom flange lateral displacement, no web gap distortion, and no fatigue cracking in the web cope or connection angles. In locations where the girder was bolted full depth to the connection angles of the transverse beam, connection restraint resulted in lateral displacement of the bottom flange and web gap distortion from the compressive stresses in the web. Hence, fatigue cracks along the bottom edges of the connection angles were all displacement induced.

Retrofits recommended for fatigue cracking in the longitudinal girders included the drilling of holes to blunt the crack tips. Further retrofit was required to prevent the lateral displacement of the bottom flange and minimize web gap distortion. Otherwise, fatigue crack reinitiation from the retrofit holes and continued crack propagation along the bolt fixity line would result. Several rows of bolts were removed from the girder to transverse beam connection to reduce the compression in the web and help move the flange toward normal alignment. Angles were then bolted to the inside longitudinal girder web and flange and to the connection angle to prevent lateral motion of the bottom flange (Fig. 10) and to provide greater resistance to the end restraint.

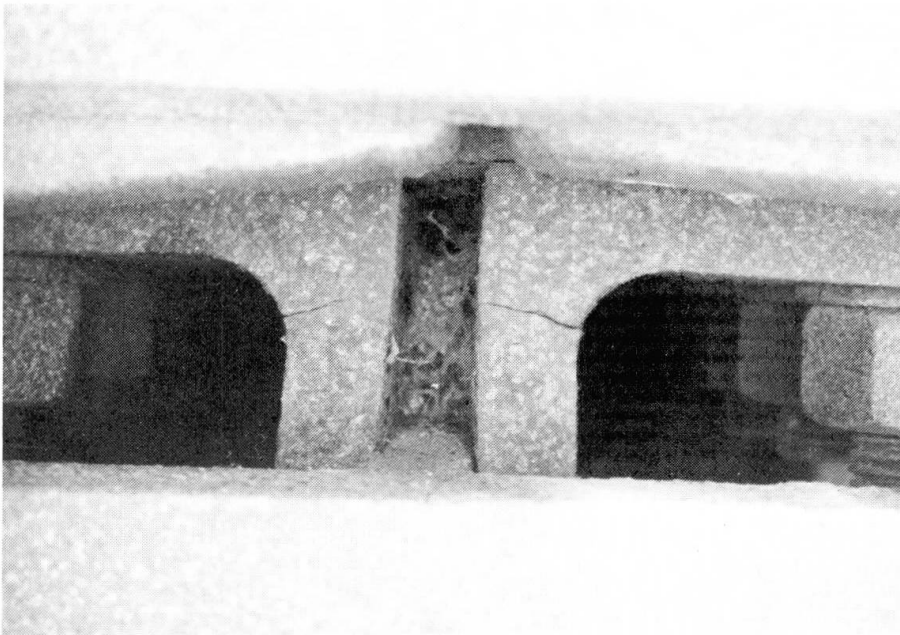
Fig. 6 Cross-Sectional View of Angle with Fatigue Cracks

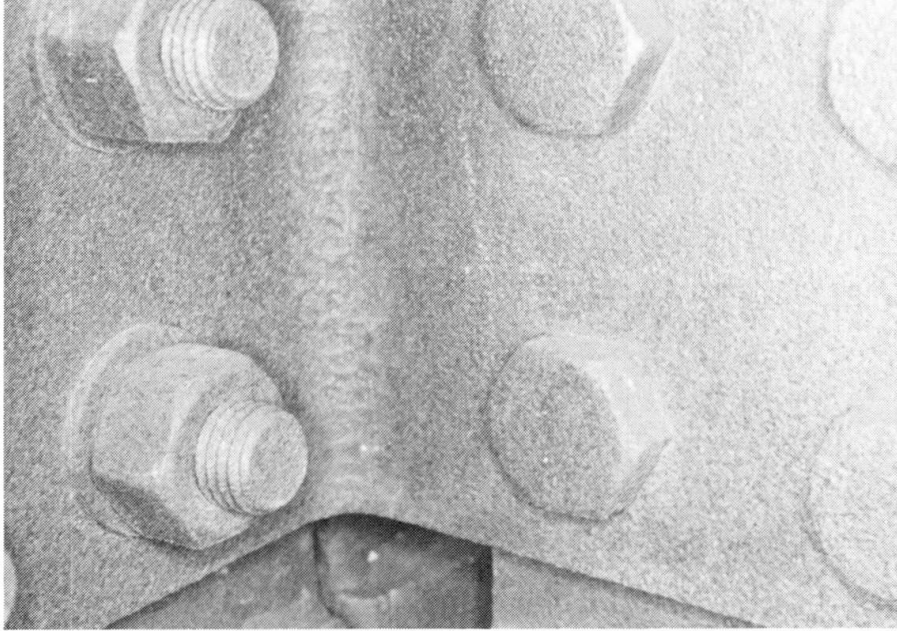
Figure 7 shows cracks which extended several inches along the bottom end of the angle fillet, between the girder web and the transverse beam of the bents. The cracks were found only at locations where the longitudinal girder web was bolted full depth to the connection angles. Other locations where the girder web was not bolted full depth exhibited no evidence of cracking (Fig. 8).

Fig. 7 Fatigue Crack in Longitudinal Girder-Beam (Bent) Angle Connection

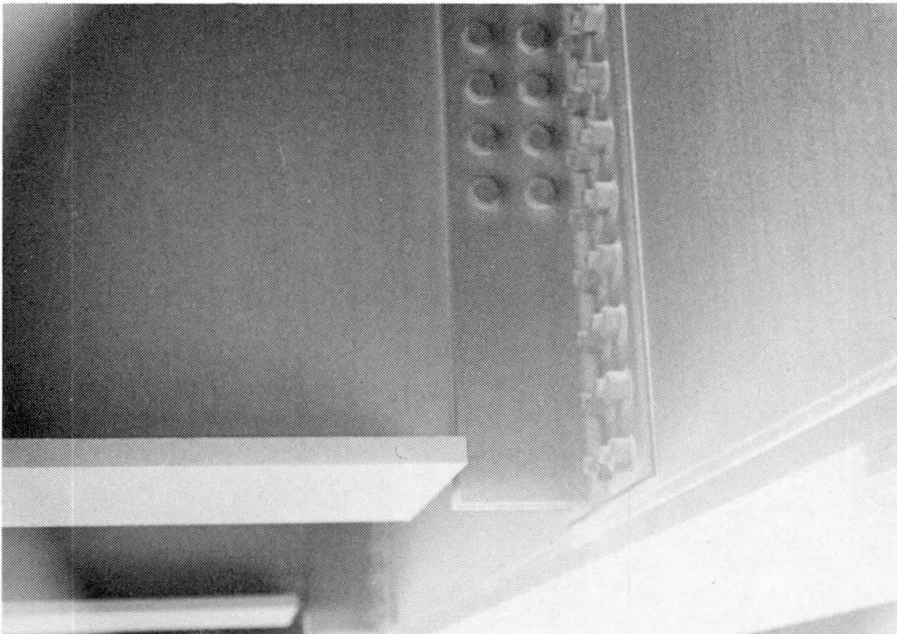
Fig. 8 Longitudinal Girder Not Bolted Full Depth to the Connection Angles

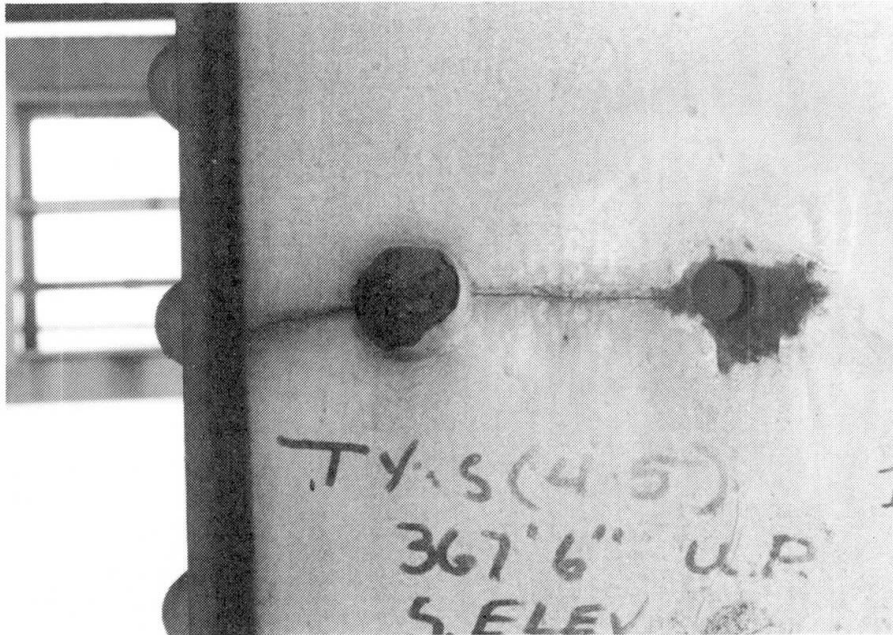
Inspections of the structure revealed fatigue cracks emanating from the rivet holes in several hanger box sections (Fig. 13). In addition to the fatigue cracks, significant amounts of corrosion product was found between the corner angles and both web and flange plates of the hanger sections (Fig. 13). Environmental corrosion was also found between the gusset and hanger plate as well as on the gusset at the elevation of the pin connection (Fig. 14).

Fig. 13 Corrosion Between a Hanger Flange Plate and Interior Connection Angle and Web Crack from Rivet Hole

The hanger connections are located directly below open roadway expansion joints which allows salt, water, and debris to fall and collect on the pin and hangers, thereby assisting and accelerating the corrosion process. Field inspections and strain measurements demonstrated that the development of corrosion caused pin restraint which, in turn, led to bending in the hangers. When the bending moment at the hanger joint was high enough to overcome the restraint, sudden release of the pin connection produced the dynamic action. Lubrication of the pins was effective in minimizing hanger bending and dynamic effects by reducing pin restraint and as such, was recommended as a routine maintenance practice. A longer term correction will require the redesign of the pin connection as well as effective control of water and debris by the elimination of open expansion joints.

Cracked hanger plates were temporarily retrofitted by the drilling of holes to blunt the crack tips. For the cracked hanger flange plates, the maximum measured stress range of 55 MPa exceeded the fatigue limit of 48 MPa for riveted members. Fatigue crack propagation is expected to continue in the flange plates. As a result, twice a year inspection of the hangers will be required, until the eventual replacement of the damaged hangers.
