**Zeitschrift:** IABSE reports = Rapports AIPC = IVBH Berichte  
**Band:** 70 (1993)

**Artikel:** Investigation of the Roman aqueduct structure of Acqui Terme  
**Autor:** Nascè, Vittorio / Pistone, Giuseppe / Roccati, Roberto  
**DOI:** <https://doi.org/10.5169/seals-53299>

## **Investigation of the Roman Aqueduct Structure of Acqui Terme**

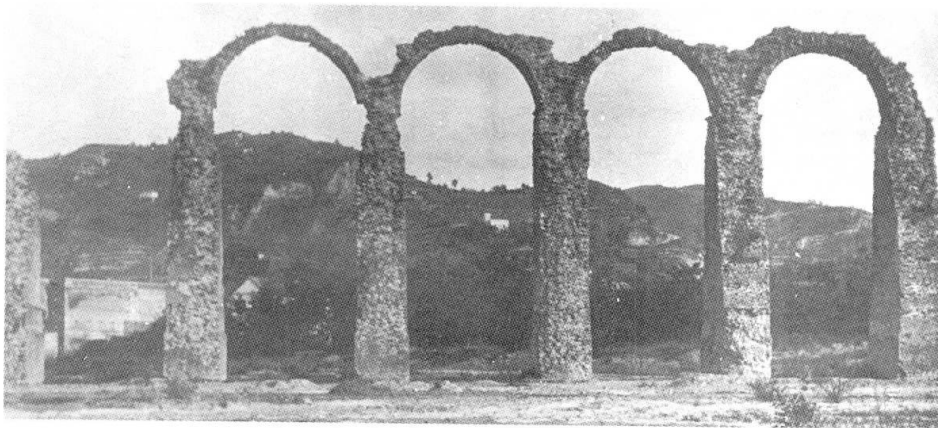
At the end of the 19th century (1896), when erosion had already damaged severely both the facing and the inner masonry (photo 1), restoration work was started and carried out in several stages, mostly on the arches.

Photo 1 - General view of the aqueduct in 1896.

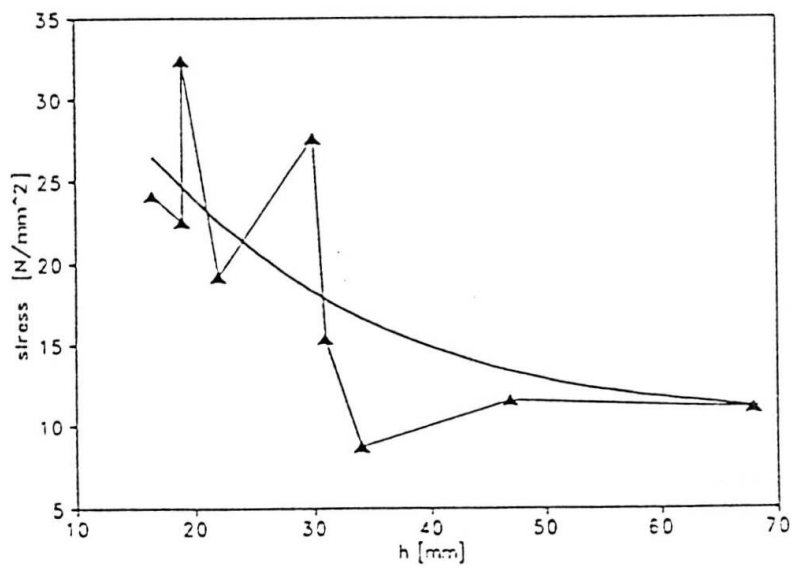
Fig. 1 - Strength as a function of the specimen height.

In the mortar, compressive strength and the elastic modulus were determined on cylinders of different heights: strength was seen to decrease with increasing specimen height (fig. 1), this being an aspect of special interest in the case being considered, on account of the sizeable discontinuities present in the mortar beds of the inner masonry, in terms of both thickness and area.

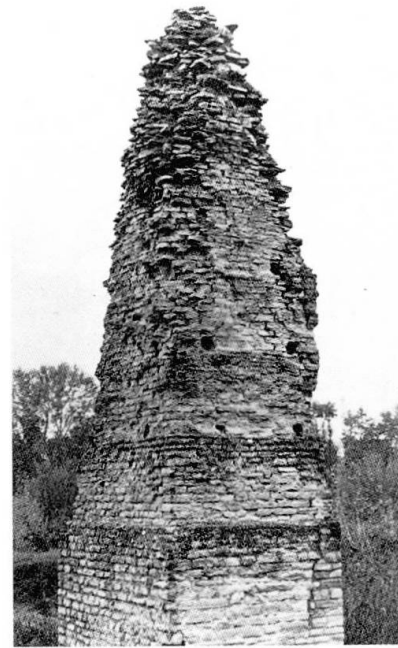
The composition of the original masonry may therefore be discerned best in isolated piers which underwent but limited repair work (photo 2). The facing layer consists of sandstone blocks, of variable width (25 cm on average) 8 cm thick, squared on the outer surface. Mortar joints, whether horizontal or vertical, have a thickness of between 2 and 3 cm, which is generally seen to increase towards the innermost part of the masonry. The average value of the ratio between the area of the mortar and the total area of the facing layer is about 0.3 (photos 3 and 4). The inner part of the masonry instead is made of sandstone blocks exhibiting irregular edges between the two parallel faces. Narrower and thinner than the facing blocks, all these elements were carefully laid horizontally one at a time. The mortar beds of the inner blocks reveal marked discontinuities and their thickness, on average, is greater than that of the facing blocks: the average value of the ratio between the mortar area and the total area of an inner vertical section, in fact, is about 0.5 (photos 5, 6). In the inner part of the masonry there are many cavities, mostly located in the median portion of the thinner vertical joints. These cavities were produced both by insufficient flow of the mortar from the bottom up as the blocks were laid and by insufficient filling of the upper mortar bed.

Photo 2 - Non restored isolated pier.

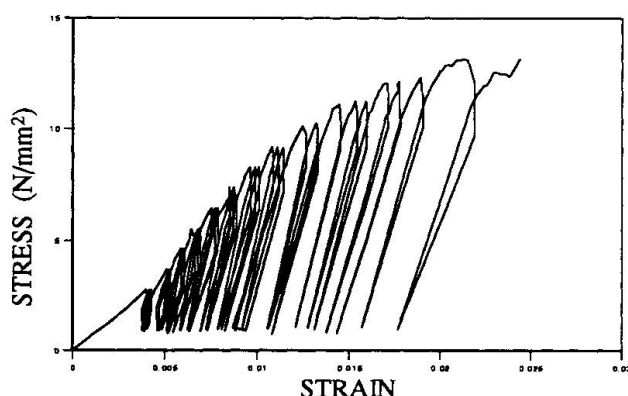
In specimen No. 2 the compression and bending effects were much smaller, on account of a more regular composition (fig. 2), and failure occurred under a load of 1420 KN ( $13.1 \text{ N/mm}^2$ ).

Fig. 2 - Stress-strain curve of strain gauge 7 - specimen 2.

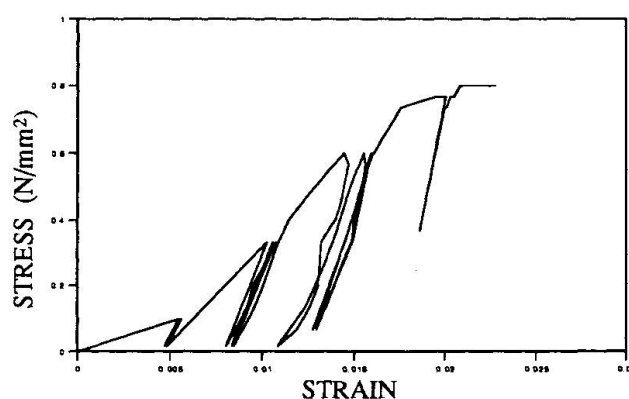
Fig. 3 - Average stress-strain curve - specimen 3.

The progressive opening of cracks did not prevent the material from exhibiting overall elastic behaviour in the individual loading cycles up to very high stress values, as confirmed by the diagram in fig. 3. This diagram illustrates a typical behaviour which was observed throughout the tests: the initial load increase, for each testing level, was accompanied by high strain values and marked residual strain, while in subsequent cycles (the load being the same) strain was lower and residual strain was virtually negligible.

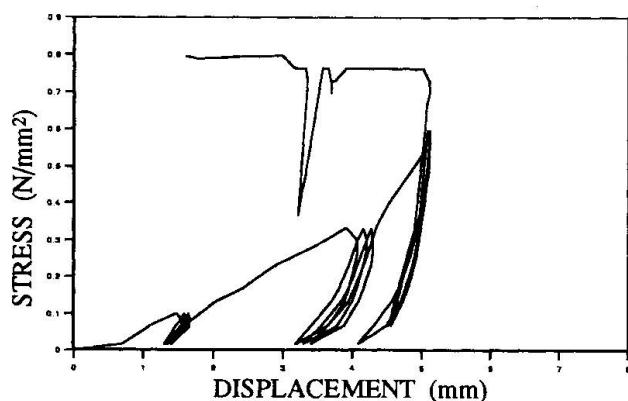
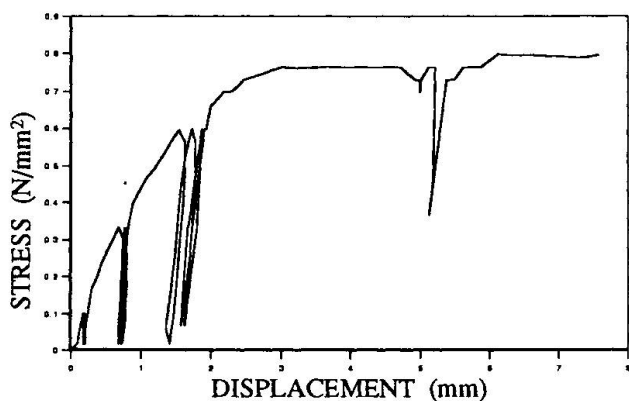
Figs. 4 - 5 - Stress-strain curve of strain gauge 4 (vertical) and 9 (horizontal) - specimen 3.

A comparison between the diagrams plotted from the readings taken by two strain gauges of about the same length on the same face of specimen No. 3 (figs. 4, 5), - a vertical and a horizontal gauge, Nos. 4 and 9, respectively - shows that the strain values are of the same order of magnitude and the horizontal one entails a transverse strain modulus about three times as high as that of the masonry at the elastic stage. Moreover, the downward portion of the curve in fig. 5 reveals a major overall settlement of the specimen under the load, this behaviour closely resembling that of specimen No. 1 already described above (fig. 6). Thus we find that the transverse strains that have been observed are greater than would be expected on the basis of the Poisson modulus of the components, and are independent - even in terms of their direction - of vertical ones in the proximity of failure. Failure involved the masonry specimen as a whole, as shown in photo 13. Strain stabilisation was especially slow at a load level corresponding to 90% of the failure load and required a waiting period of about 20 minutes, this being a confirmation of the major influence exercised by the permanence of the load on the collapse of very irregular masonry.

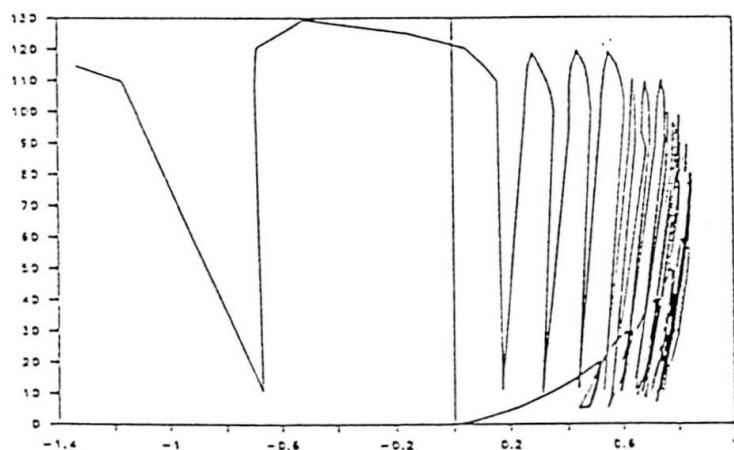
In the case of sample No. 1, though care had been taken to apply the load to its centre of gravity, a marked compression and bending effect occurred due to the presence of a stiffer and stronger core in one of the corner area. Failure took place at 1180 KN ( $8.6 \text{ N/mm}^2$ ), during the second loading cycle of the last triplet, at a strain value markedly higher than that observed during the previous cycle where the specimen, however, had reached a load of 1300 KN ( $9.4 \text{ N/mm}^2$ ).

Fig. 6 - Load-displacement curve of strain gauge 5 - specimen 1.

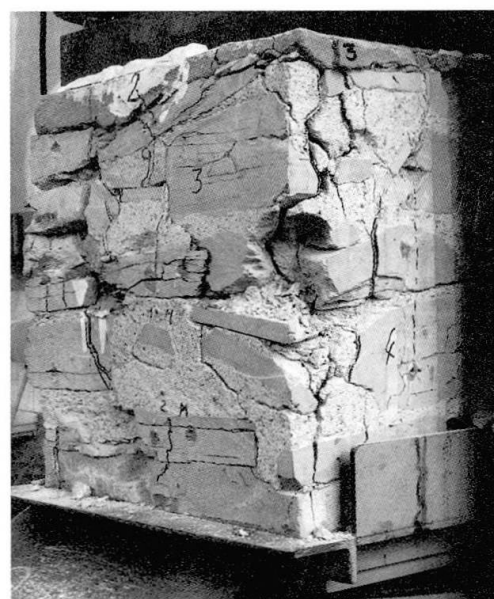
The behaviour of specimen No. 3 was relatively uniform, with no sizeable compression and bending effects: a series of diffused micro-cracks appeared rather early over all the faces. At 1000 KN ( $3.3 \text{ N/mm}^2$ , 40% of the failure load), widespread crack formation was already evident and it kept increasing over the successive cycles, the load level remaining the same (photo 7). This phenomenon continued steadily until failure which occurred at 2400 KN ( $8.0 \text{ N/mm}^2$ ).

Photo 7 - Collapse of specimen No. 3.
