Autor(en): **Nascè, Vittorio / Pistone, Giuseppe / Roccati, Roberto**

Zeitschrift: **IABSE reports = Rapports AIPC = IVBH Berichte**

Band (Jahr): **70 (1993)**

Investigation of the Roman Aqueduct Structure of Acqui Terme

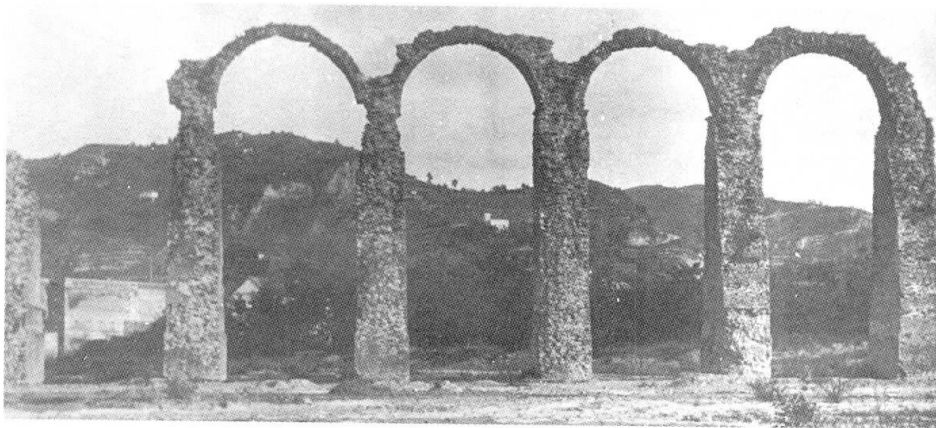
At the end of the 19th century (1896), when erosion had already damaged severely both the facing and the inner masonry (photo 1), restoration work was started and carried out in several stages, mostly on the arches.

Photo 1 - General view of the aqueduct in 1896.

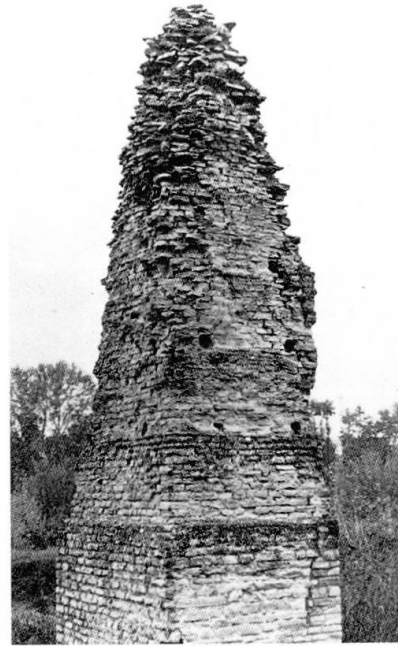
The composition of the original masonry may therefore be discerned best in isolated piers which underwent but limited repair work (photo 2). The facing layer consists of sandstone blocks, of variable width (25 cm on average) 8 cm thick, squared on the outer surface. Mortar joints, whether horizontal or vertical, have a thickness of between 2 and 3 cm, which is generally seen to increase towards the innermost part of the masonry. The average value of the ratio between the area of the mortar and the total area of the facing layer is about 0.3 (photos 3 and 4). The inner part of the masonry instead is made of sandstone blocks exhibiting irregular edges between the two parallel faces. Narrower and thinner than the facing blocks, all these elements were carefully laid horizontally one at a time. The mortar beds of the inner blocks reveal marked discontinuities and their thickness, on average, is greater than that of the facing blocks: the average value of the ratio between the mortar area and the total area of an inner vertical section, in fact, is about 0.5 (photos 5, 6). In the inner part of the masonry there are many cavities, mostly located in the median portion of the thinner vertical joints. These cavities were produced both by insufficient flow of the mortar from the bottom up as the blocks were laid and by insufficient filling of the upper mortar bed.

Photo 2 - Non restored isolated pier.

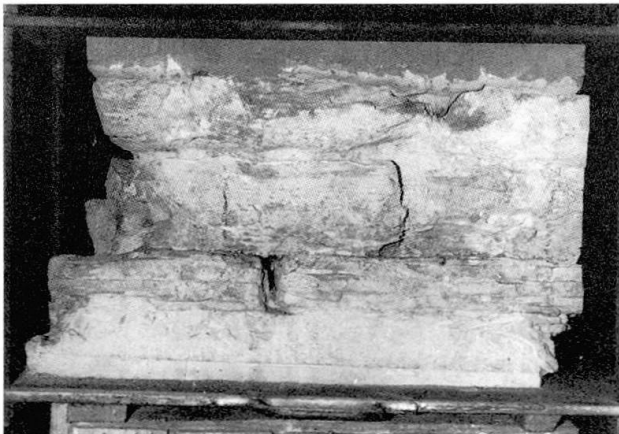
Photo 3 - Sample obtained from facing masonry.

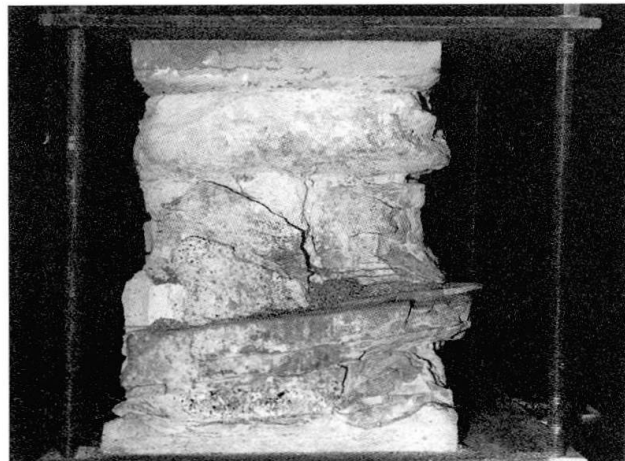
Photo 4 - Sample obtained from facing masonry.

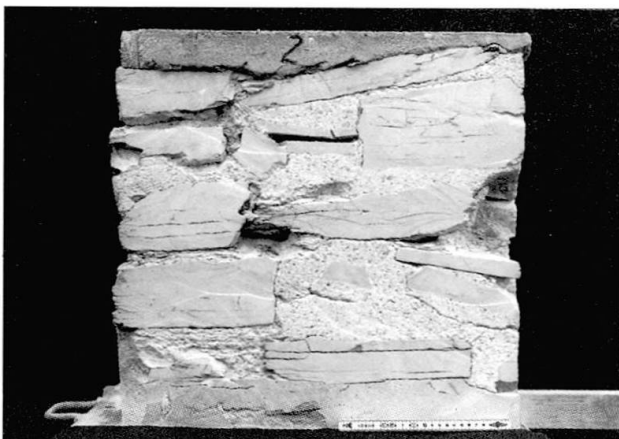
Photo 5 - Sample obtained from inner masonry.

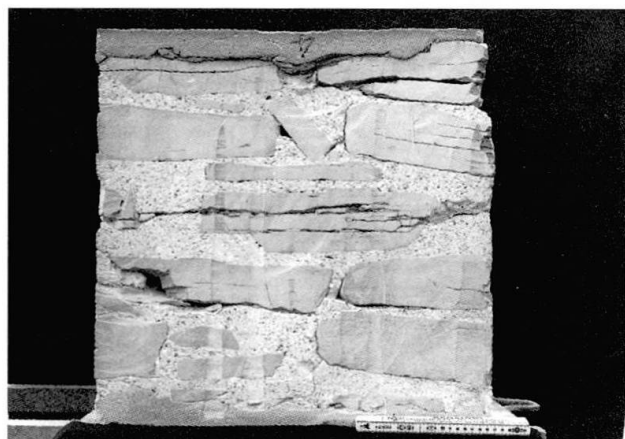
Photo 6 - Sample obtained from inner masonry.

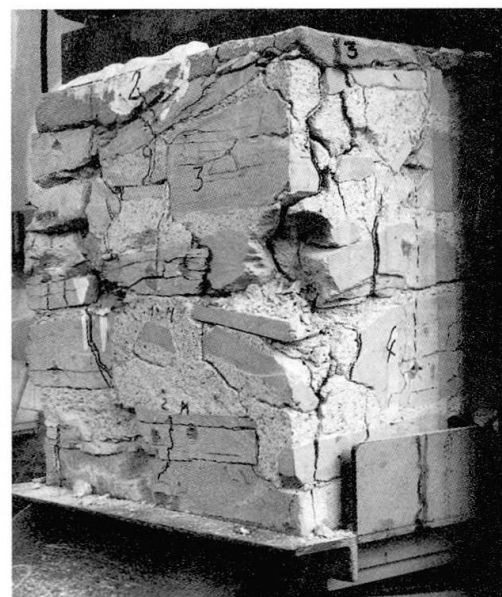
The behaviour of specimen No. 3 was relatively uniform, with no sizeable compression and bending effects: a series of diffused micro-cracks appeared rather early over all the faces. At 1000 KN (3.3 N/mm^2 , 40% of the failure load), widespread crack formation was already evident and it kept increasing over the successive cycles, the load level remaining the same (photo 7). This phenomenon continued steadily until failure which occurred at 2400 KN (8.0 N/mm^2).

Photo 7 - Collapse of specimen No. 3.
