Studies for the rehabilitation of Mexico City Cathedral

Autor(en): **Meli, Roberto / Sanchez-Ramirez, A. Roberto**

Studies for the Rehabilitation of the Mexico City Cathedral

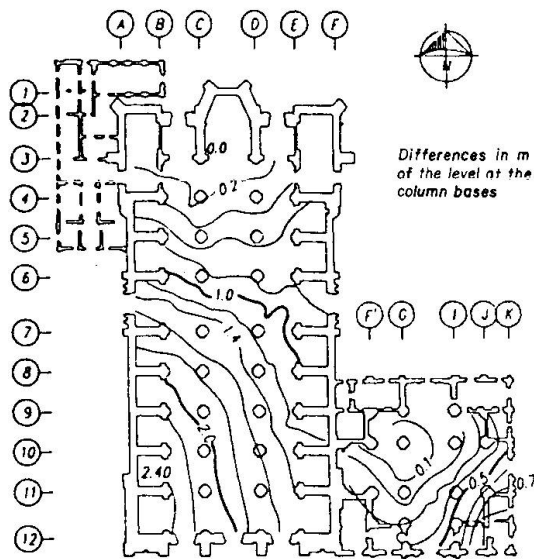
Fig. 3 Differential settlements (Dec. 1989)

Fig. 3 shows the pattern of differential settlements measured in the floor of the Cathedral some time before at the beginning of the rehabilitation work (late 1989). Another useful representation of the phenomenon is given by the curves of equal rate of differential settlements in the year before the commencement of the works (Fig. 4). Two major mechanisms of deformation can be appreciated. One is the sinking toward the Southwest corner, another is the "emergence" of the central nave in the Northern part.

The first mechanism has produced a pattern of transverse cracks in the roof and walls, especially near the central dome, and some separation of the Southern facade, with its very heavy towers, from the rest of the church.

The second mechanism produced the outward rotation of the columns and lateral walls, and the opening of the vaults and arches in the roof, originating a pattern of longitudinal cracks in the roof, floor and foundation. This second mechanism is the most critical from the structural point of view, because of the inclination of the columns receiving the greatest vertical loads, especially those supporting the central dome. As can be seen in Fig. 5, the present shape of the column shaft shows changes of direction due to corrections made during the construction. The total eccentricity between the upper and lower part of the column is, for this case, 0.6m representing 25% of the size of the column. Some vertical cracks at the upper part of the column are attributed to the compressive stresses generated by the eccentric compression.

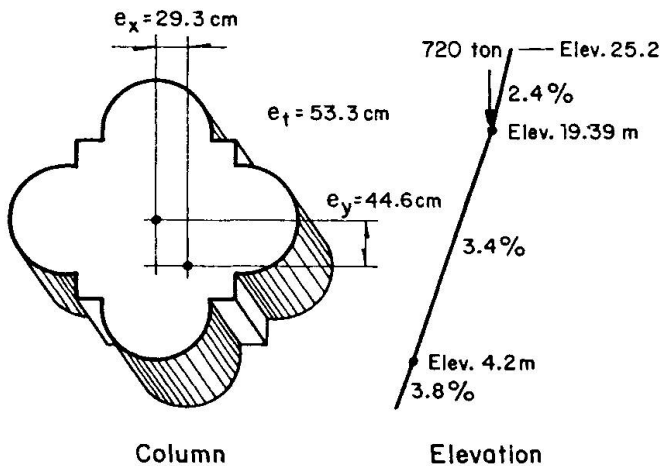
Fig. 5 Deformed shape of a central column and applied forces due to self-weight

stability of the central columns shows that bending moments induced by the eccentricity of the force produced by the weight of the roof, increase the maximum compressive stress 2.3 times above that computed for the undeflected shape of the column. In this fashion stresses are now very near to the maximum capacity of the stone.

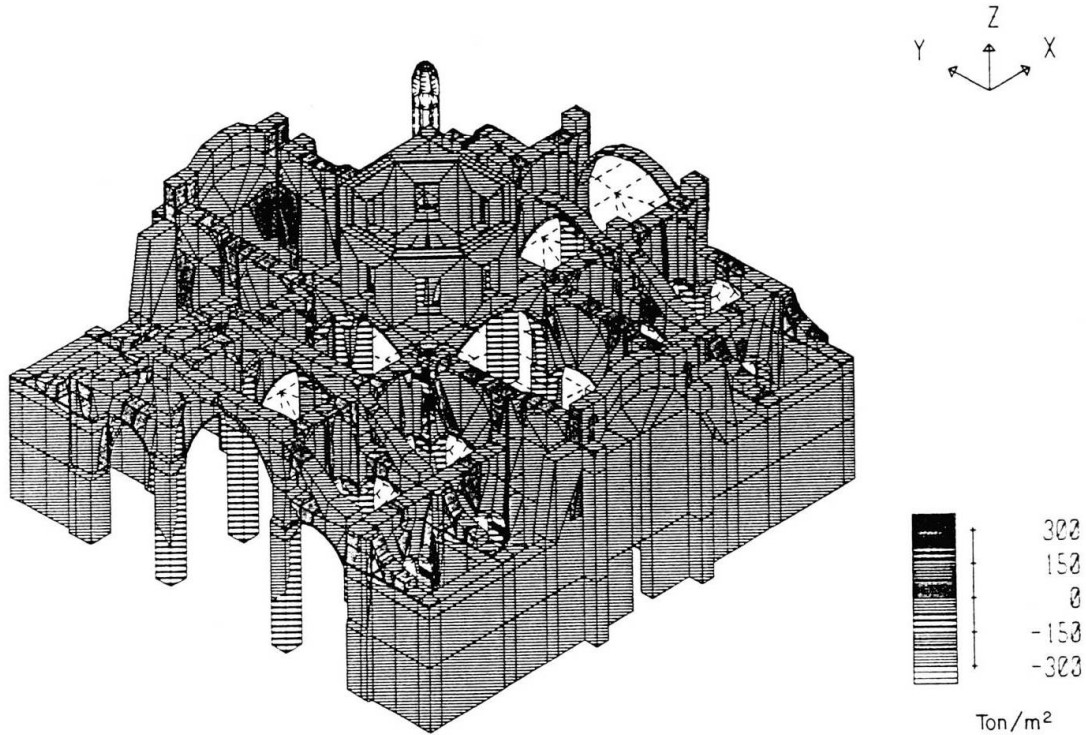
Fig. 6 State of stress due to gravity loading from a finite element analysis of the central portion of the Cathedral

A thorough view of the state of stresses induced by the vertical loads in the central part of the monument is shown in Fig. 6. A move schematic representation of the flow of forces in members supporting the central dome is shown in Fig. 7. It can be appreciated that the weight is transmitted toward the foundation essentially by axial forces in the vaults, arches, columns and walls. The level of stresses in the members of the original structure disregarding the changes in their geometry due to settlements and adjustments, is well within the range of capacity of the materials.

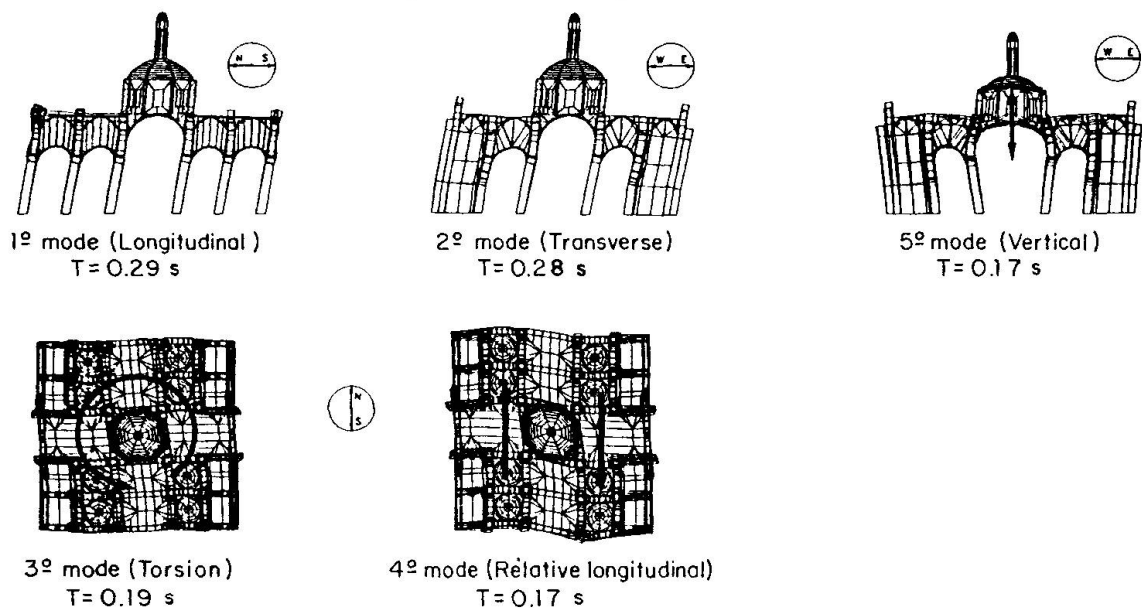
Fig. 9 Modal shapes of vibration from a finite element model of the central portion of the Cathedral

The previously described linear elastic tri-dimensional model was used for a dynamic analysis to compute the modal shapes and periods of vibration (Fig. 9). It was found that in plan deformations of the roof favoured torsional modes of vibration and that the large concentrated mass of the central dome produced significant vertical vibration. Computed periods were compared with those derived by measuring the vibration of the building in ambient conditions. Consistently, computed periods are smaller than those measured. This is attributed to the lack of fixity of the base of the structure where the foundation allows significant rotations of the walls and columns. Additionally, the extense cracking of the structure significantly reduces the stiffness, thus increasing the vibration period.

For the assessment of the seismic safety, a constant spectral ordinate of 0.2m was assumed. It was considered that, because of the existing cracking and of the small tensile strength of the materials, parts of the structure could vibrate independently from the rest. Therefore, the seismic safety of the most critical portions was assessed primarily by simplified methods. In general terms, it was concluded that the strong peripheral belt constituted by the facade walls and by the walls surrounding the chapels provided a satisfactory overall safety. Nevertheless, the additional lateral displacements of the columns during their
