## An Engineering View of the Statue of Liberty Restoration

### Edward COHEN

Managing Partner  
Ammann & Whitney  
New York, NY, USA

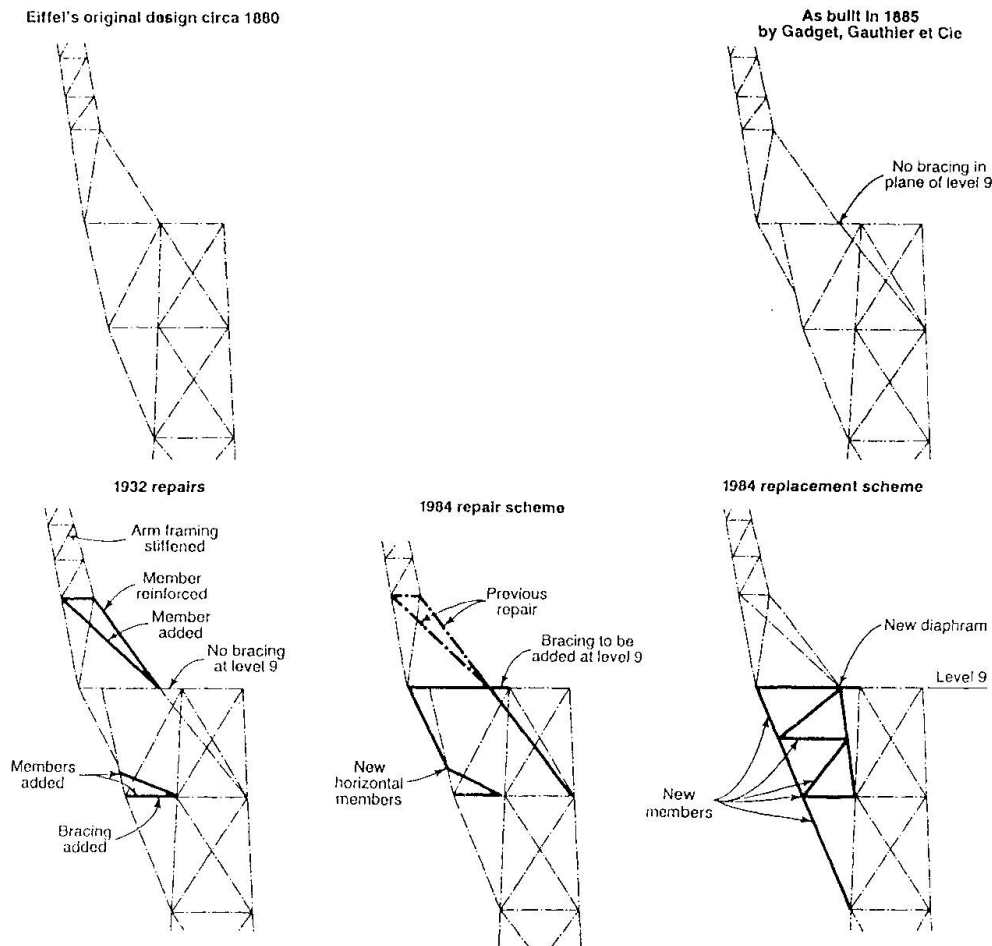
**Fig. 4** History and Proposed Repairs of the Right Shoulder

The shoulder and head arch problems have existed since the Statue was constructed, a result of the misalignment of the head and shoulders from the originally designed positions, which created flexibility and overstresses in these areas. In the shoulder, the main deficiency was lack of torsional resistance which resulted in dangerous levels of axial stresses in critical members.

Several attempts to repair the weak shoulder were made in the past, most apparent of these is the unsuccessful attempt made by the U.S. Army in 1932. During the current project, two alternative solutions were proposed. The first alternative, termed the replacement scheme, consisted of removal of several members of the existing deficient shoulder and reconstructing the shoulder with a new truss, to achieve structural continuity to the main pylon. The second alternative, the repair scheme, adds several members to the existing structure to achieve the required rigidity and factor of safety. The history of the problem and proposed repairs of the shoulder are illustrated in Fig. 4.

Because the existing structure had historical significance, being as initially erected in Paris, it was decided to implement the repair scheme.
