The Study of an Old Palace Structure and its Repair

Ibrahim MOHARRAM

Assist. Professor
Ain Shams University
Cairo, Egypt

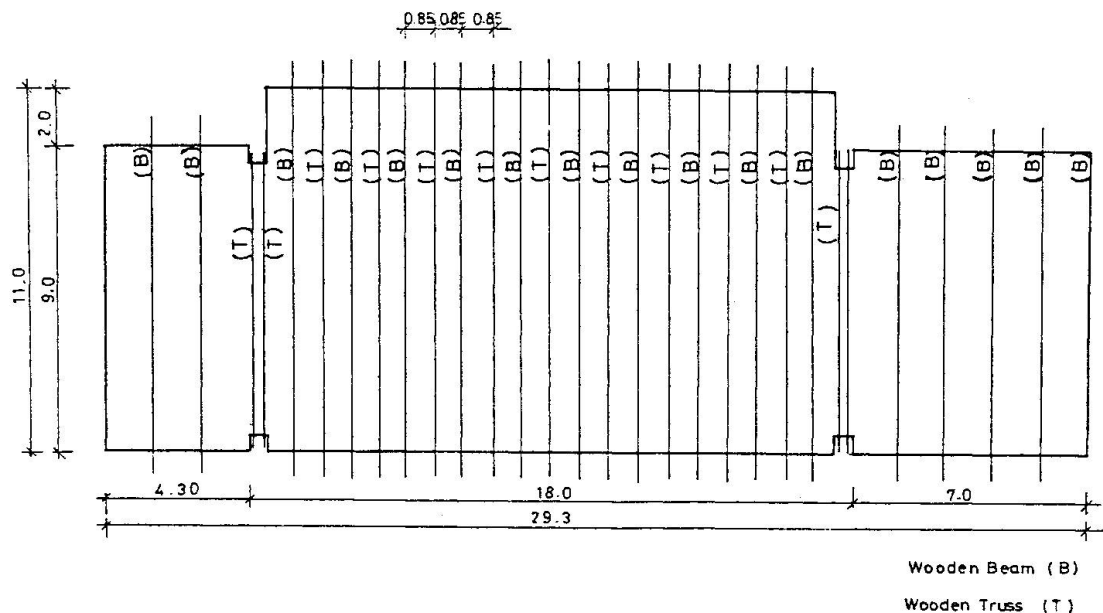
This building was well maintained and in a good condition. Nevertheless, there was water leakage in one of its major halls. Figure (1) shows the layout of the hall under study. This hall is one of the most luxurious halls in the palace. The ceiling and walls contain precious masterpiece decorations. The main hall was 18 meters long and 11 meters wide. Connected to this hall from one side was an entrance hall (9 m x 7 m) and from the other side to a hall (9 m x 4.3 m) connecting it to the main throne hall.

The structural system consists of load-bearing masonry wall with a thickness of about 70 cm. The precious decorative false ceiling was hung by means of wooden trusses and beams resting on the bearing walls. The spacings between the trusses were 1.70 m, and between the trusses there was a wooden beam at the same level of the bottom chord of the trusses, as shown in Figure (1). Figure (4) shows the dimensions of a typical truss.

From inspecting the hall false ceiling of the main building, sagging of the decorated false ceiling was noticed as well as traces of water leakage. But nevertheless, from inspecting the hall from the space between the false decorated ceiling and the roof, longitudinal cracks were quite visible in beams and trusses.

Fig. (1) Layout of the Hall (in the Old Building) showing Locations of Beams and Trusses

Figure (4 and 5) illustrates the method used in repairing and strengthening the trusses of the hall. The following procedure was adopted:

- Collars were primarily loosely installed every about 50 cm to the truss members.
- The cracks were filled with a bonding material consisting of saw dust and an epoxy adhesive. Care was taken during filling to avoid any voids.
- The bolts of the collars were then tightened (during the initial drying period), thus forcing out any voids in the viscous epoxy and providing uniform bonding between the sides of the crack.
- Finally, the wooden structure was painted by an epoxy resin protecting it from humidity, decay and any environmental conditions.
- Leakage of water at the roof was fully checked and repair was carried out to ensure that no leakage would occur in the future.

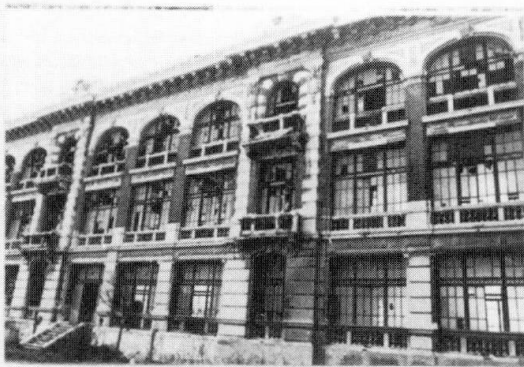
Figure (2) shows the extension building and a sample of the damaged parts. The building was abandoned for sometime and badly maintained. Traces of water leakage could be seen from water piping system at the basement, at the bathroom and at ceiling walls of the top floor (due to rain). Cracks and spalling of concrete could be seen in reinforced concrete elements, while some uncovered corroded steel reinforcement bars were detected.

(a) Part of the Extension Building

Fig. (2) Photos taken to the Extension Building showing a sample of the damaged parts

- A full check and repair of the rain water drainage system, plumbing and maintenance of the building.
- Removal of all concrete cover for steel reinforcement where concrete has been affected and removal of all rust that might be found on the reinforcement bars by means of sand blasting.
- Areas where steel reinforcement was excessively corroded should be replaced by new bars.
- Steel bars should be covered by a protective layer against rust and bars should be covered by a bonding agent layer to ensure a good bonding between steel and newly placed concrete cover.
- Shot creting with a dense mix ensuring that the mix fills in all the voids between steel bars and main concrete body.

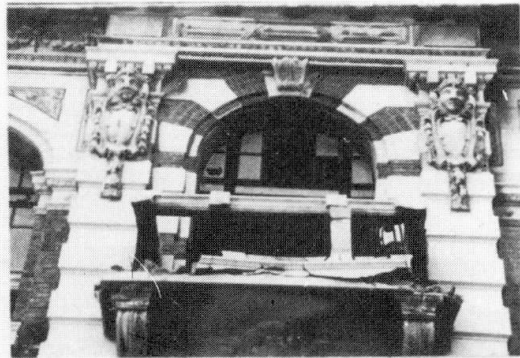
(b) A Balcony

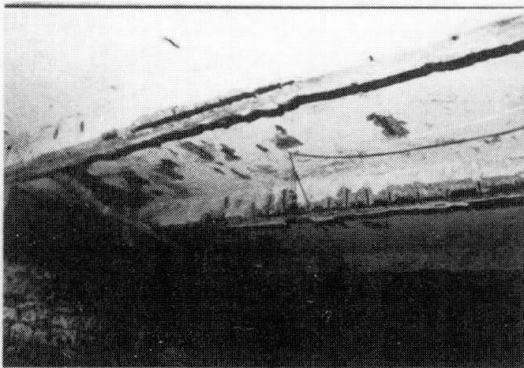
(c) The Basement

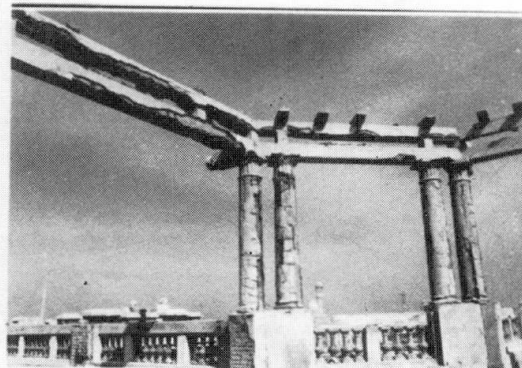
(d) The Terrace

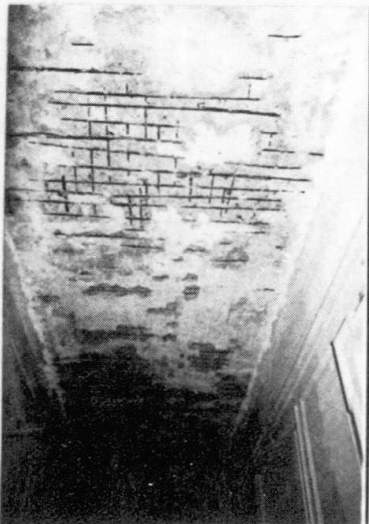
(e) A Slab

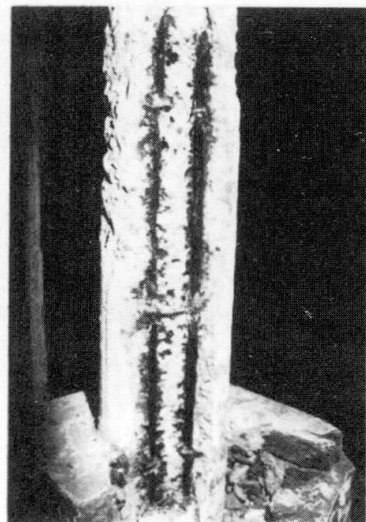
(f) A Column
