The Study of an Old Palace Structure and its Repair

Ibrahim MOHARRAM

Assist. Professor
Ain Shams University
Cairo, Egypt

SUMMARY

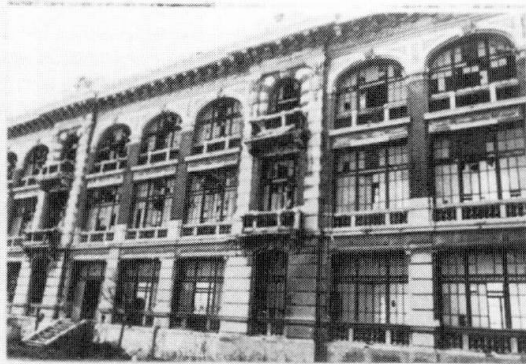
(a) Part of the Extension Building

Figure (2) shows the extension building and a sample of the damaged parts. The building was abandoned for sometime and badly maintained. Traces of water leakage could be seen from water piping system at the basement, at the bathroom and at ceiling walls of the top floor (due to rain). Cracks and spalling of concrete could be seen in reinforced concrete elements, while some uncovered corroded steel reinforcement bars were detected.

Fig. (2) Photos taken to the Extension Building showing a sample of the damaged parts

- A full check and repair of the rain water drainage system, plumbing and maintenance of the building.
- Removal of all concrete cover for steel reinforcement where concrete has been affected and removal of all rust that might be found on the reinforcement bars by means of sand blasting.
- Areas where steel reinforcement was excessively corroded should be replaced by new bars.
- Steel bars should be covered by a protective layer against rust and bars should be covered by a bonding agent layer to ensure a good bonding between steel and newly placed concrete cover.
- Shot creting with a dense mix ensuring that the mix fills in all the voids between steel bars and main concrete body.
