# Posters: Session 4

Zeitschrift: **IABSE reports = Rapports AIPC = IVBH Berichte**

Band (Jahr): **70 (1993)**

## Posters - Session 4

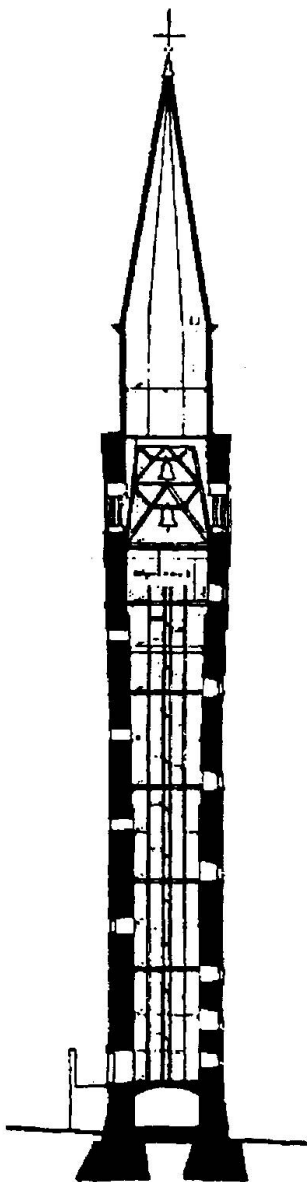
Figure 1

Some major concerns about its actual safety level were however justified by the not negligible inclination ( about 1% ) and by evident traces of past heavy damages, often caused by lightnings, which were repaired between the end of the last century and the beginning of the present one.

In particular, pictures exist of the damages at the northern corner of the tower, which was near to collapse at the beginning of this century, and the inner part of such corner still presented damages and cracks in 1990.

This was obtained first by reconstructing damaged masonry portions using traditional materials and techniques. In particular hand made solid clay units and mortars and injections made with hydrated lime mixed with "cocciopesto", which gives hydraulic properties to the admixtures, have been used.

Then, the inactive ties have been substituted and some new ties have been added. Finally, the confinement of the inner parts of the masonry walls have been substantially improved where an external confinement is already provided by the existing iron ties by means of five steel diaphragms in the positions indicated in Figure 1. They are included in the system of the internal stairs as shown in Figure 2 a. Their principal characteristics are shown in Figure 2 b.

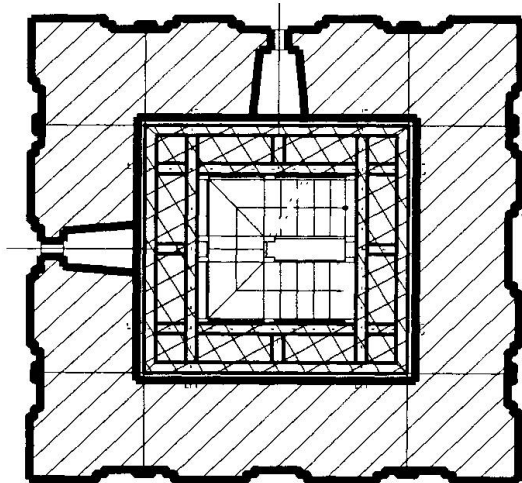
Figure 2 a: section of the tower at the level of one of the diaphragms.

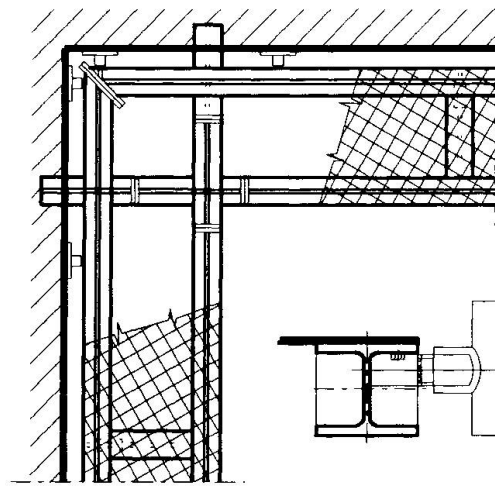
Figure 2 b: details of the steel diaphragms and of the devices used to put them in contact with the masonry walls.

The installation of the diaphragms inside the tower has been made possible by the use of several bolted joints. This construction technique allows the maintenance and, in case, the removal or substitution to be easily executed.

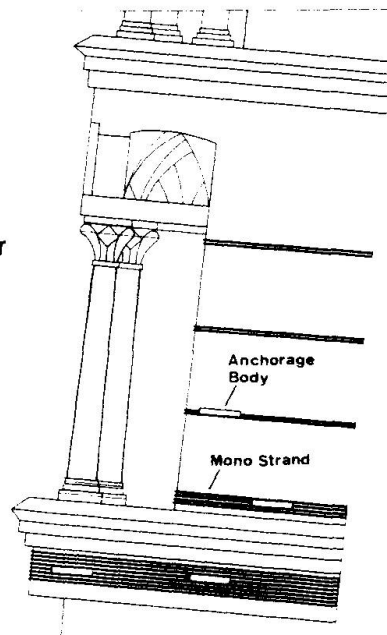
**Fig. 1:**  
Tendon Lay-Out  
at First Loggia

The idea was to wrap a number of prestressing strands around the circumference of the tower in the area of the first loggia as shown in Fig. 1. It was decided to place monostrands distributed over the height of the loggia wall. In addition, 8 monostrands were placed above the arches of the lowest level columns. The tendons were initially stressed to 50 % of their guaranteed ultimate strength. Very strict requirements with regard to the visual and functional effect on the tower were set:

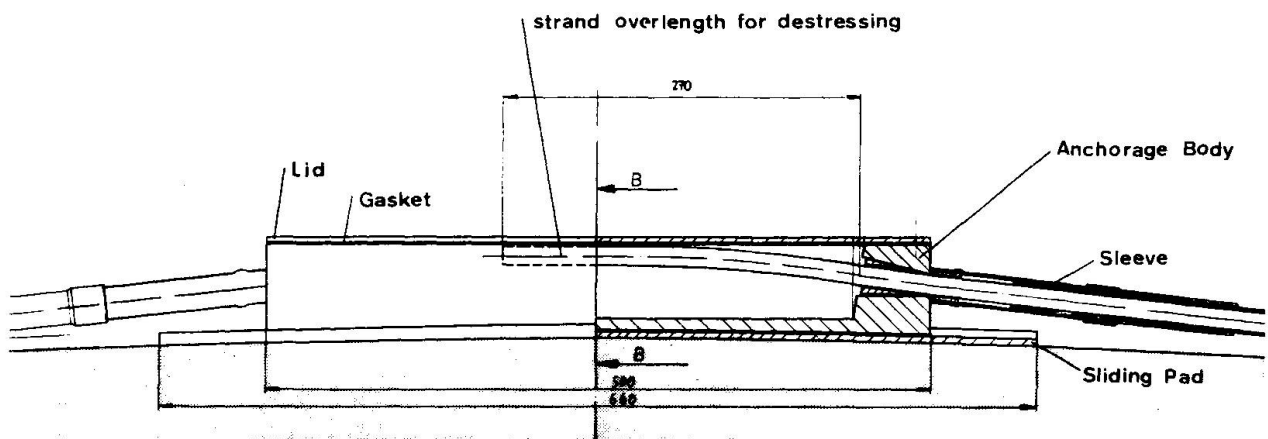
**Fig. 2: Specially Designed Monostrand Anchorage Body on Sliding Pad**

The anchorage system has minimized outside dimensions, thus causing hardly any visual impact on the structure. After stressing, the strand overlength is hidden in the anchorage body and covered by closing the lid as shown in Fig. 2.

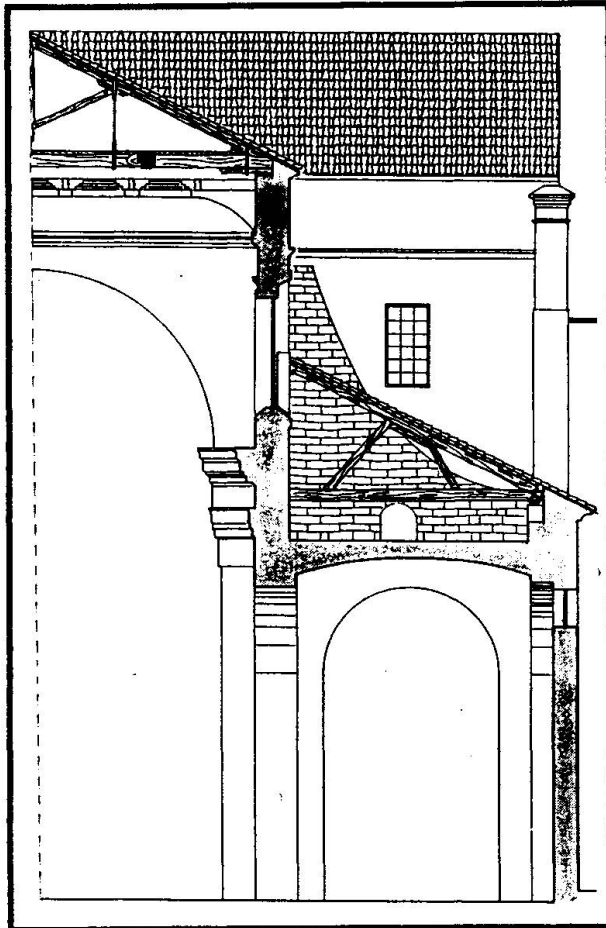
The main diseases were: deep fractures in the arches and in the vaults of both the side aisles, compression failure of some masonry pillars and a substantial foundation settlements in a wide zone between the principal facade and the right side aisle.

The masonry buttresses, built to contrast the seismic lateral loads, fulfilled their function during last earthquake event, but disjoined from the bearing walls and plasticized in the cross sections of lowest strength. The principal facade presented dangerous slipping surfaces and disjunction from the aisles walls, and the outbuildings were diffusely damaged. The wooden coverings were in a severely degraded state.

Fig. 1 Cross-section of the right side aisle before structural rehabilitation

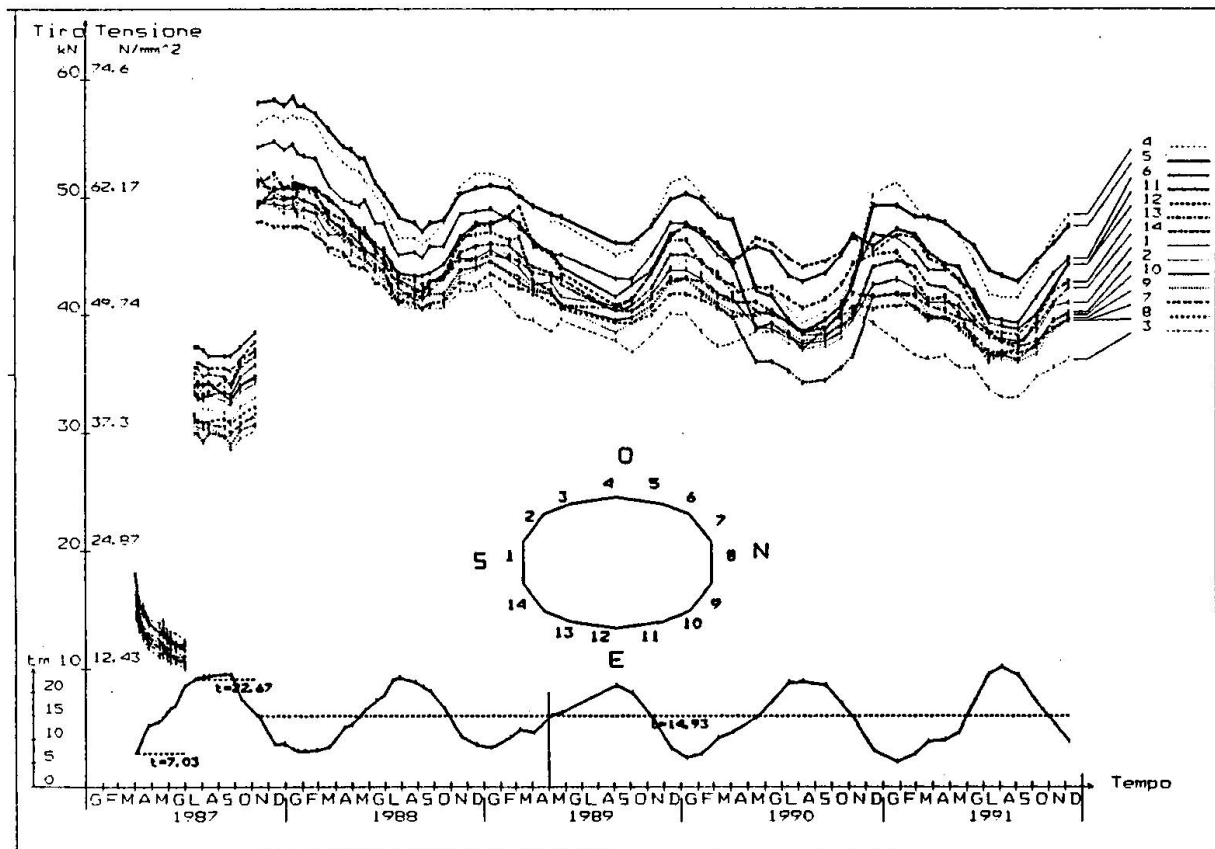
Diagrams of the variation in time of the stresses in the bars over 5 years (as obtained by the monitoring system) have been analysed and a separation between the relaxation of the stresses in the bars (due to plastic flow of the masonry) and parasite stress effects due to the differential thermal dilatation of masonry and steel bars has been tried. Maximum value of mean relaxation of stresses in the 56 tensioning bars has reached the order of 20% of initial values (stress decrease from 50 to 40 KN per bar) in the four years following initial tensioning. (fig.1)

Correlation of these data with monitored movements of the main cracks of the dome leads to the conclusion of the need for a recalibration of the stress levels in the post-tensioning system to be performed in 1993. The need of more reliable data on the internal temperatures in the dome masonry has led to a program for measuring and monitoring these parameters to be operative also in 1993.

Fig.1 Variation in time of forces and stresses in the post-tensioning ring (mean values of 4 bars for each of the 14 sections of the ring) and variation of inside temperatures.

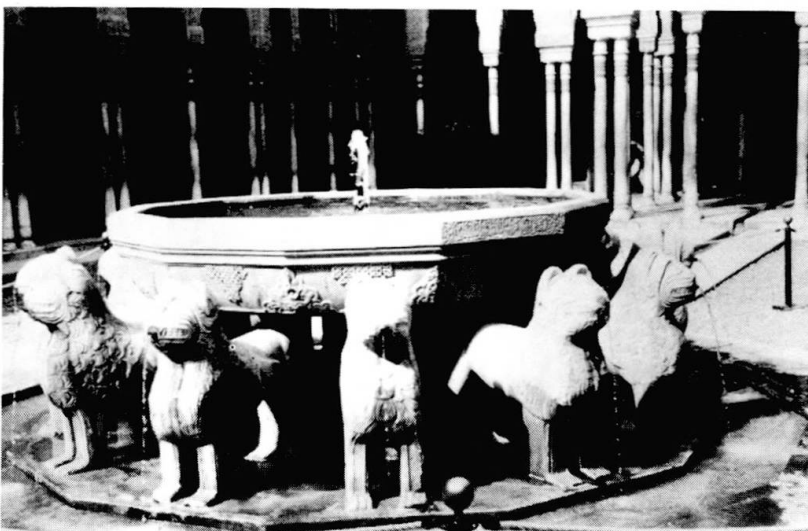
The whole of the Macael marble artifacts, in different structures of the Arab Palaces, show a satisfactory conservation stage, with some exceptions: e.g., colonnades in "Patio de los Leones" (figure 1).

Fig. 1 "Patio de los Leones", Alhambra.

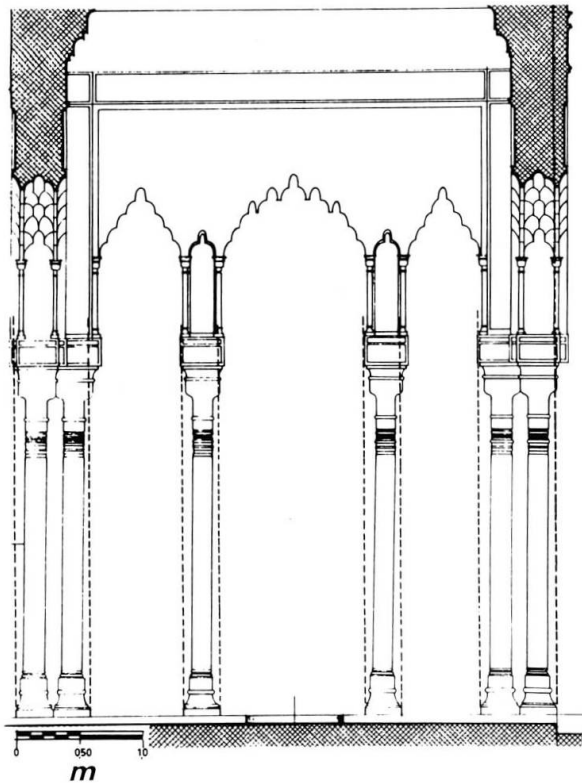
Fig. 2 Static situation, drawn in 1976, for "Templete de los Mocarabes", Court of the Lions.

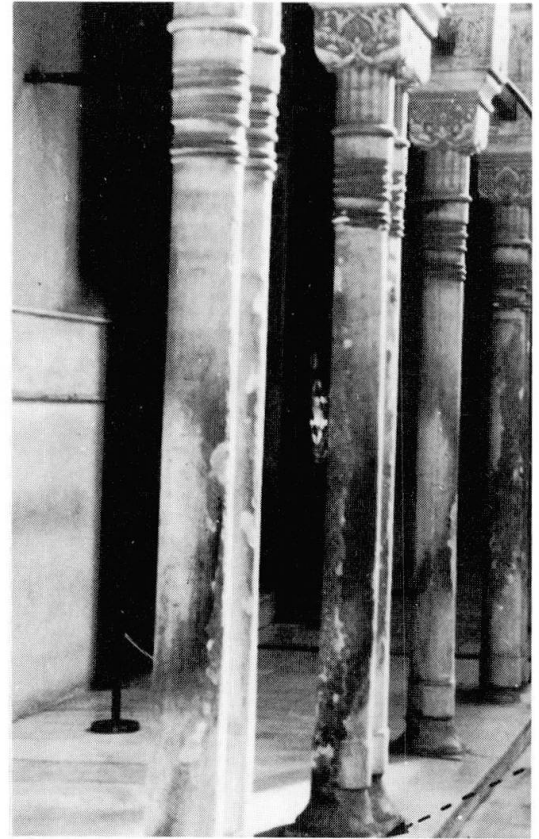
Fig. 3 Progressive reduction in height of bases, and damaged shafts according to mechanical weakness plane.

by direct correlations between the increases of the apparent decay degree and total anisotropy index, measured in marble artifacts. Moreover, this evolution has been related to: a) rotation of the foliation plane, consistent with the shaft placement, influencing the durability of the artifacts under the same exposure conditions; and b) evident displacements of the original static conditions (figure 2), and new signs of differential settlement and plumb-line diversifications in severe damaged shafts, recognized particularly in the "Galeria de Dos Hermanas" colonnade (figure 3).

A convenient control on stability conditions of the colonnades appears useful to found the adequate maintenance interventions, before carrying out replacements of damaged marble artifacts and/or protective treatments.
