Structural Reinforcement of the Cathedral in Cava dei Tirreni

Nicola AUGENTI

Professor
Univ. of Naples
Naples, Italy

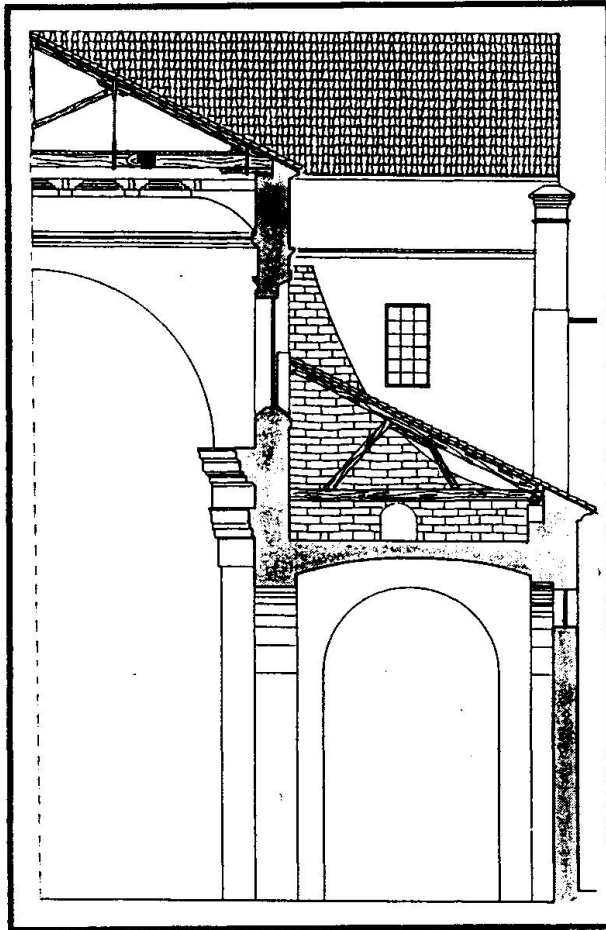
The main diseases were: deep fractures in the arches and in the vaults of both the side aisles, compression failure of some masonry pillars and a substantial foundation settlements in a wide zone between the principal facade and the right side aisle.

The masonry buttresses, built to contrast the seismic lateral loads, fulfilled their function during last earthquake event, but disjoined from the bearing walls and plasticized in the cross sections of lowest strength. The principal facade presented dangerous slipping surfaces and disjunction from the aisles walls, and the outbuildings were diffusely damaged. The wooden coverings were in a severely degraded state.

Fig. 1 Cross-section of the right side aisle before structural rehabilitation

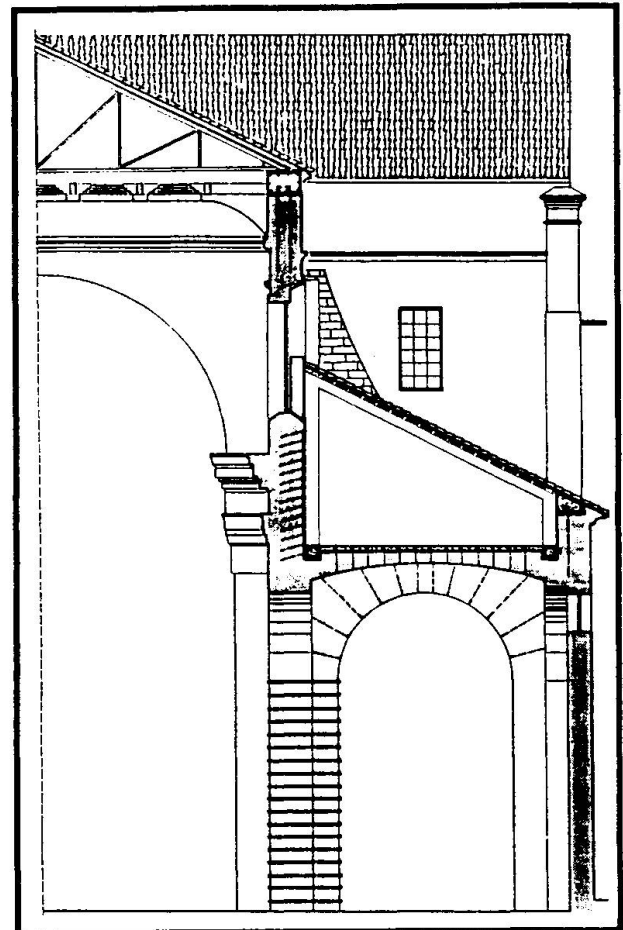
Fig. 2 Cross-section of the right side aisle after structural rehabilitation

The task of contrasting the seismic lateral loads is now performed by reinforced concrete frames effectively shaped, which are much lighter than the demolished tuff buttresses and have a much higher strength per unit volume. These elements bear the new r.c. pitch roof of the lateral aisle, and allow a complete connection between the pillars-arches complex and the masonry walls of the central nave: r.c. and masonry are linked together by means of steel nails.
