Structural rehabilitation of an industrial steel building

Structural Rehabilitation of an Industrial Steel Building

Nicolae TARANU, Petru STRATEANU and Dorina ISOPESCU

Department of Civil Engineering
Technical University of Iasi, Romania

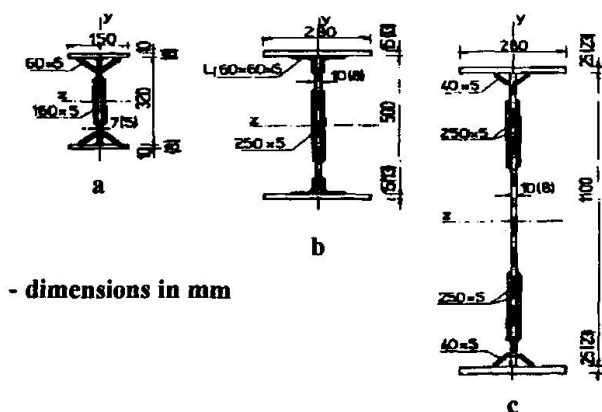
The verification procedures for ultimate limit states and for serviceability limit states have been applied according to the Romanian Standard STAS 10108/0, and to the Code P-100-92, for design of structures in seismic zones. To assess the corrosion effect on the loadbearing capacity of the structural steel members the initial geometric characteristics (A_0 =the noncorroded initial area and W_0 =the noncorroded initial section modulus) have been compared with the same properties after exploitation in corrosive atmosphere (A_c =the corroded cross-sectional area and W_c =the section modulus of the corroded structural members). The numerical values of the deterioration ratios have been calculated for all main structural members as follows: purlins, $W_c/W_0 = 0.785$; crane girders, $W_c/W_0 = 0.912$; columns, $W_c/W_0 = 0.789$ and $A_c/A_0 = 0.820$; frame girders, $W_c/W_0 = 0.823$ at midspan, and $W_c/W_0 = 0.901$ on columns.

Fig.2 Strengthening solutions of bent elements: a-purlins; b&c-tapered frame girders

To restore the initial loadbearing capacity of the steel members, the strengthening solutions presented in figs.2 and 3, have been proposed. The strengthening pieces illustrated by dashed areas have been attached to the weakened members after careful cleaning of the corroded elements. The dimensions given in the parenthesis correspond to the corroded areas. After consolidation the ratios between the strengthened sections characteristics (W_1, A_1) and the initial ones (W_0, A_0) have been calculated: purlins, $W_1/W_0 = 1.03$; columns, $W_1/W_0 = 1.04$ and $A_1/A_0 = 1.02$; frame girders, $W_1/W_0 = 1.08$ at midspan, and $W_1/W_0 = 1.02$ on columns.

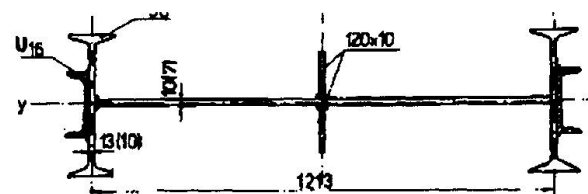
Fig.3 Cross-section strengthening of the main steel columns
